Summary of Results

Walk the WBID Exercise for Wagner Creek (WBID 3288A)

September 2011

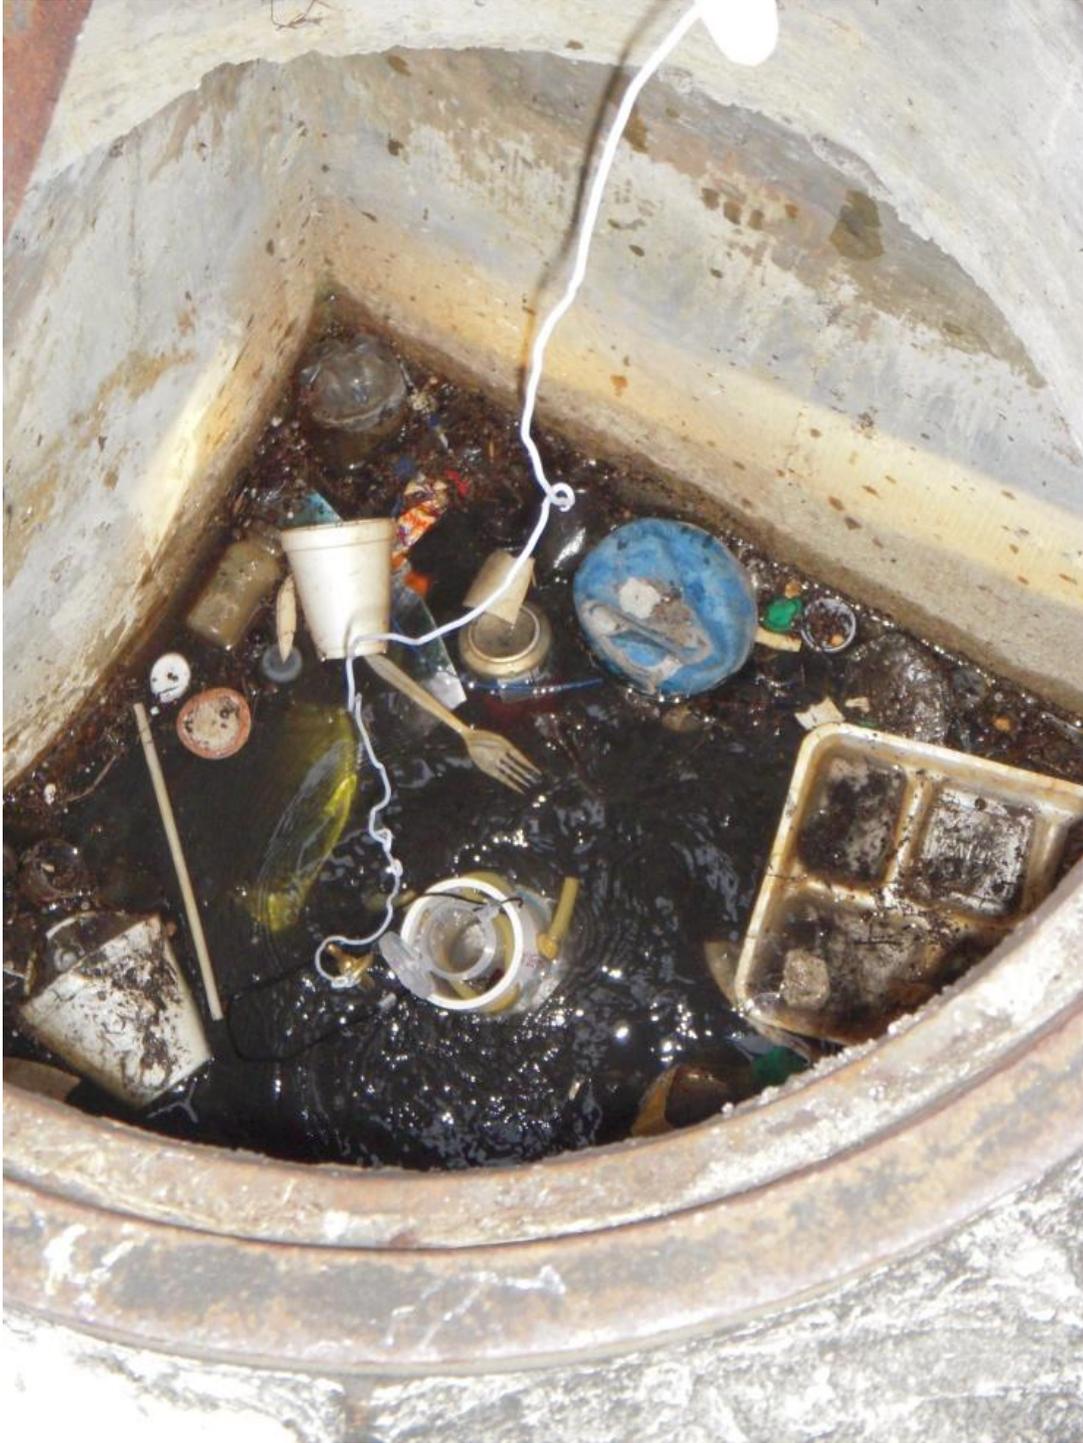
Figure 3. *Trash and debris in a stormwater manhole thought to be at the headwaters.*

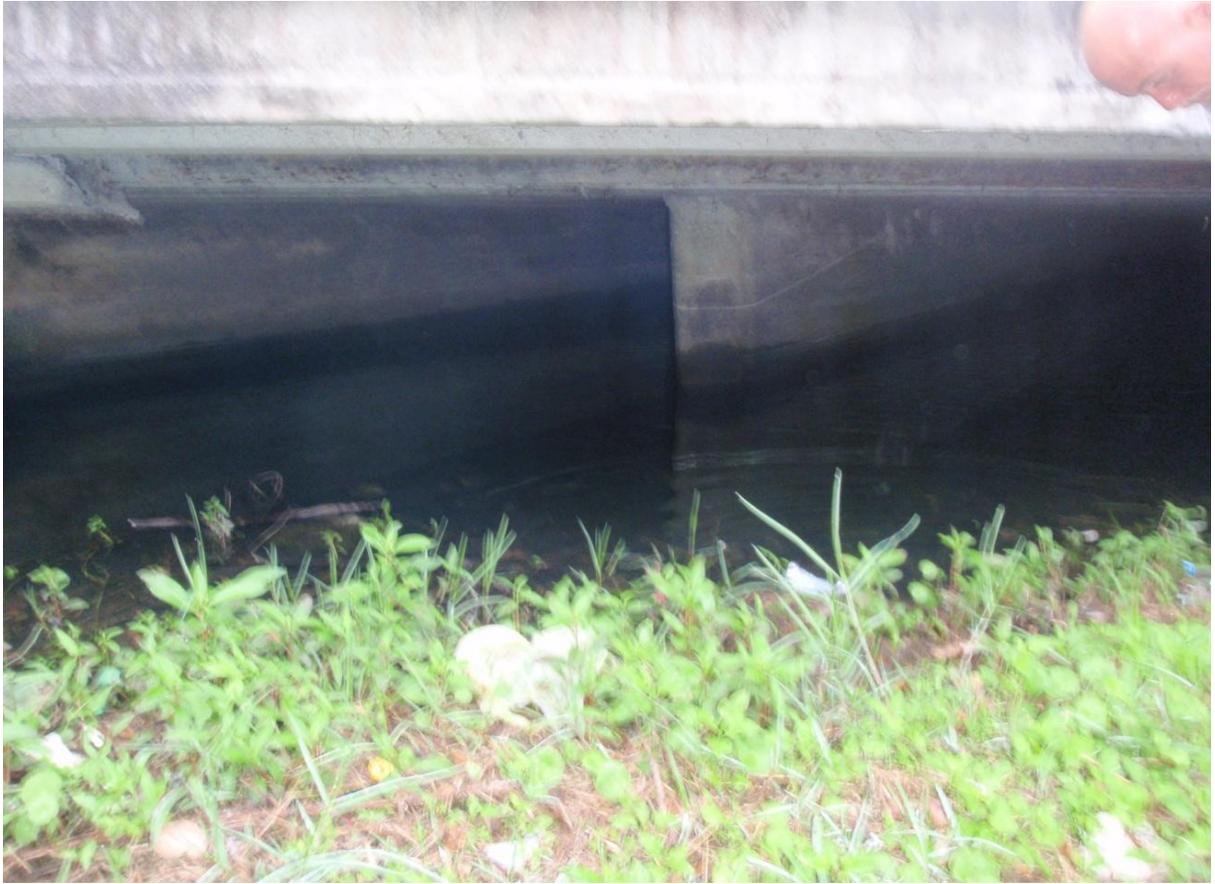
Figure 5. View of stagnant water and trash buildup in the stormwater conveyance that flows underground to the 20th Street Bridge; the accumulation may be caused by a blockage and should be investigated. This may be where the perennial portion of Wagner Creek now begins.

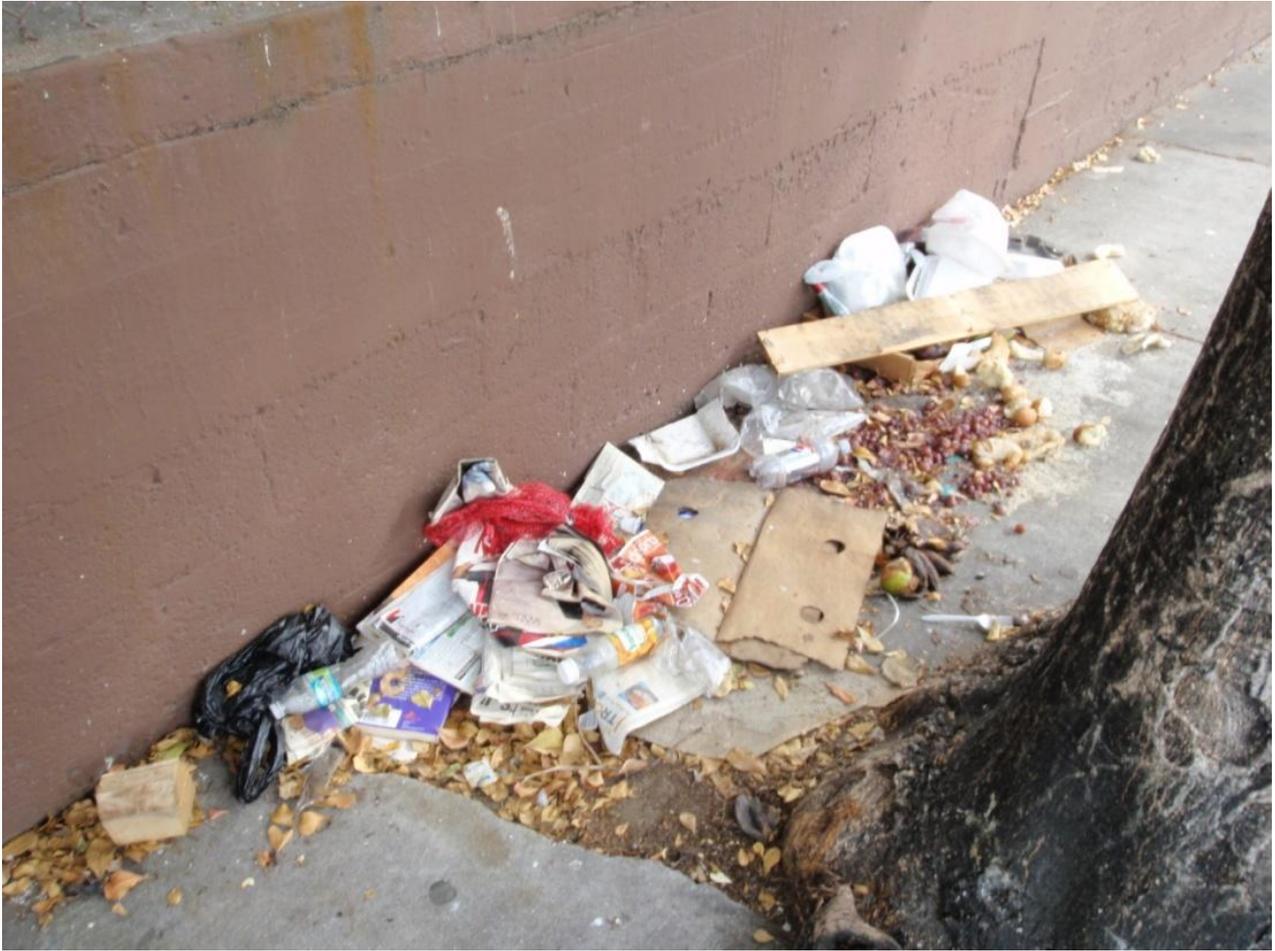
Figure 9. Trash and debris along the street at the Allapattah Produce Market.

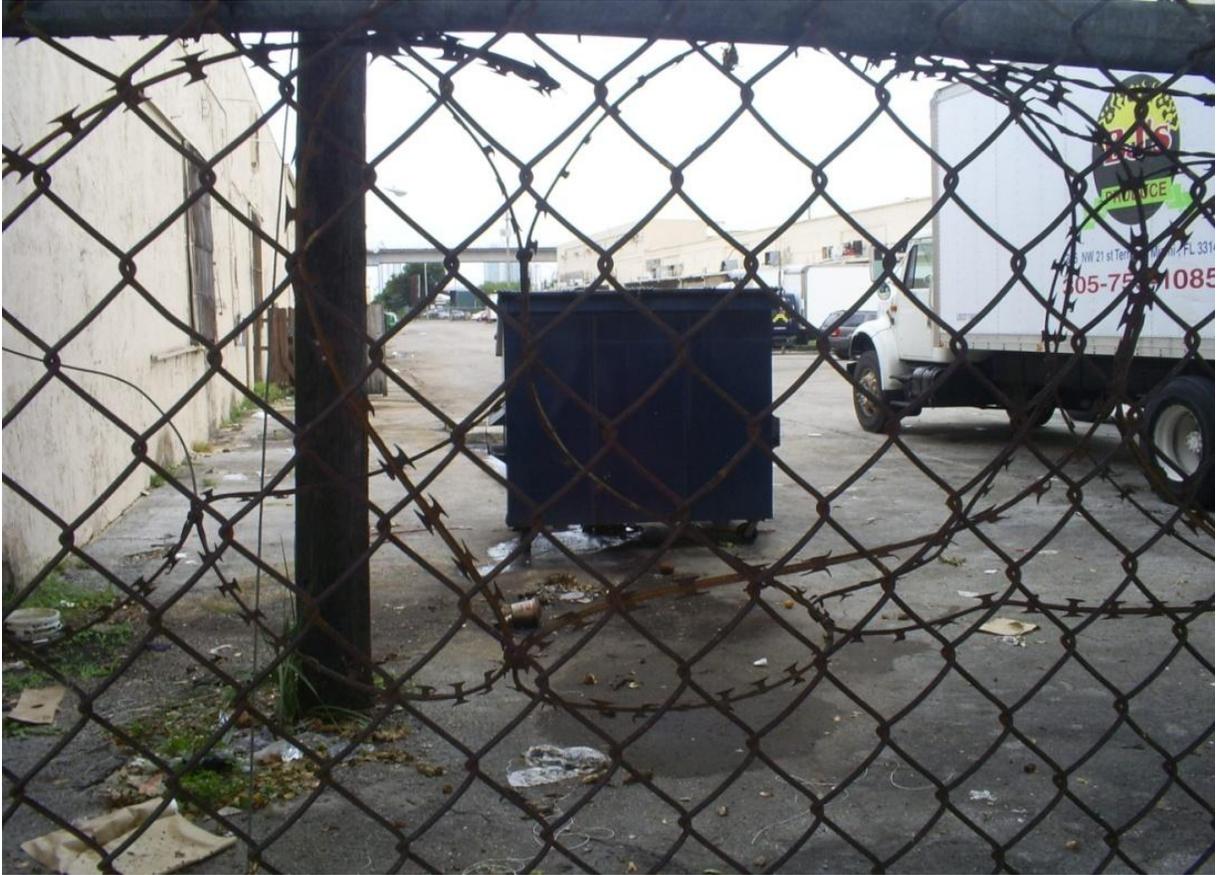
Figure 12. *Unsecured lids on a dumpster at the Allapattah Produce Market. The field team made observations at 1265 NW 21st Terrace.*

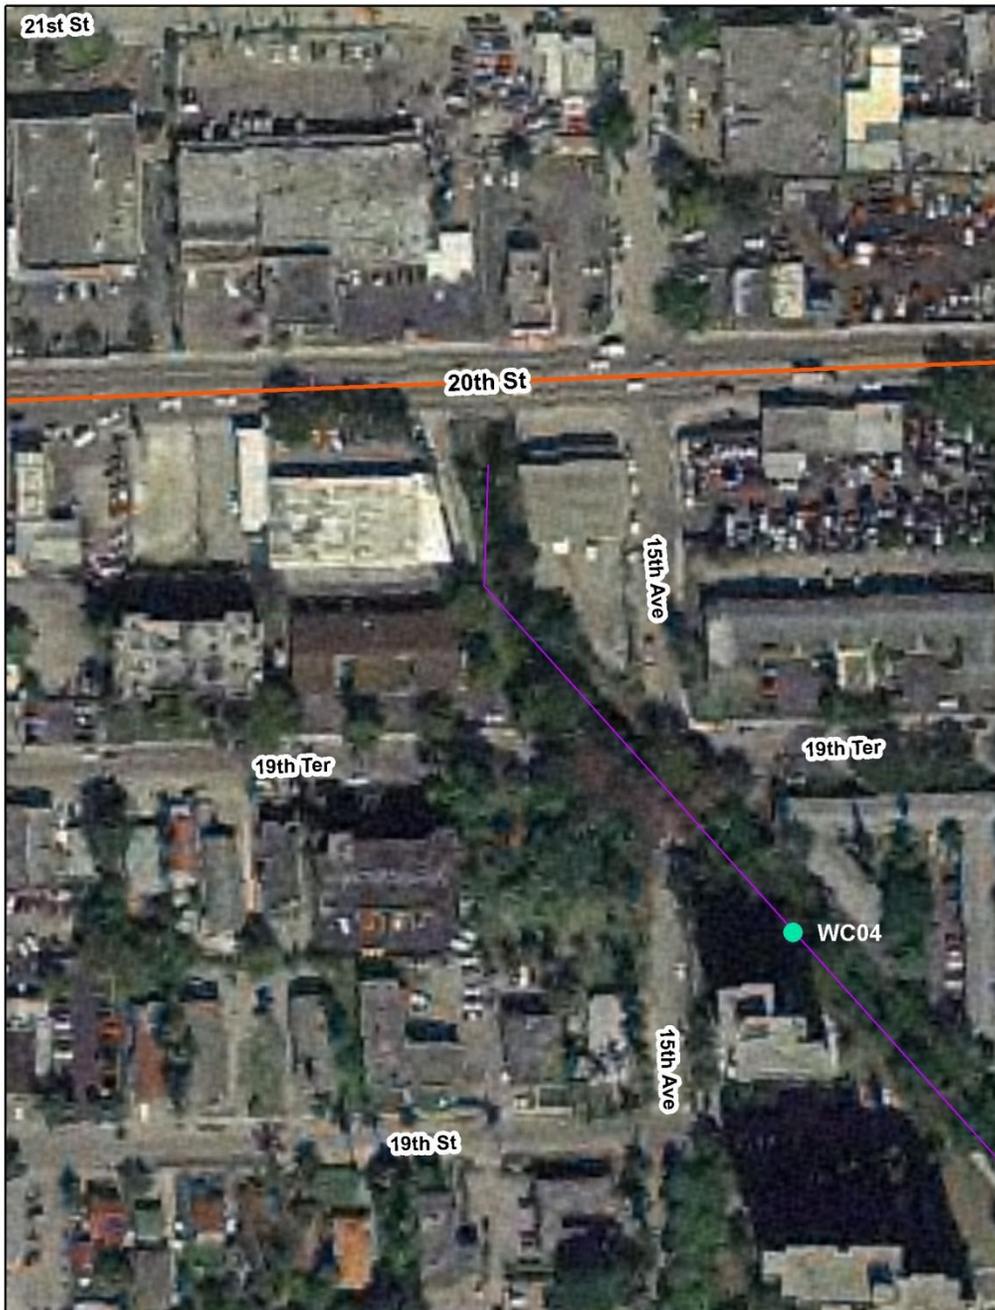
Figure 14. Aerial photo showing the location of Station DADEWC04, in Wagner Creek–Seybold Canal. Popeye’s Chicken is located on the north side of NW 20th Street near where Wagner Creek first emerges from the underground culvert. A storm drain belonging to the Popeye’s Chicken parking lot was observed to be completely full of debris.

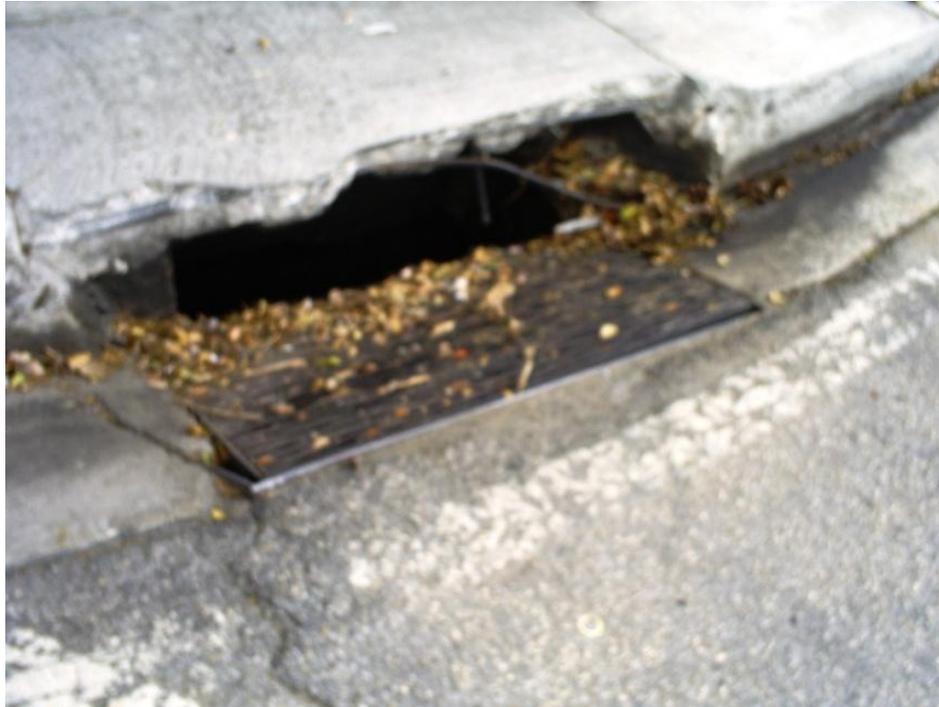
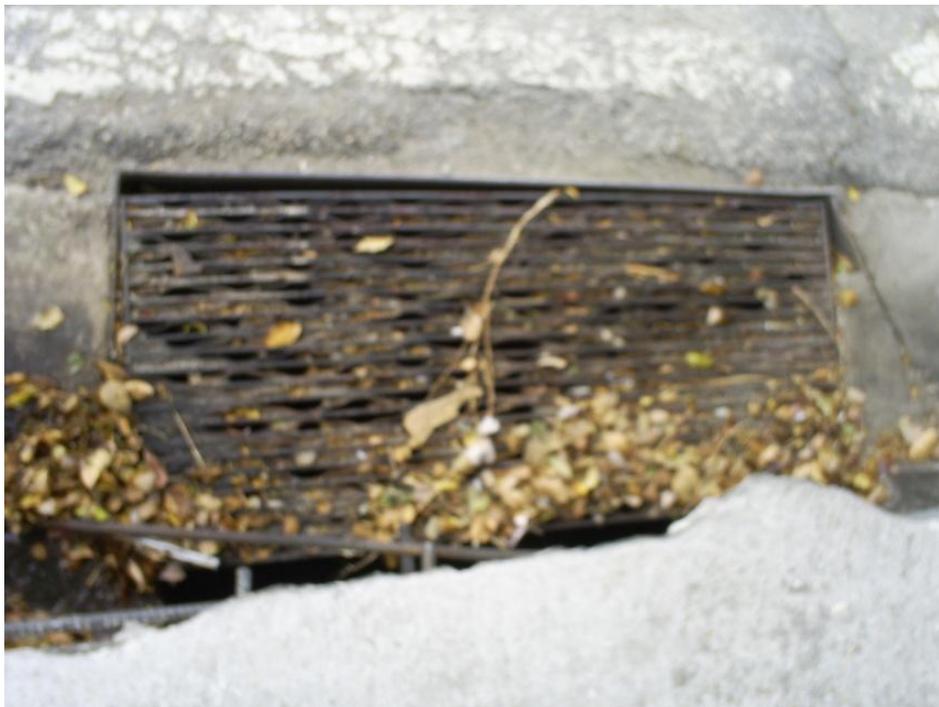
Figure 19. Broken storm drain covers at NW 20th Street belonging to Miami–Dade County; the openings allow trash and other materials to enter the underground conveyance directly and provide a breeding ground for fecal coliform.

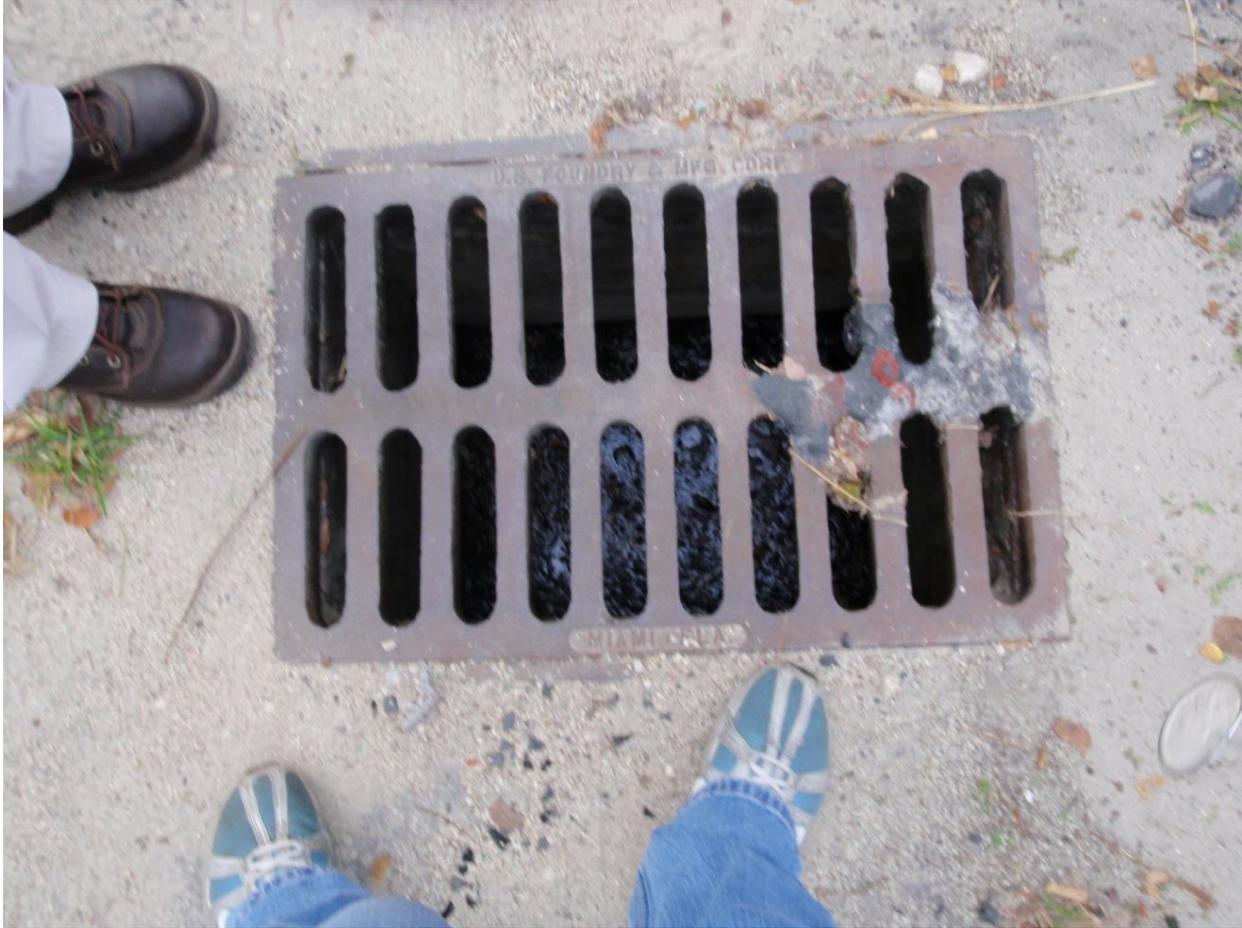
Figure 20. A storm drain on NW 15th Avenue south of NW 20th Street is filled with trash and not draining properly; any flooding that results could cause a failure of the wastewater system, and trash can provide a breeding ground for fecal coliform.

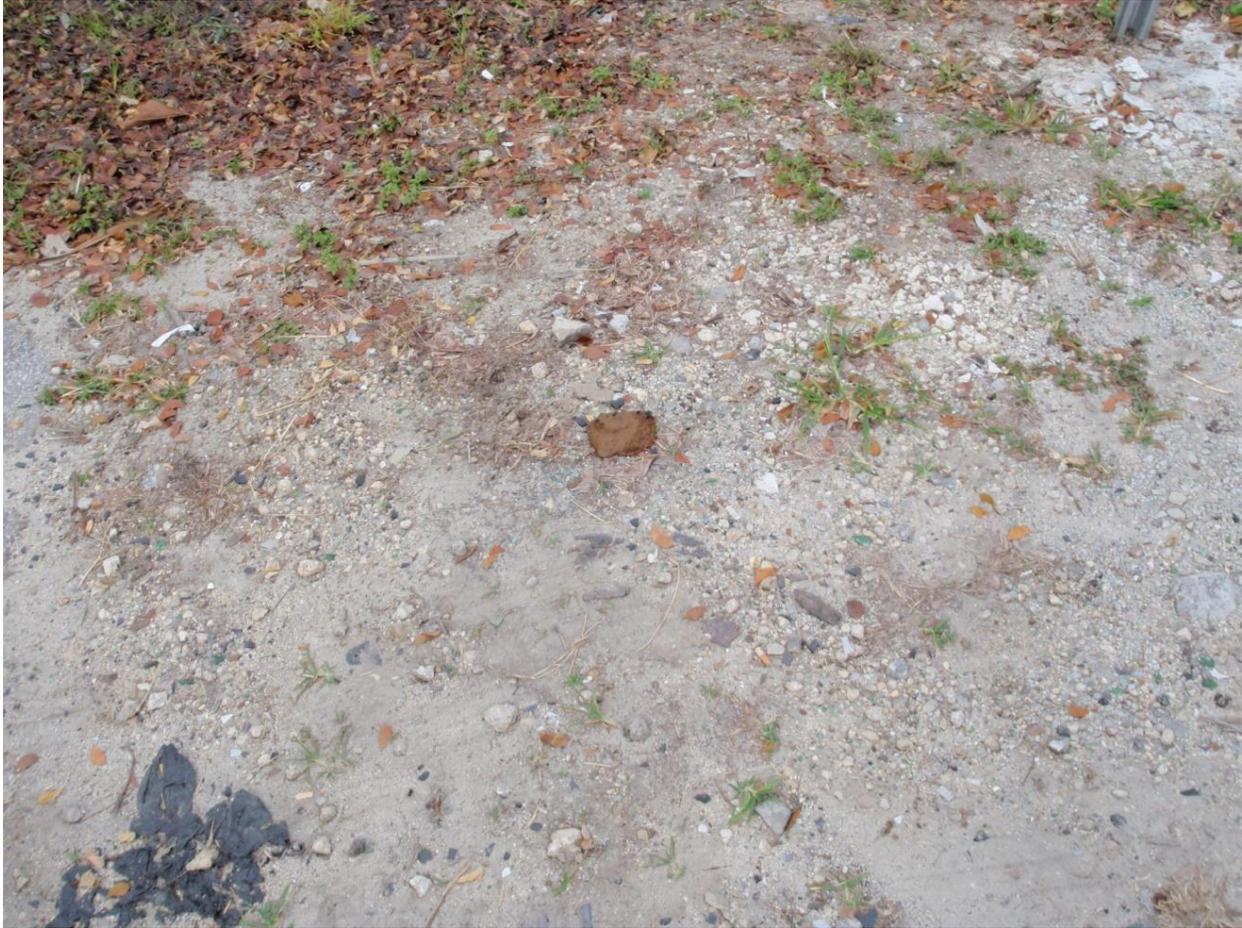
Figure 21. Dog feces were observed near a stormwater drain at 20th Street; both sides of Wagner Creek near the 20th Street Bridge are popular areas for dog walking, and rainfall could wash fecal coliform from these areas into the creek.

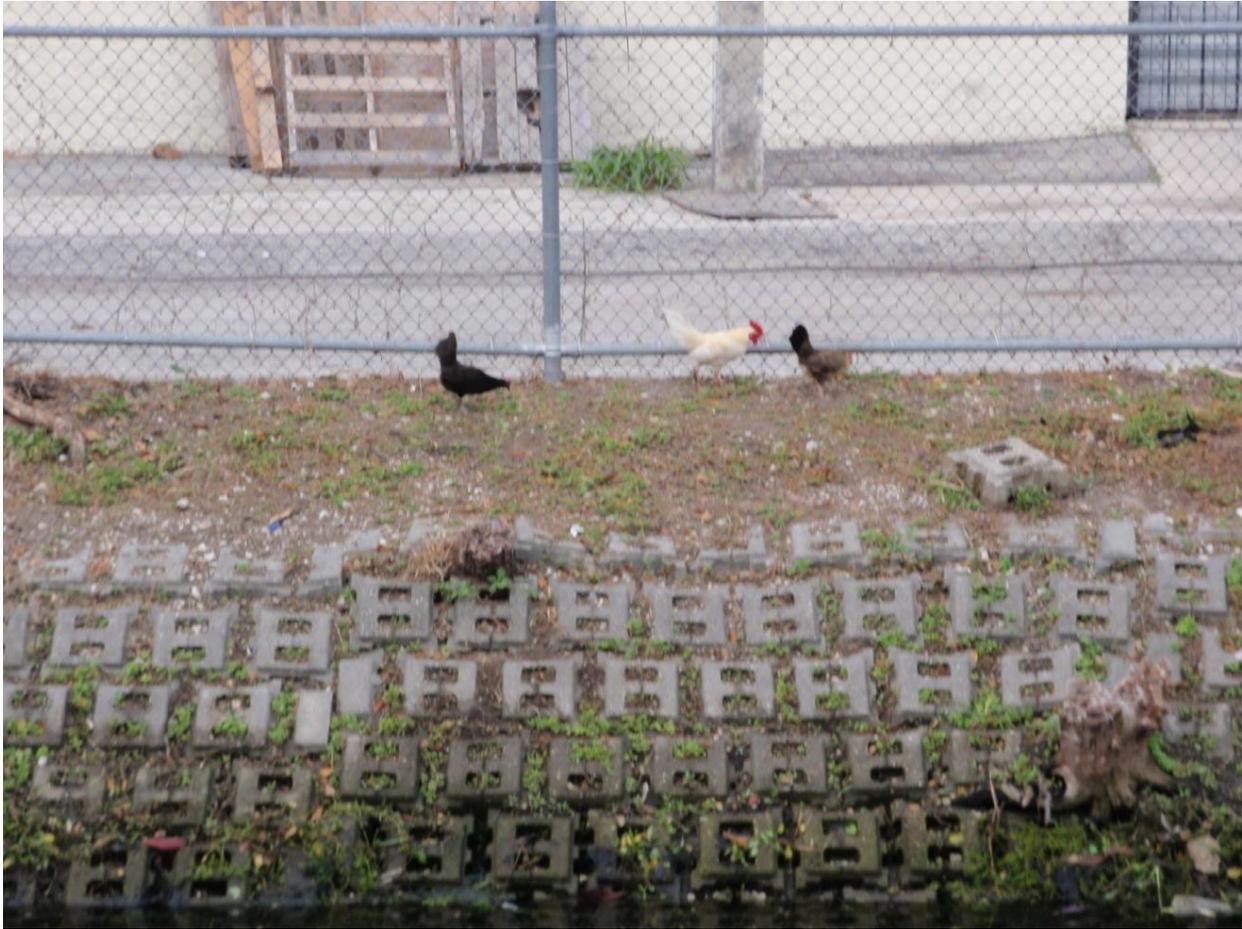
Figure 22. Free-range chickens and a rooster were observed along the creek downstream of the 20th Street Bridge; their feces could wash into the creek, causing fecal coliform contamination.

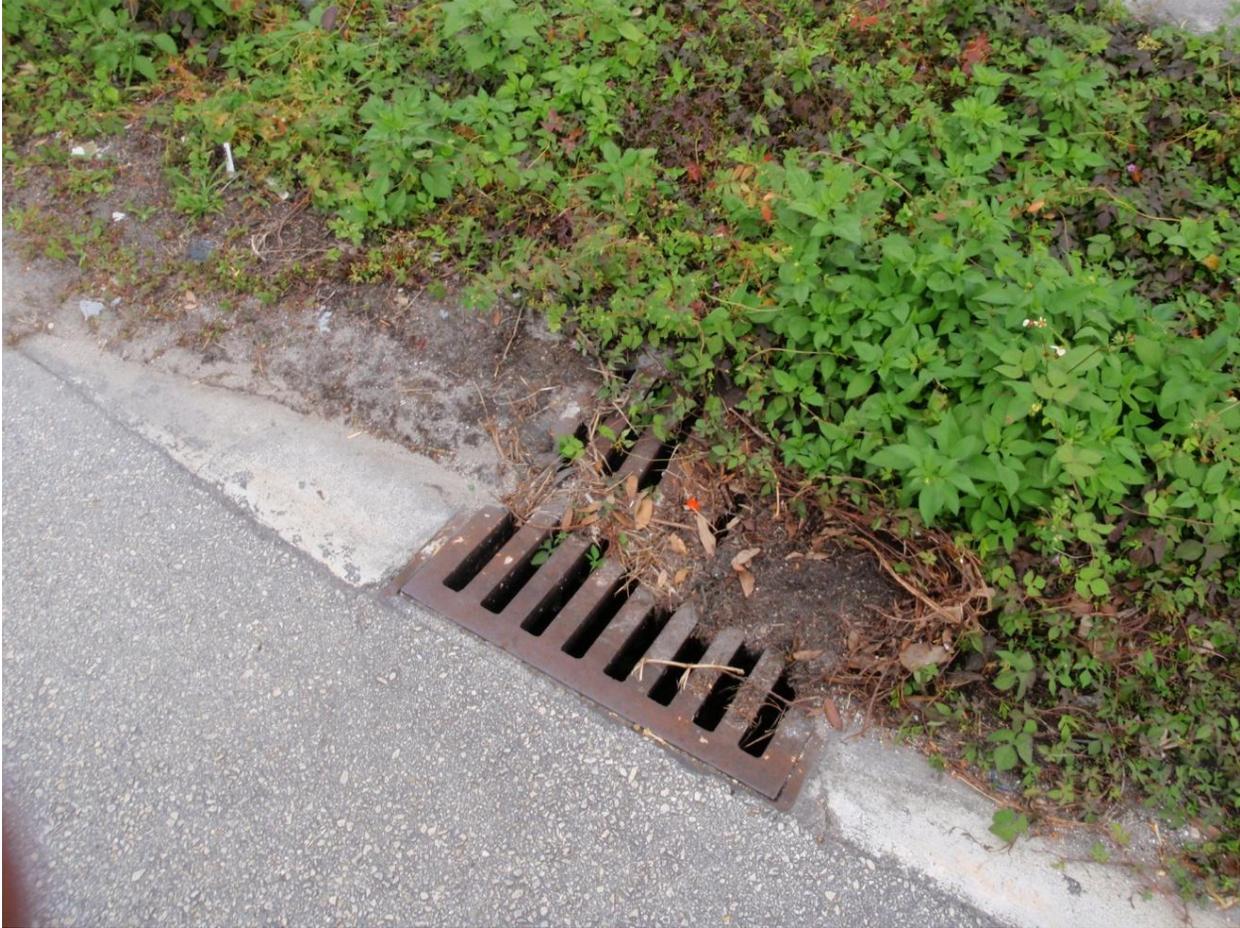
Figure 25. View of a partially blocked stormwater drain at 1501 to 1511 NW 13th Court; any flooding that results could lead to the failure of septic and wastewater infrastructure.

POST-FIELD EVENT NOTE: The City of Miami's records indicate that this inlet discharges via an outfall to Wagner Creek and that there have not been any flooding complaints at this location for the past two and a half years. Only two flooding complaints were found for NW 13th Court between NW 15th and NW 16th Streets from November 2006, to March 30th, 2011. This inlet is maintained by the City of Miami Public Works Department.

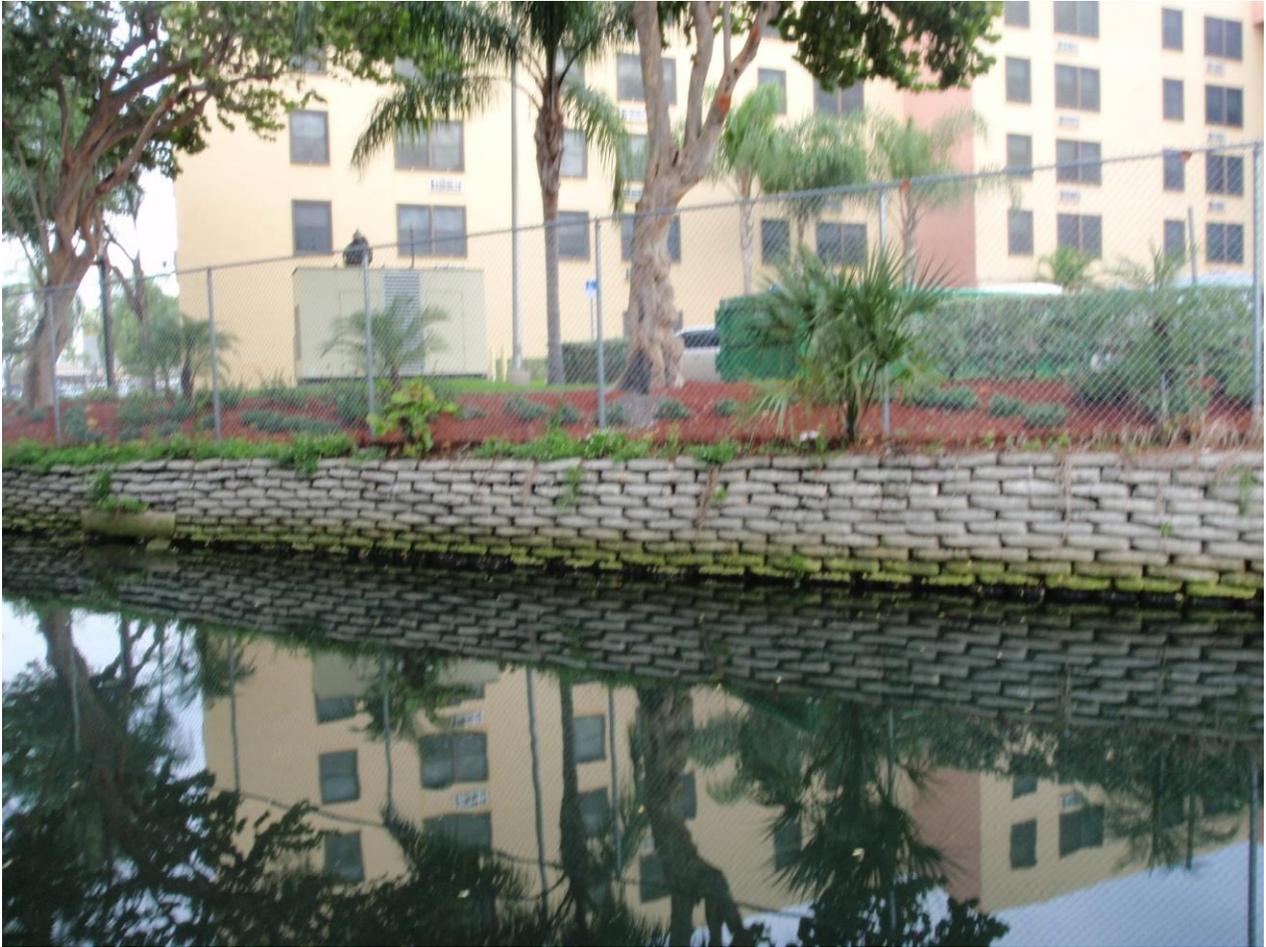
Figure 28. *Apartments along the creek at 1310 NW 16th Street, with private storm drain outlets that discharge directly to the creek; this is a gated community, with no access for an inspection.*

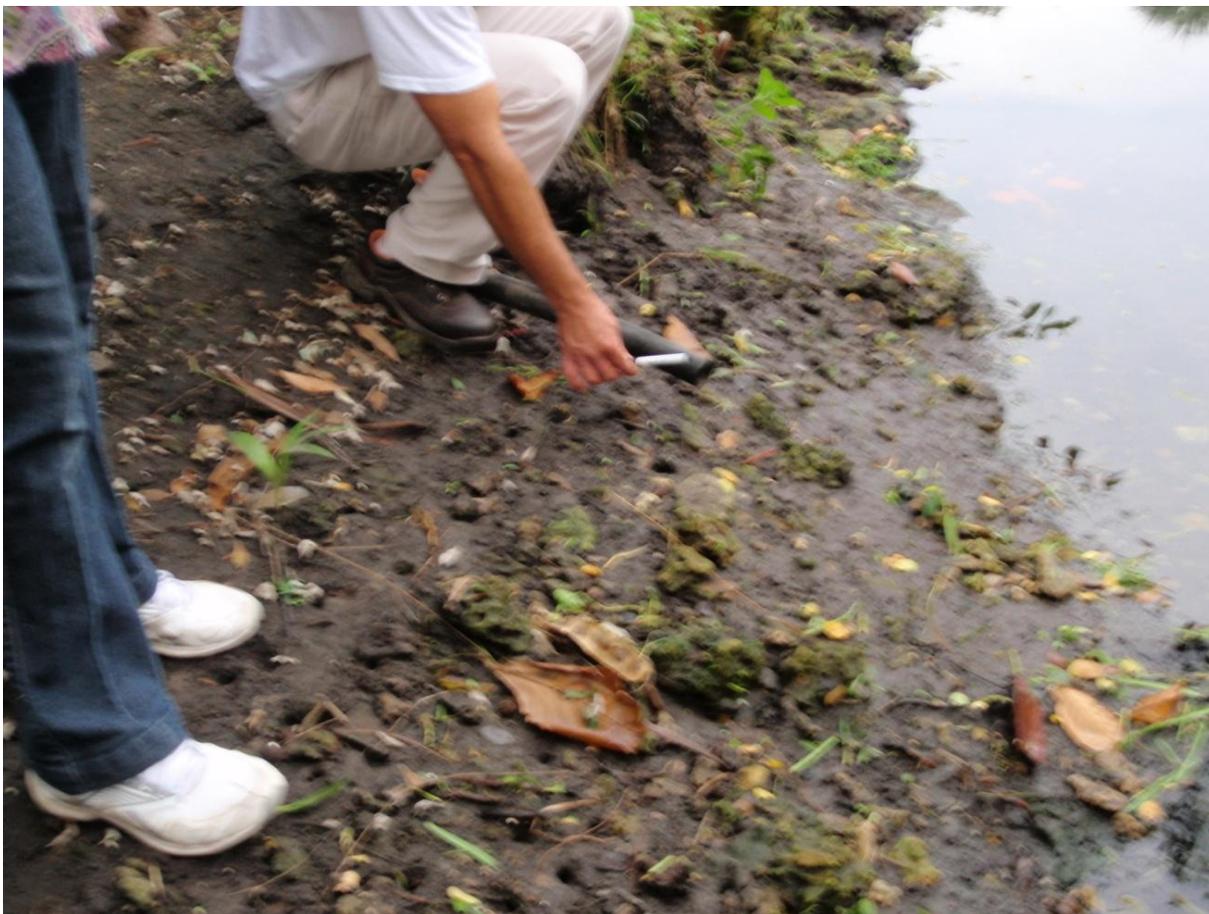
Figure 29. PIC 1 at NW 13th Court consisted of a pipe sticking out of the ground.

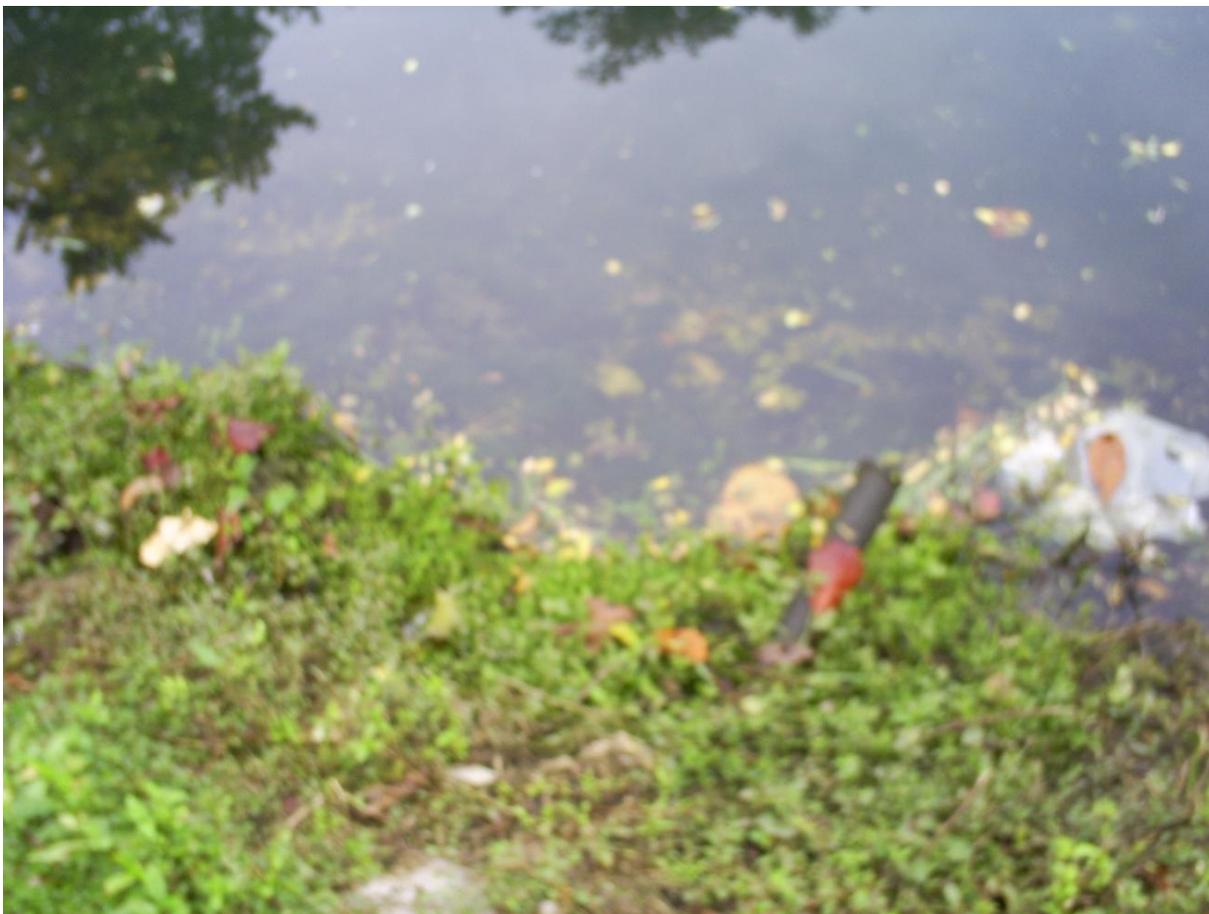
Figure 30. PIC 3 consisted of an unknown pipe sticking out of the ground.

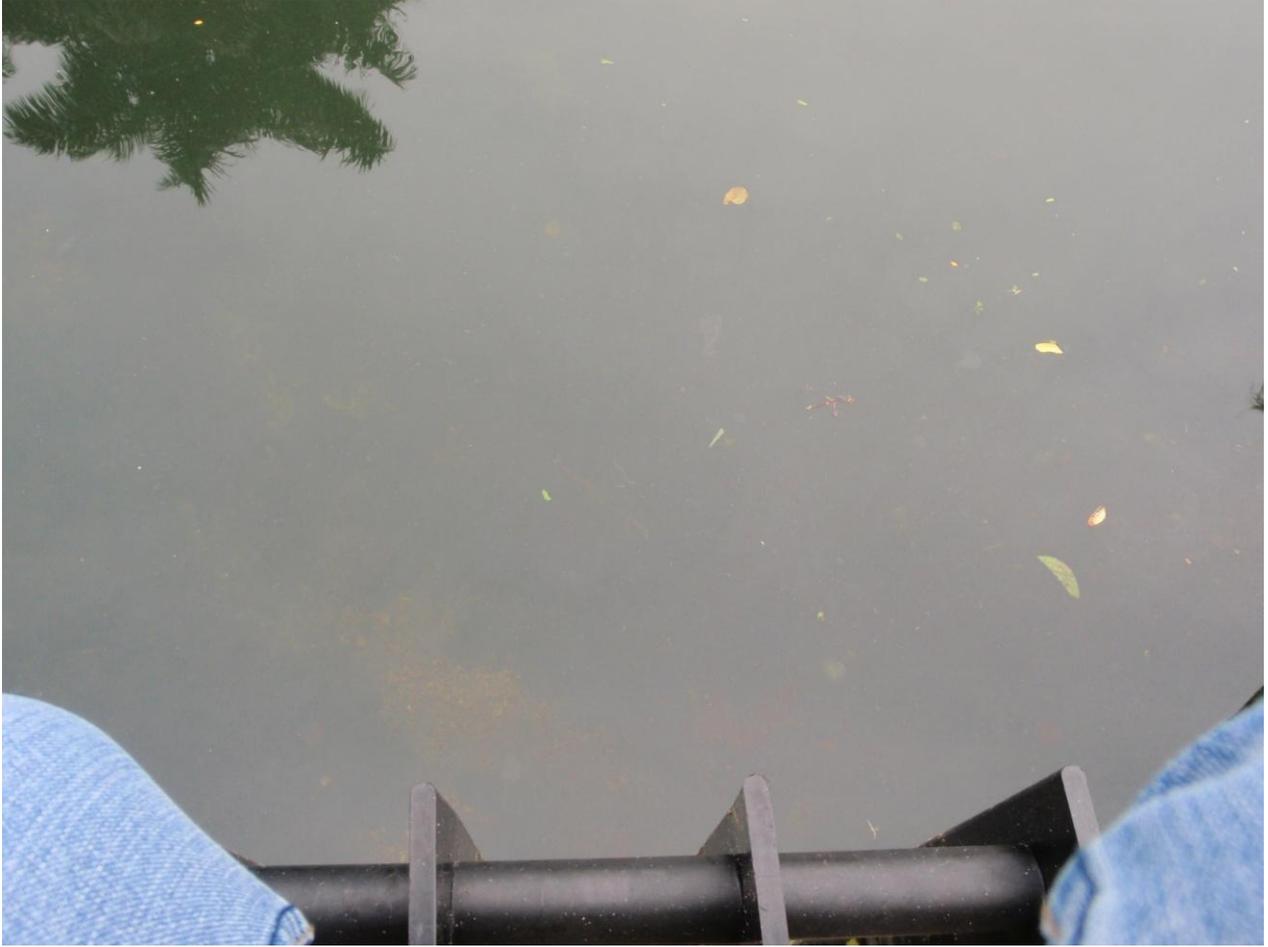
Figure 32. Solids and oils floating on surface water at a stormwater outfall from the VA Hospital building.

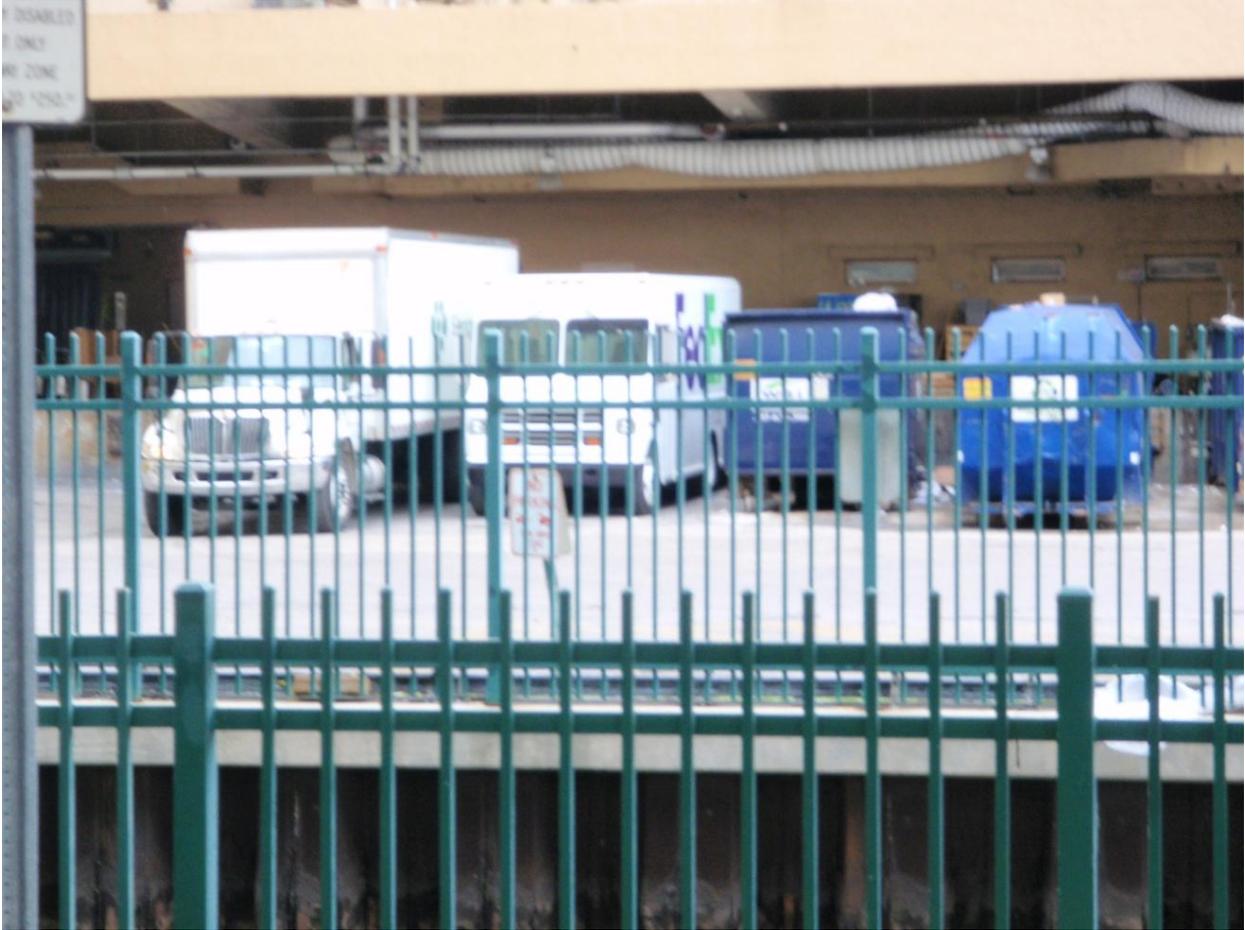
Figure 35. A channelized Wagner Creek flowing past the University of Miami Medical Center, showing dumpsters and trucks right next to the creek, with no berm to prevent untreated stormwater runoff from entering the water.

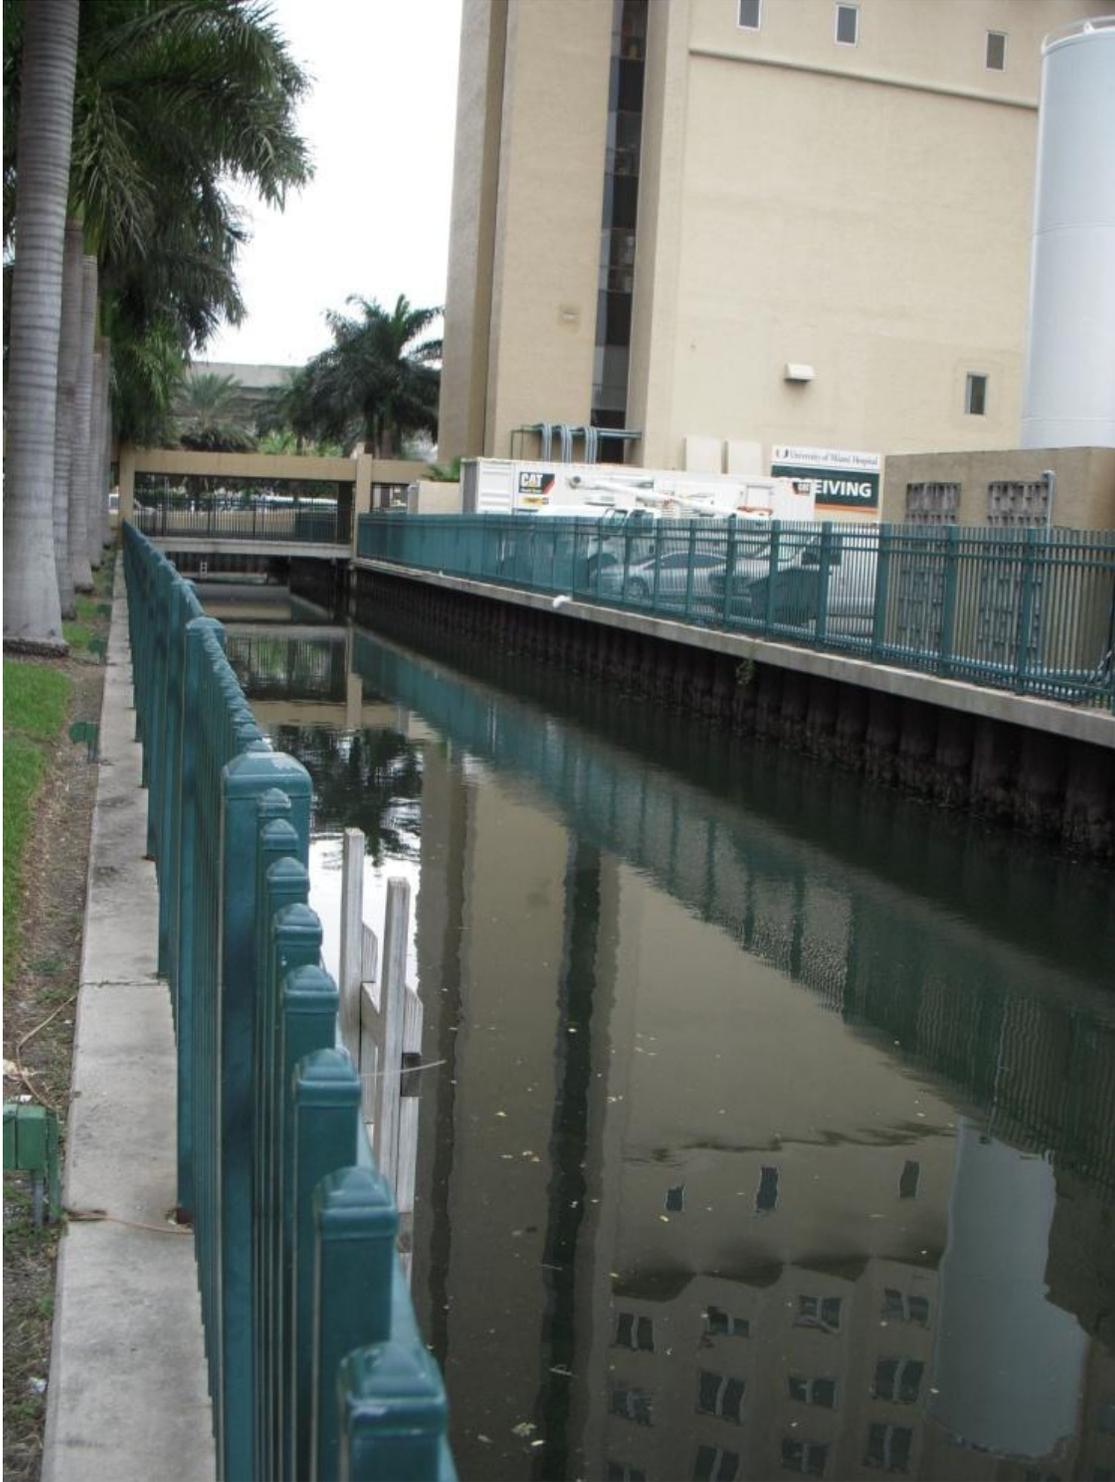
Figure 38. Wagner Creek is channelized next to the University of Miami Medical Center. When the hospital was built, the creek was rerouted to make a 90-degree turn so that there would be enough space on the existing lot to place the hospital building.

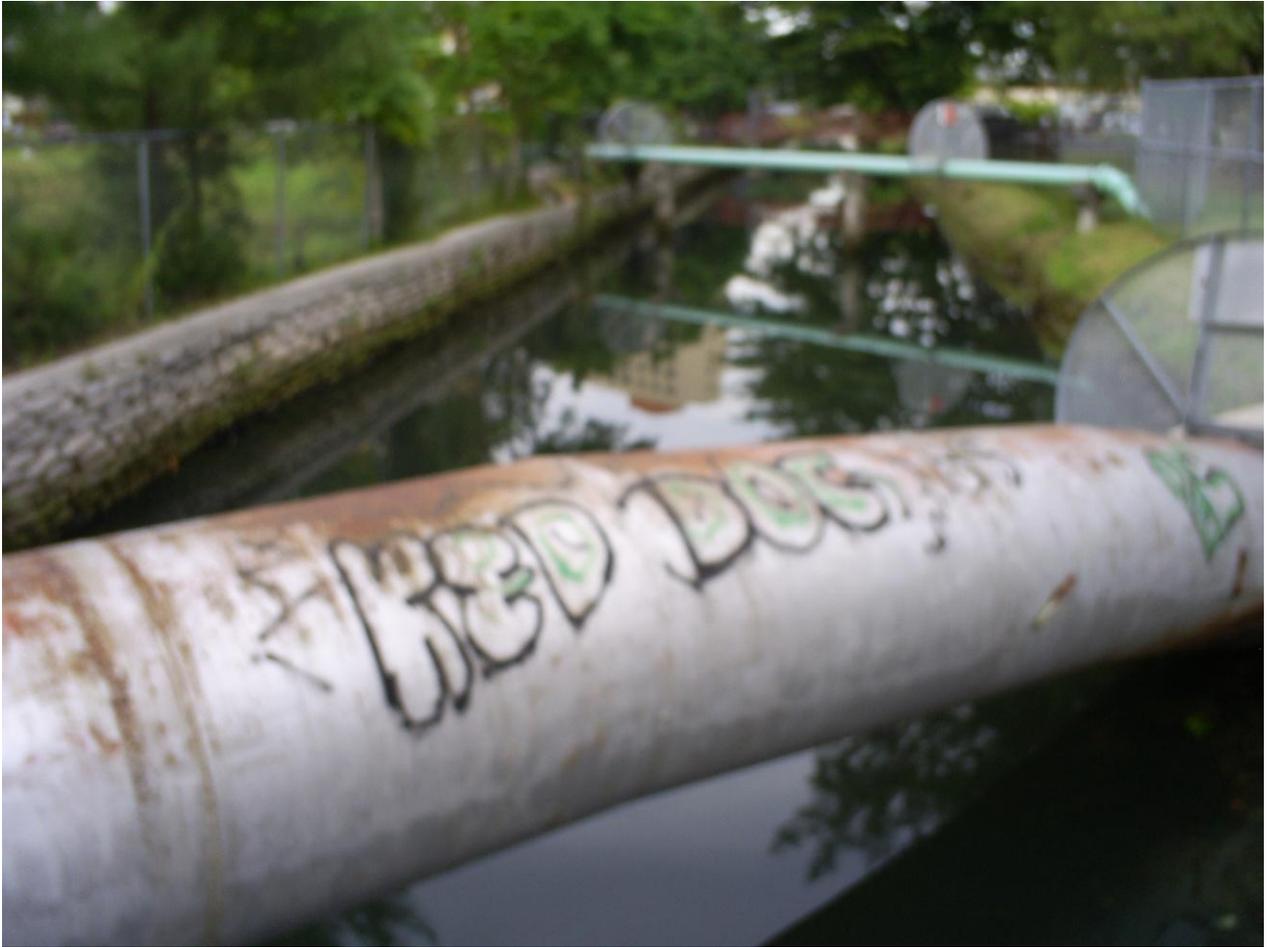
Figure 39. Abandoned sewer line crossing the creek north of the NW 17th Street Bridge.

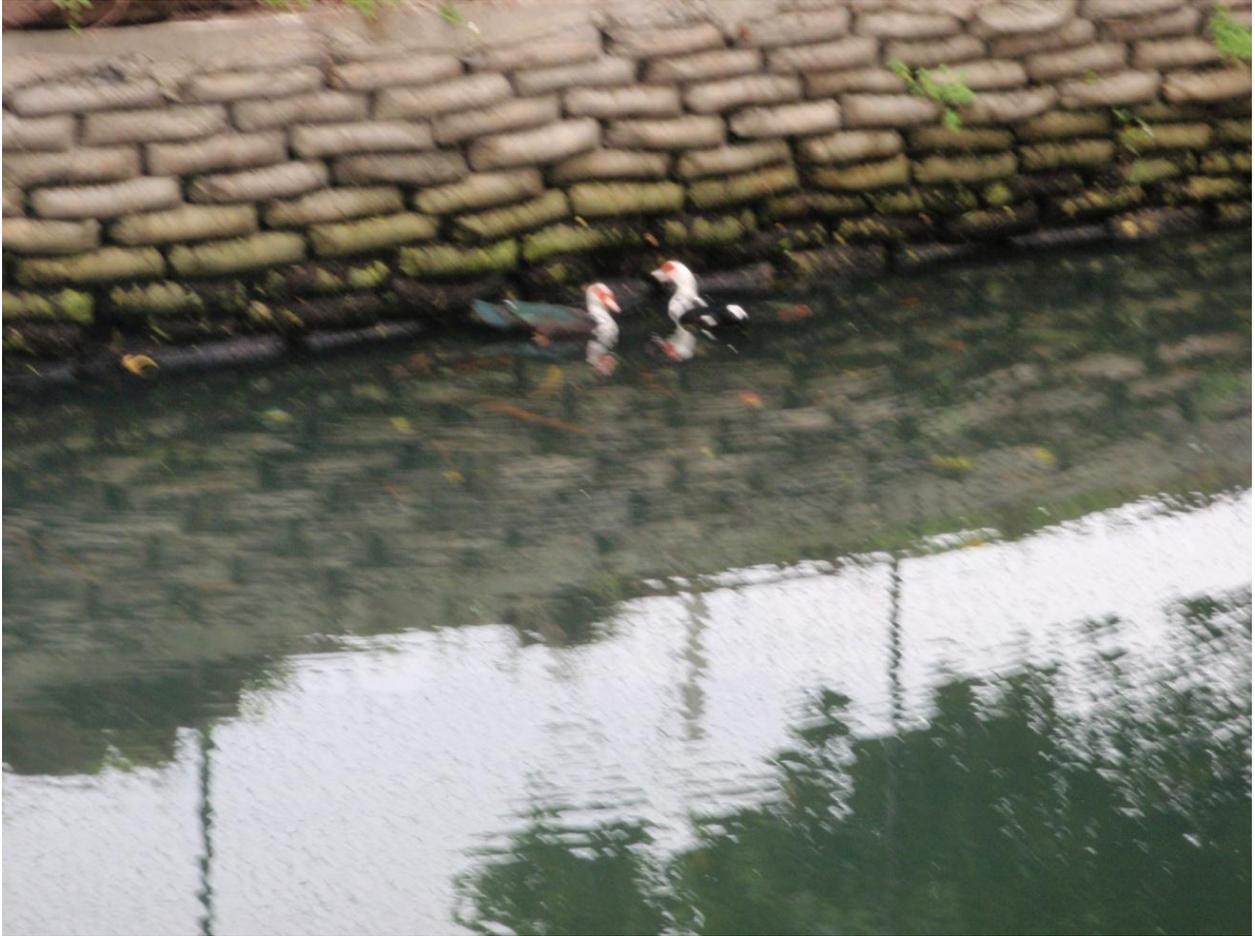
Figure 40. Muscovy ducks in the creek at NW 14th Avenue; waterfowl can be a source of high fecal coliform bacteria in surface waters.
