Summary of Results

Walk the WBID Exercise for Wagner Creek (WBID 3288A)

September 2011

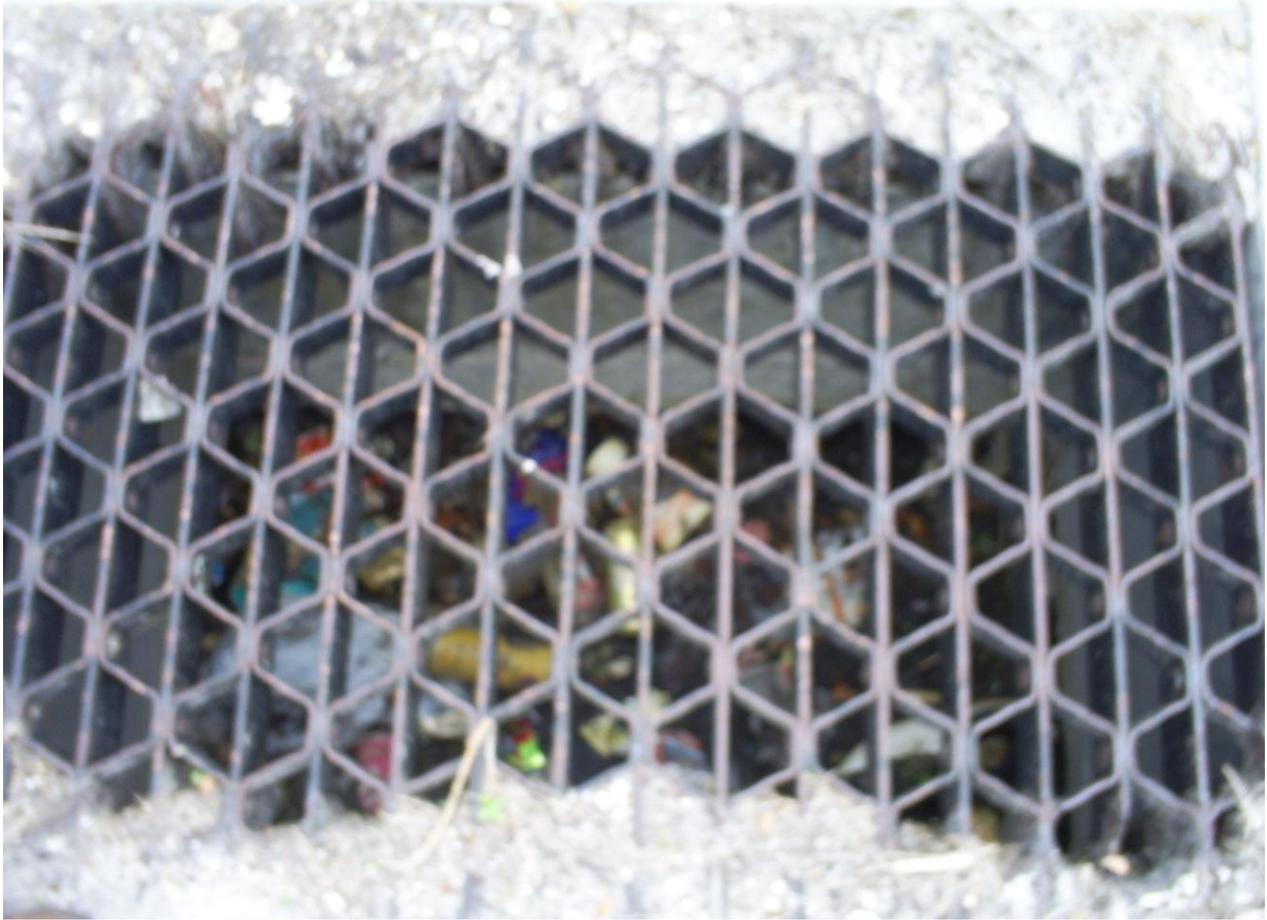
Figure 42. Litter, debris, and trash in a stormwater drain inside the Miami–Dade Transit Culmer Metrorail Station in the Highland Park area.

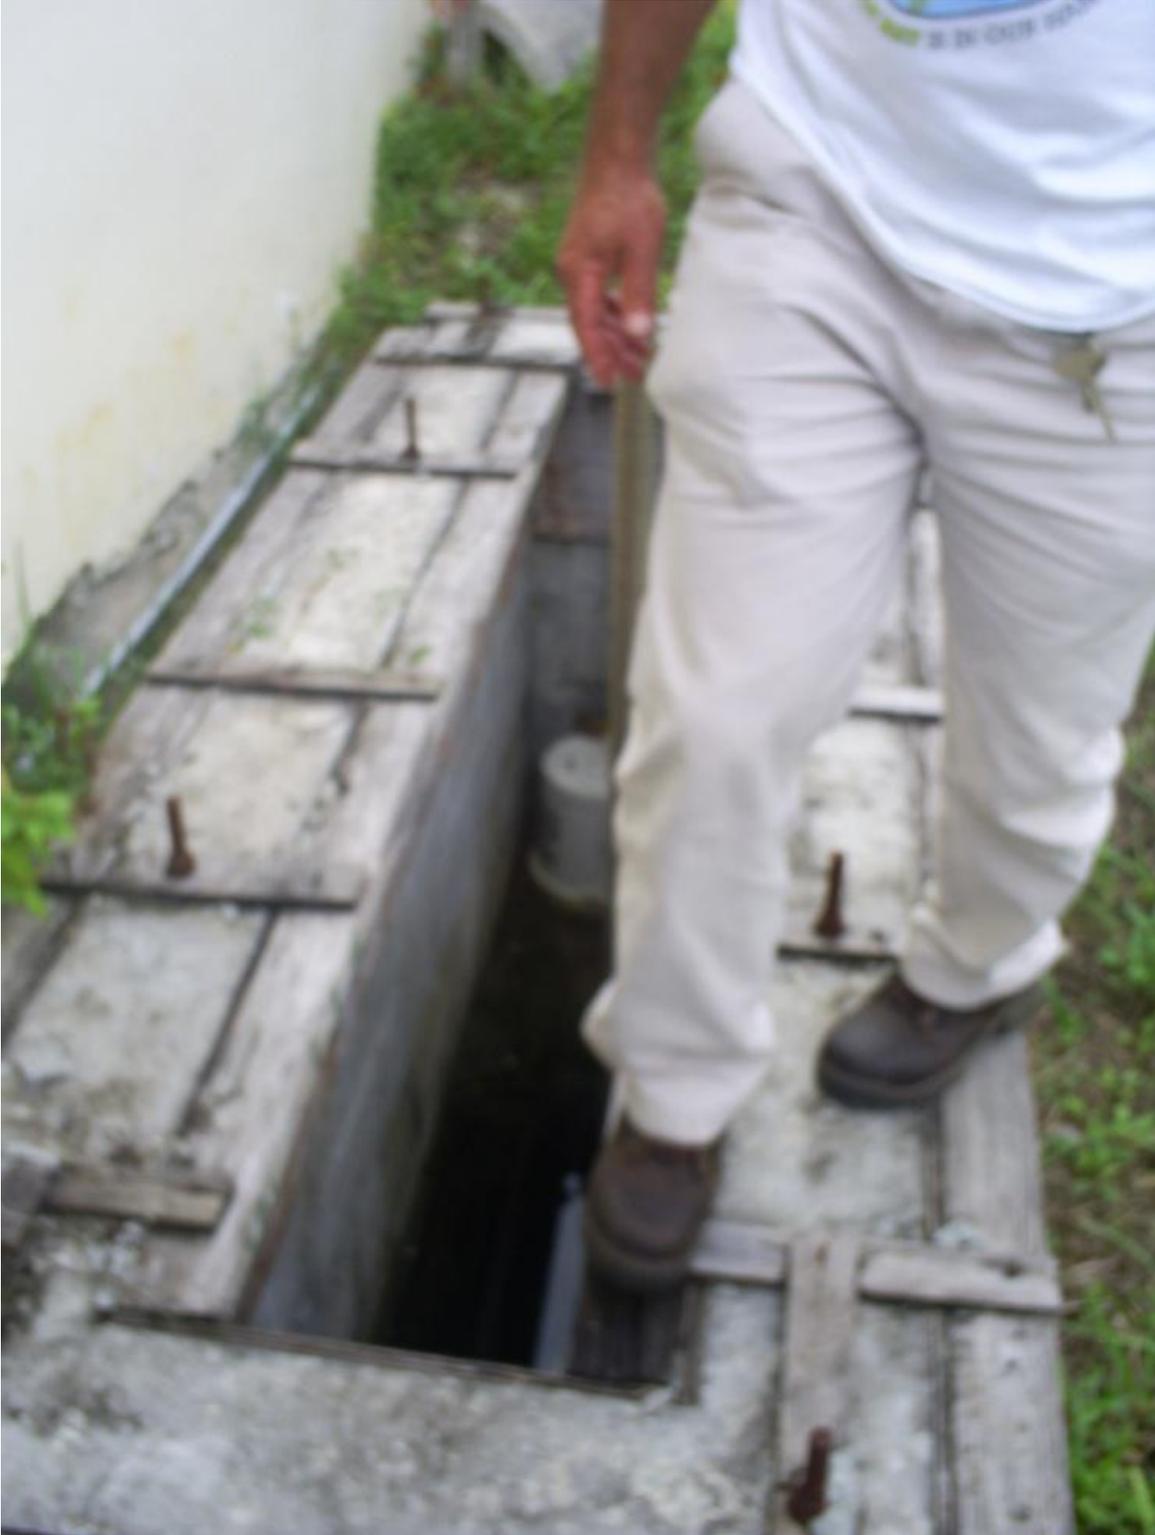
Figure 46. A PIC at the City of Miami Overtown stormwater pump station consists of those portions of the incomplete upgrades that allow foreign objects to enter the stormwater system.

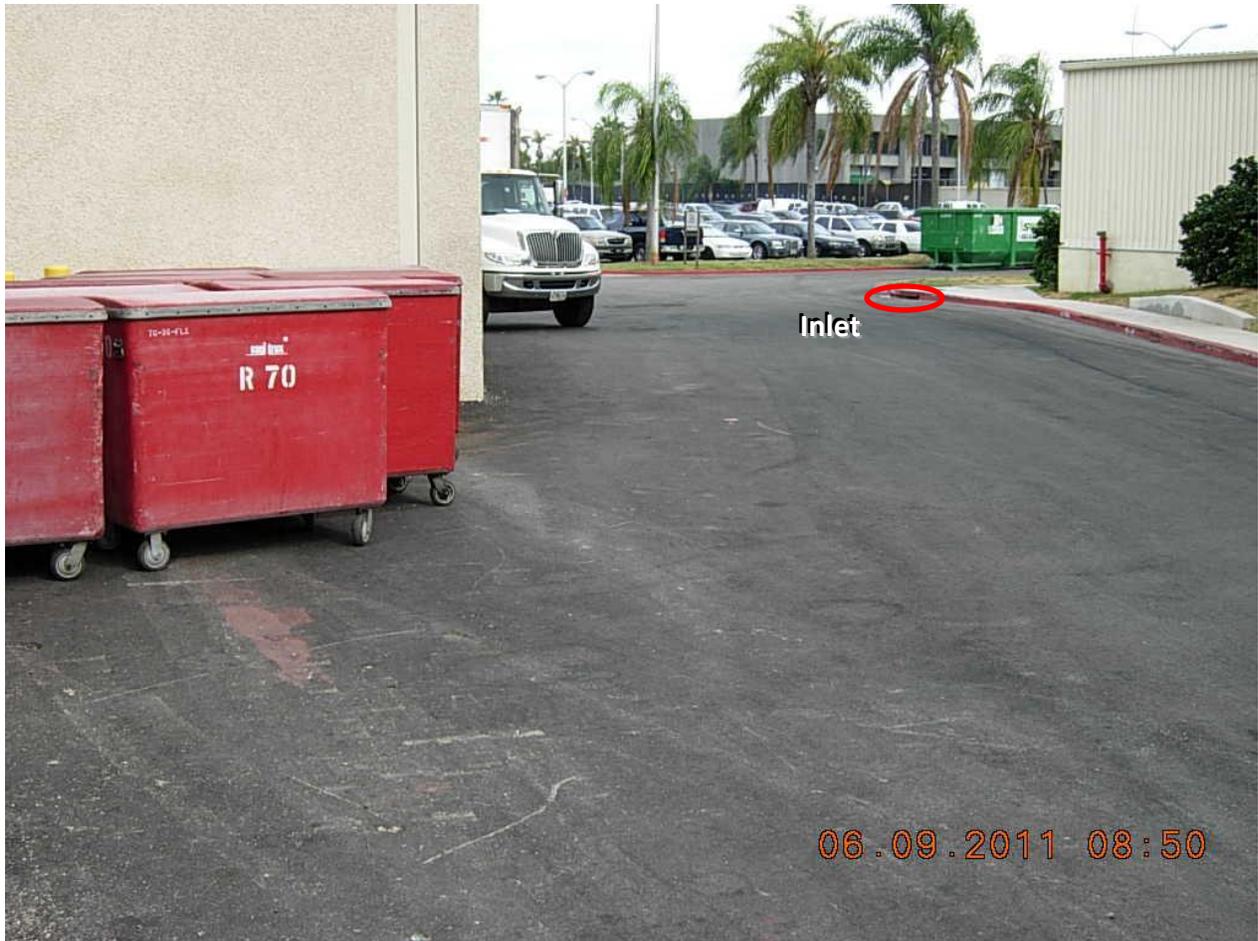
Figure 53. View of a portion of the VA Hospital site, near the western parking lot. On the way in to inspect the sanitary lift stations, the team observed closed biomedical waste bins upstream of the curb opening inlet (circled in red at top right). One of the team members observed some small holes in the bins. In the same area, a roll-off container was observed upslope of a drop inlet (at left).

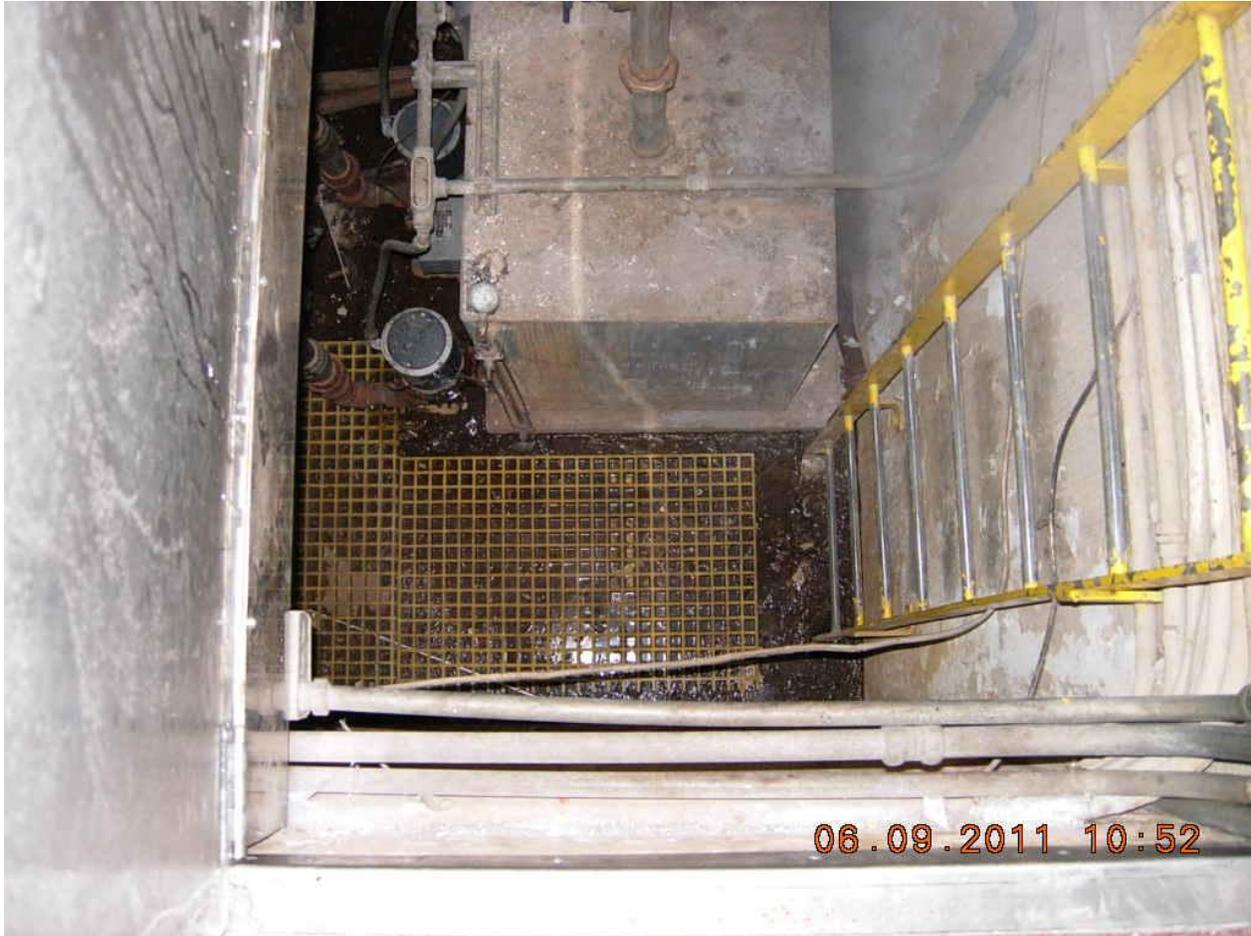
Figure 54. *View of the first VA Hospital sanitary lift station, located inside one of the buildings. The VA staff stated that the pump station was “open” rather than “sealed” because it is located in an area where there is a continuous flow of air from outside. Harold Moesch from FDEP entered the pump station for a closer investigation. No unusual conditions were observed. There was a noticeable mercaptan odor at this location.*

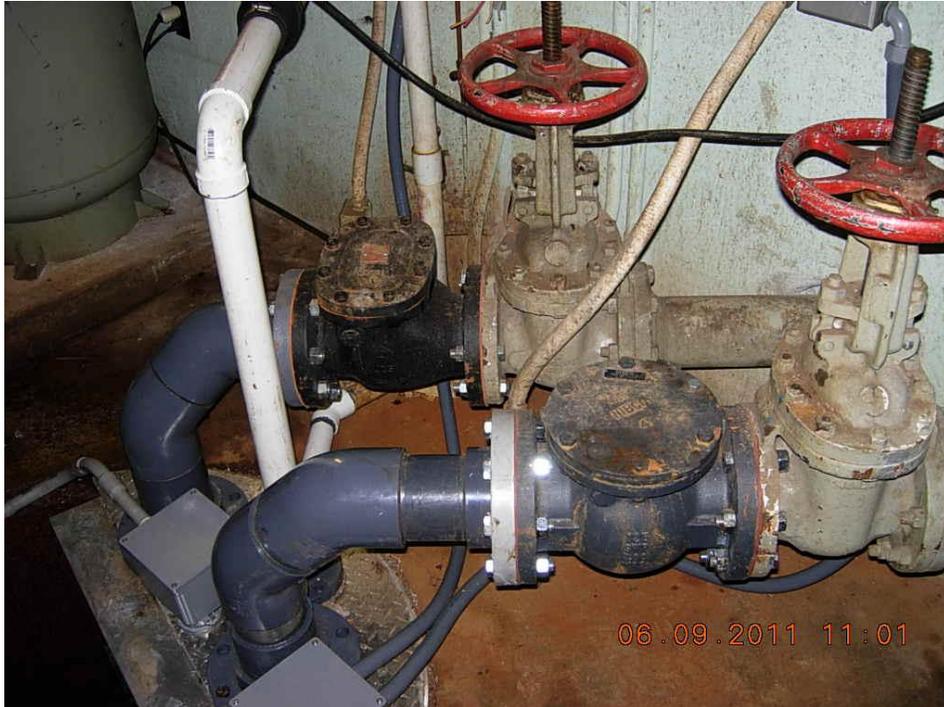
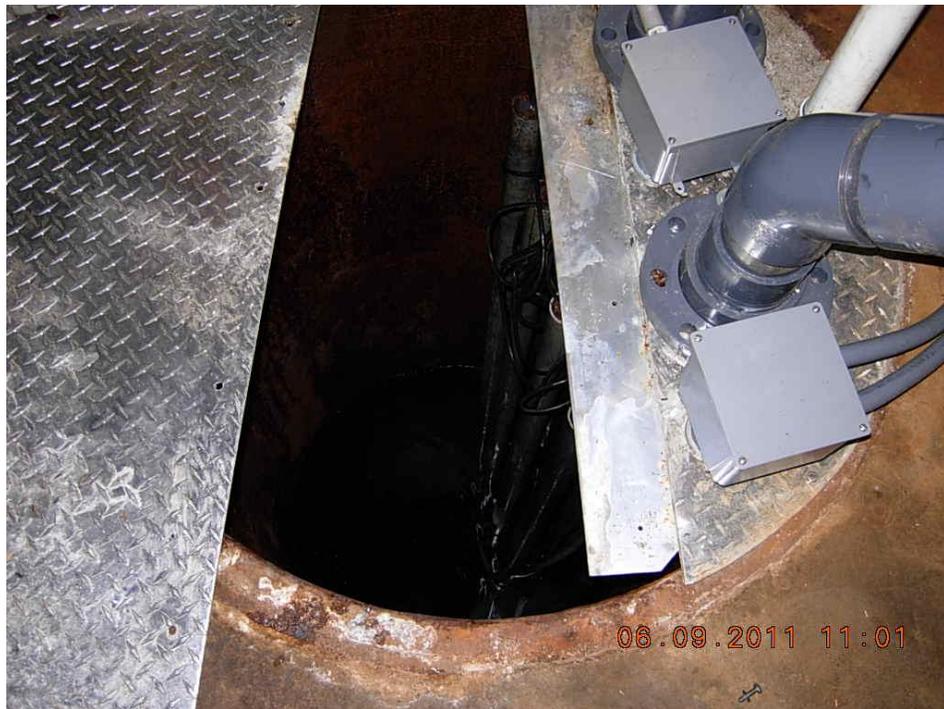
Figure 55. Views of the second VA Hospital sanitary lift station, also located inside one of the buildings. A noticeable sewage odor with ammonia prevailed. The pump station is sealed.

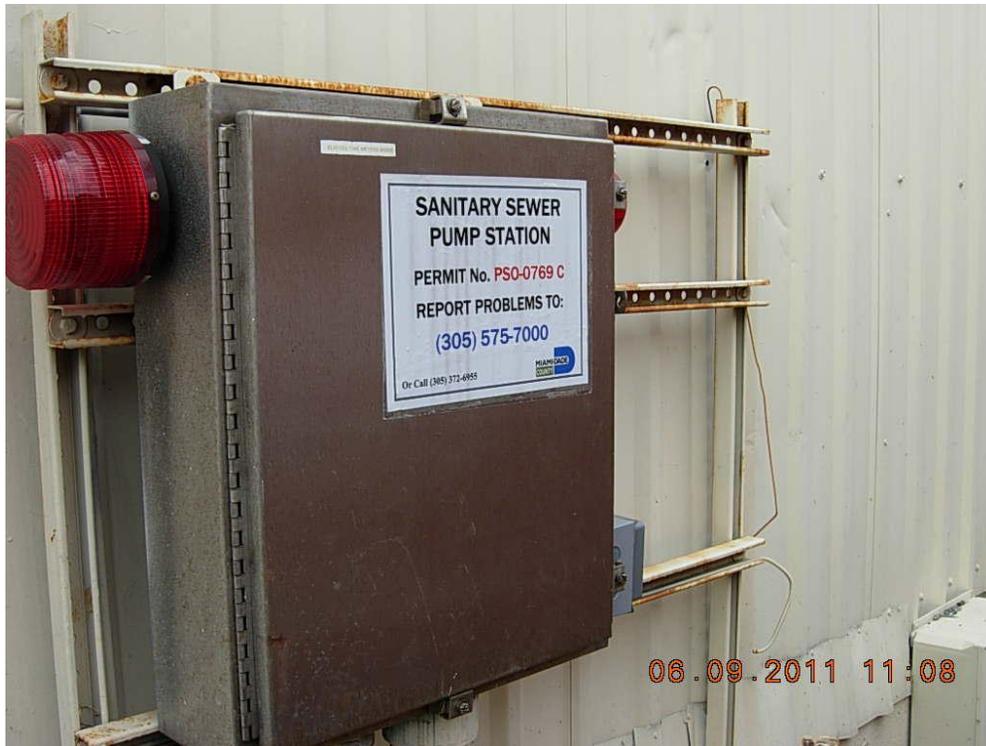
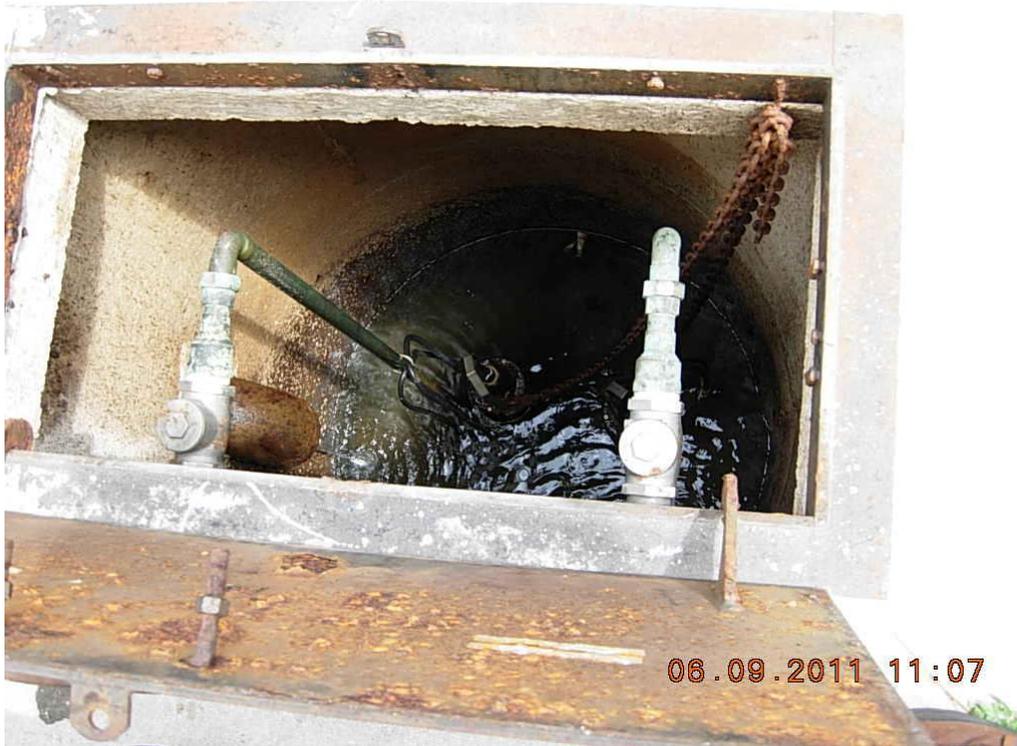
Figure 56. Views of the VA Hospital sanitary lift station located outside between Buildings 8 and 9. The pump station appeared relatively clean. No grease was observed.

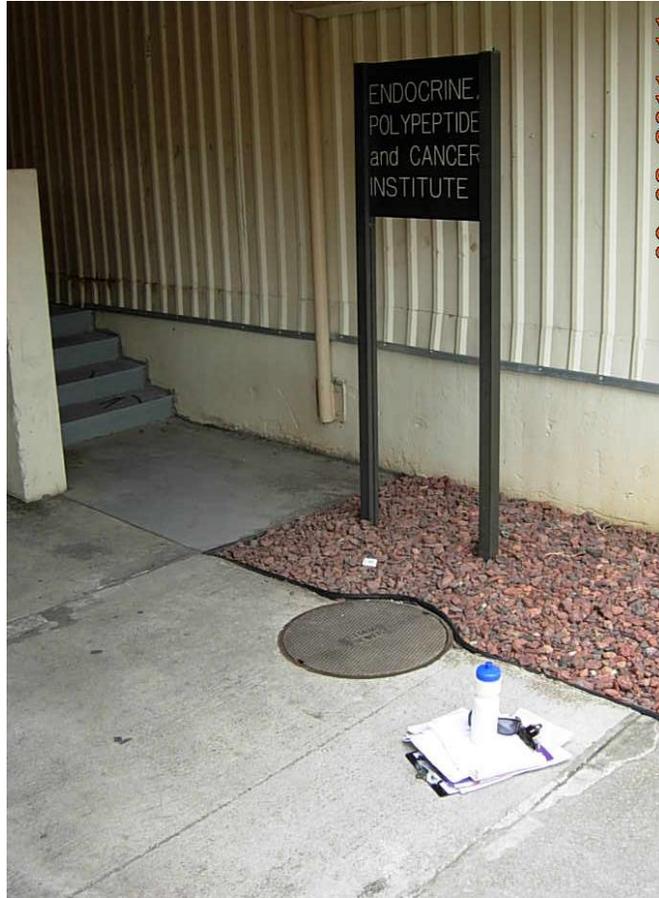
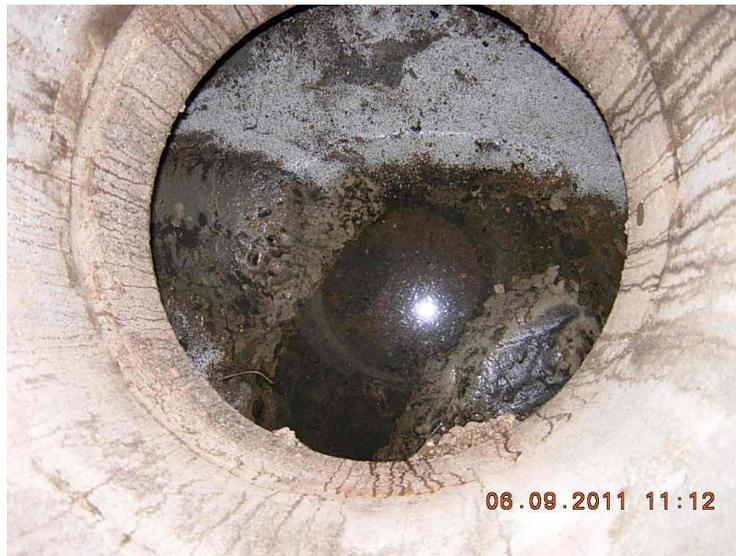
Figure 57. Views of the storm sewer manhole located around the corner from the VA Hospital's third pump station near the Endocrine, Polypeptide, and Cancer Institute. Upon inspection, no sanitary sewage impact was observed at this manhole.

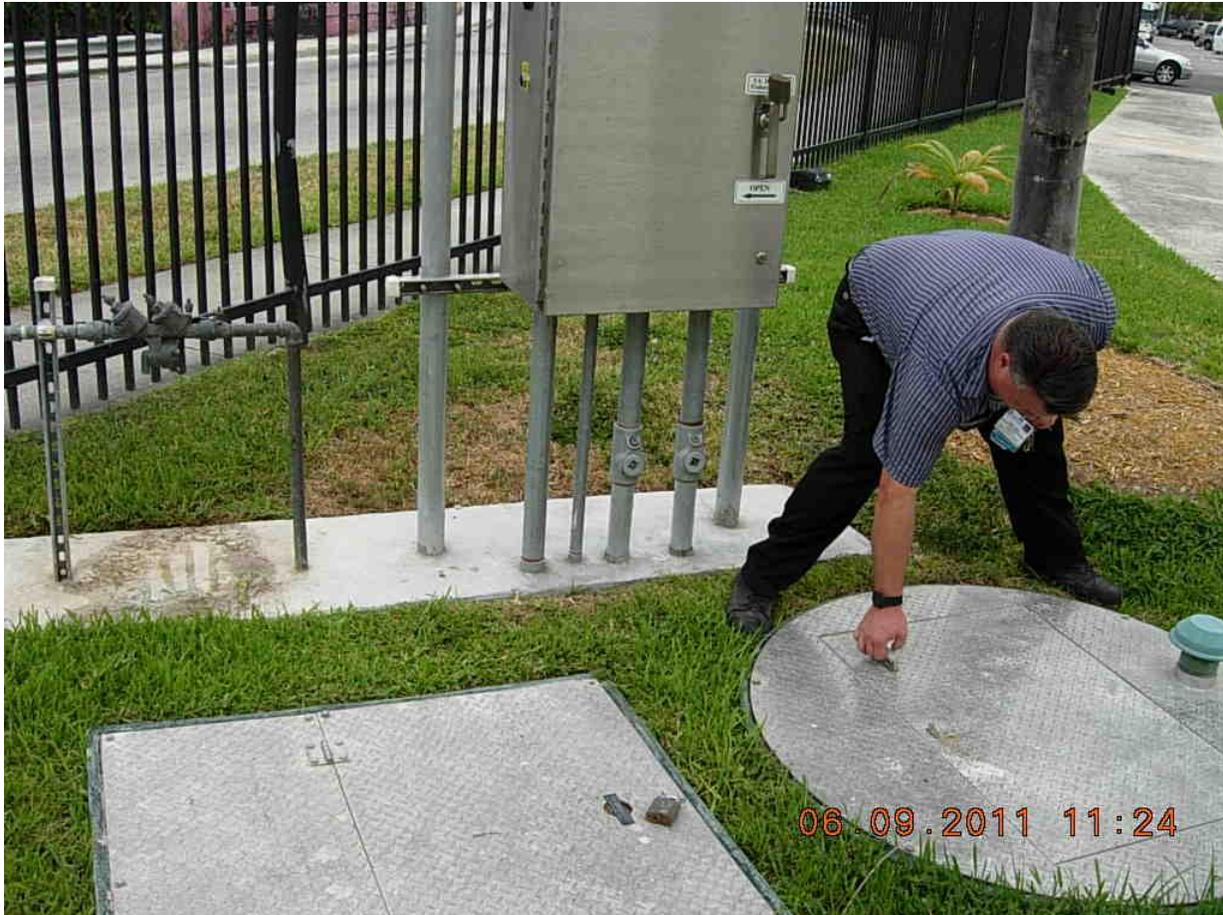
Figure 58. View of the fourth VA Hospital sanitary lift station near NW 17th Street, close to the newly completed Fisher House. The Wagner Creek guardrail is just visible in the upper left corner of the photo. This is a new lift station that had not yet completed the DERM permitting process at the time of inspection. Scott Olsen of the VA Hospital opened the pump station. Debris and some globules were observed. Allen Cox from DERM suggested pumping out the new station.

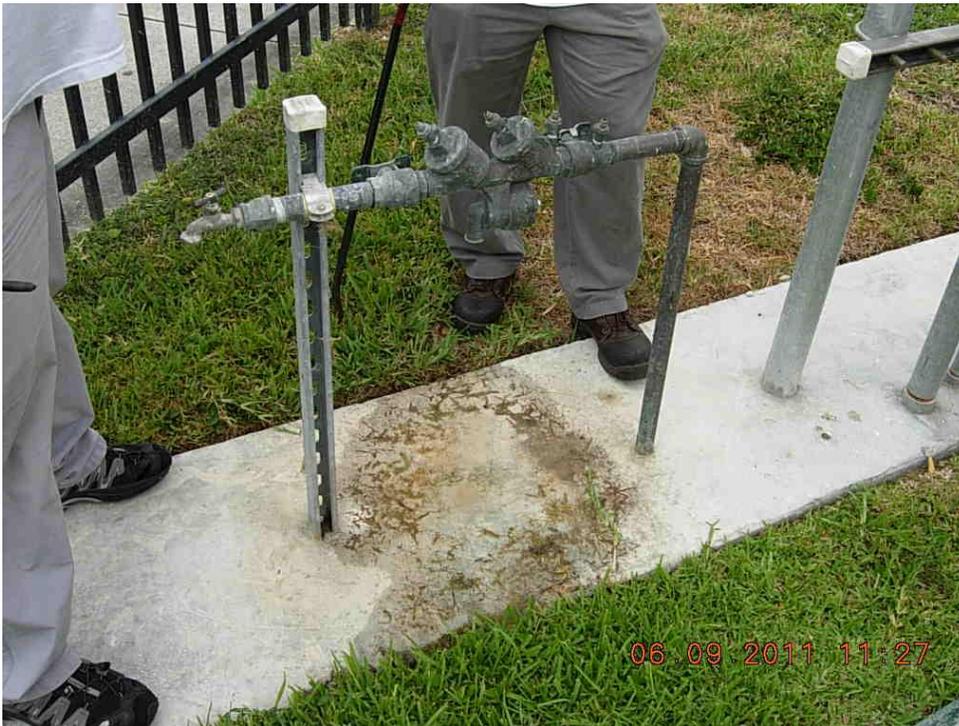
Figure 60. Close-up view of slowly leaking backflow preventer at the lift station.

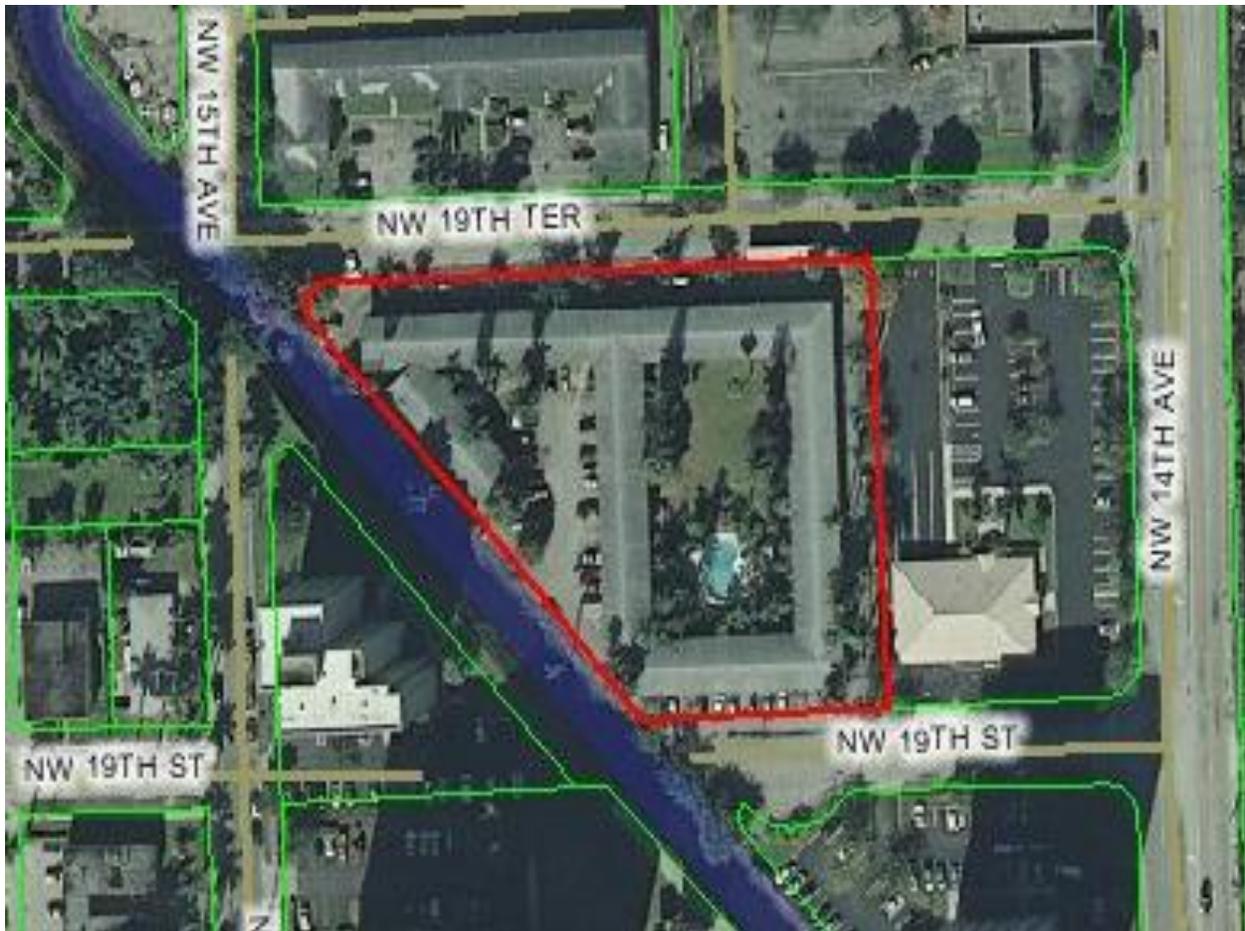
Figure 62. Aerial photo of Creek Club Apartments, 1434 NW 19th Terrace. The team observed several PICs connected to the apartment complex.

POST-BOAT TOUR NOTE: None of the connections observed appear in any of the City of Miami's Public Works records.

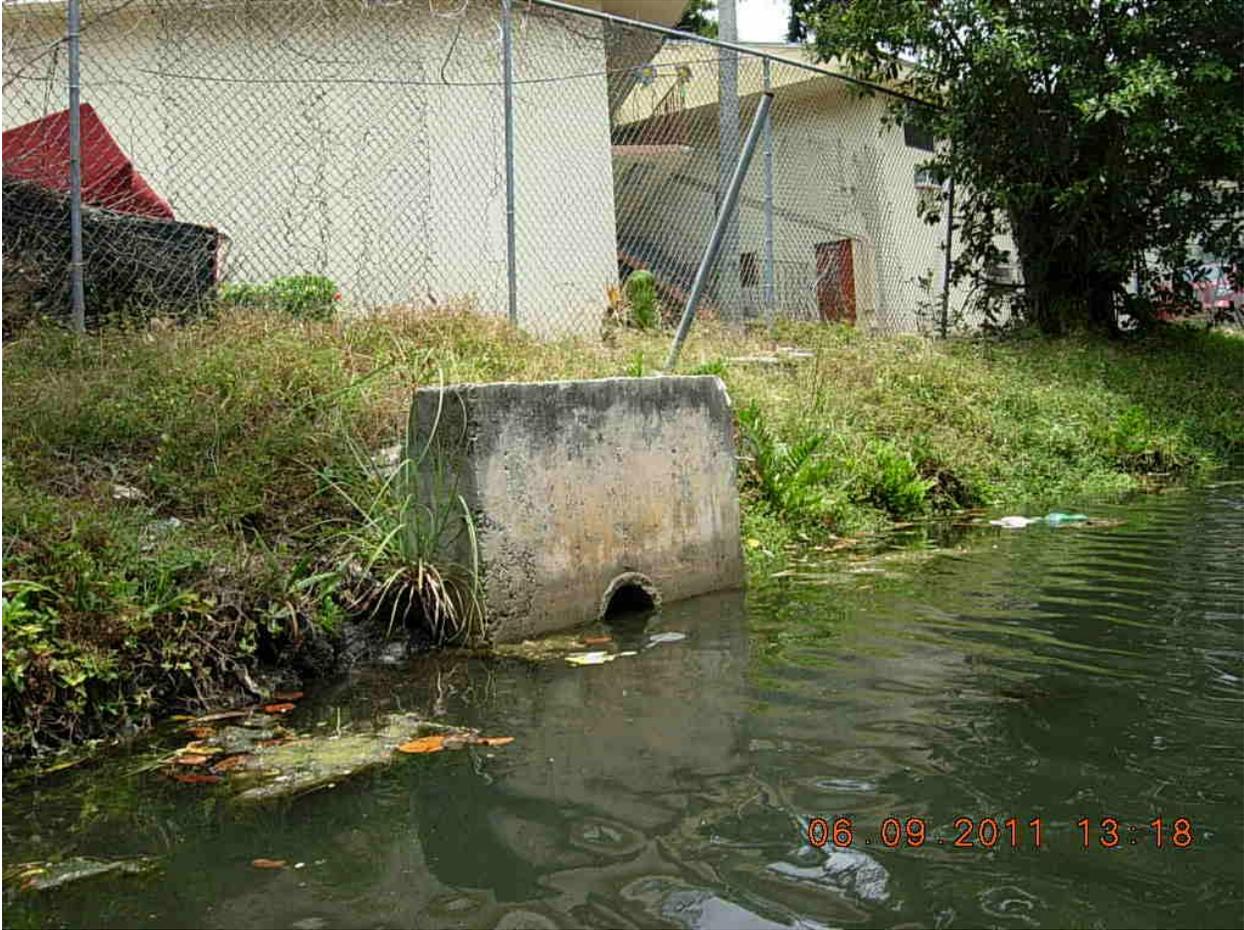
Figure 63. The first PIC was an 8-inch-diameter concrete pipe with a headwall. GPS coordinates are 25 47' 37.142" N, 80 13' 15.892" W.

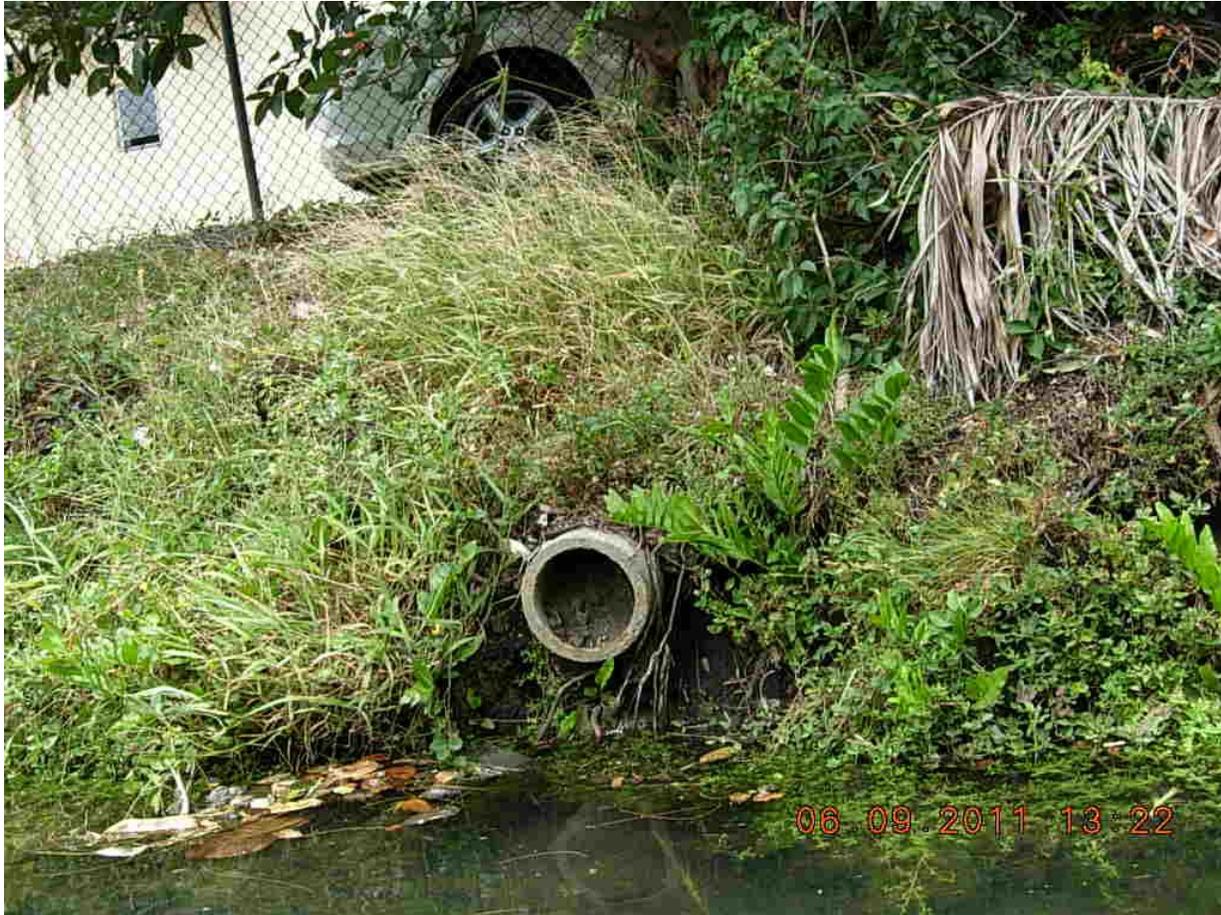
Figure 65. Another 8-inch diameter concrete pipe, without a headwall, was located farther to the south and appeared to belong to the same apartment complex. The outfall was full of sediment. GPS coordinates are 25 47' 36.299" N, 80 13' 14.842" W.

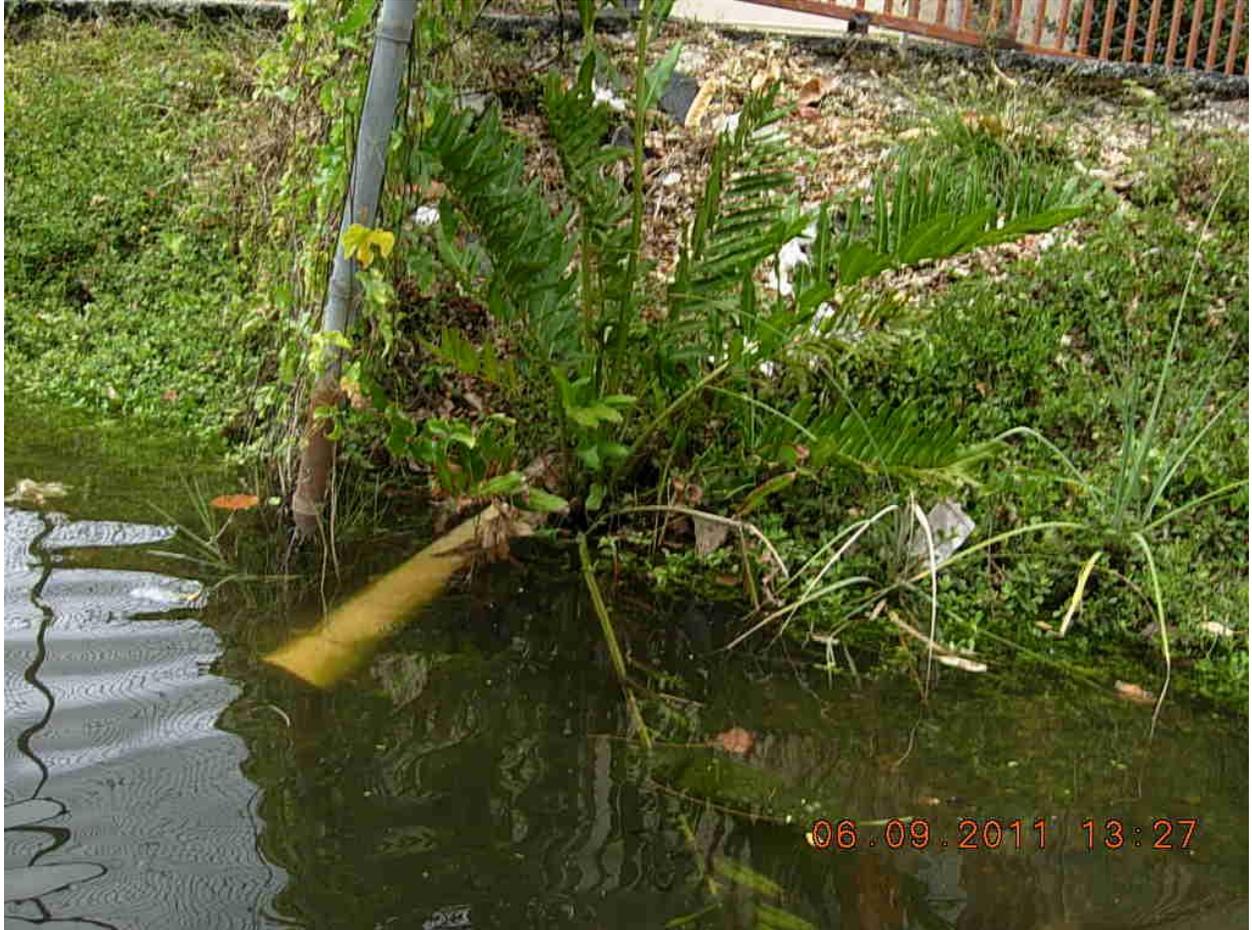
Figure 67. A polyvinyl chloride (PVC) pipe approximately 2 inches in diameter located near the southern boundary of the property could be a PIC or an irrigation line. GPS coordinates are 25 47' 35.028" N, 80 13' 13.741" W.

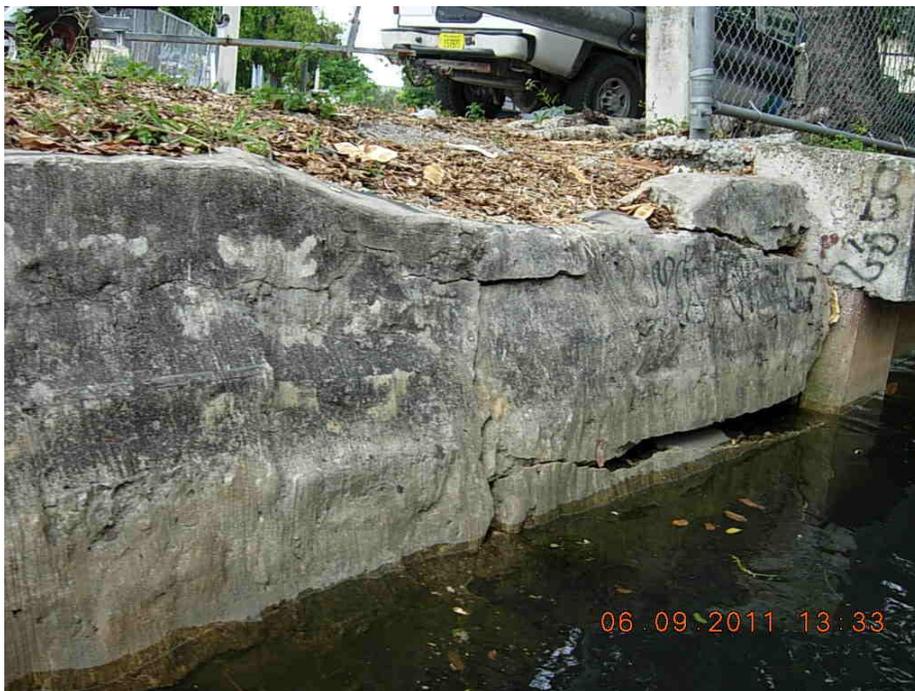
Figure 69. Due to the topography near the put-in point, surface runoff was also observed to be a potential source of fecal coliform bacteria.

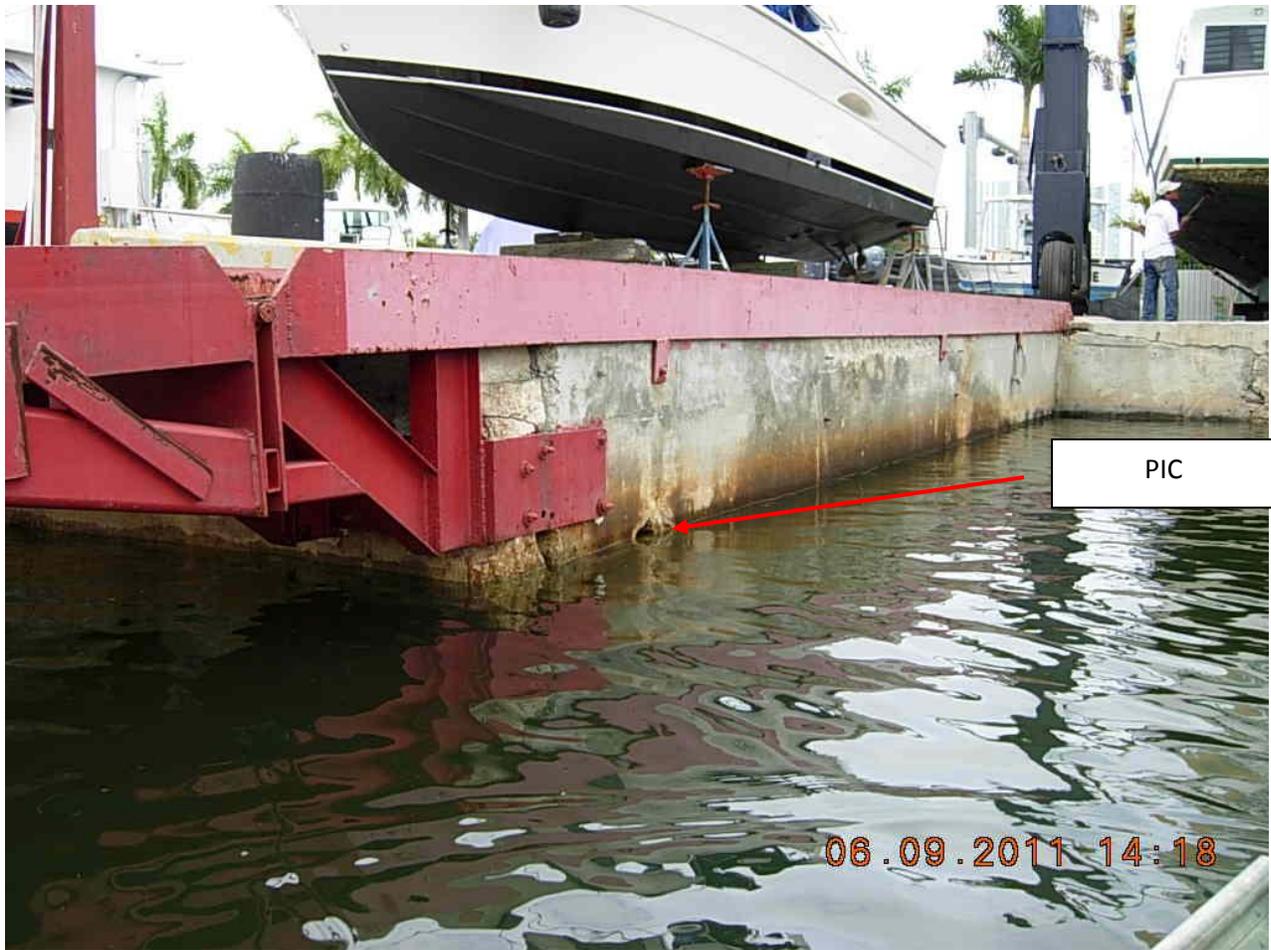
Figure 71. PIC observed at Campeones Boatyard, 600 NW 7th Avenue. GPS coordinates are 25 46' 45.720" N, 80 12' 25.987" W.

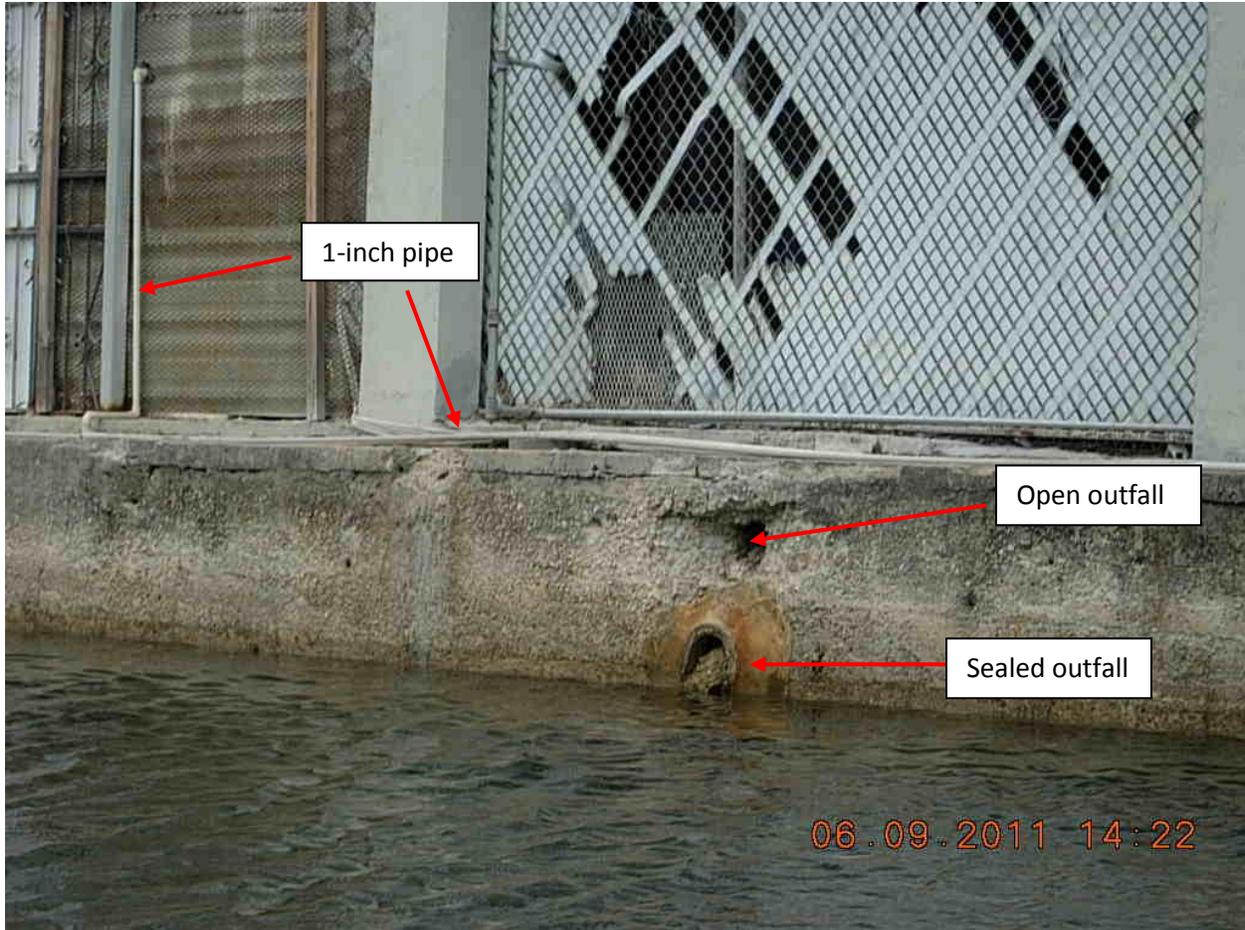
Figure 72. Additional PICs observed at Campeones Boatyard. The lower outfall appears to be either full of sand or abandoned and filled with concrete. The upper outfall still appears active. Also note the small-diameter pipe that extends from the screen and then runs along the top of the seawall. The GPS coordinates of these outfalls and PICs are 25 46' 49.231" N, 80 12' 25.968" W.

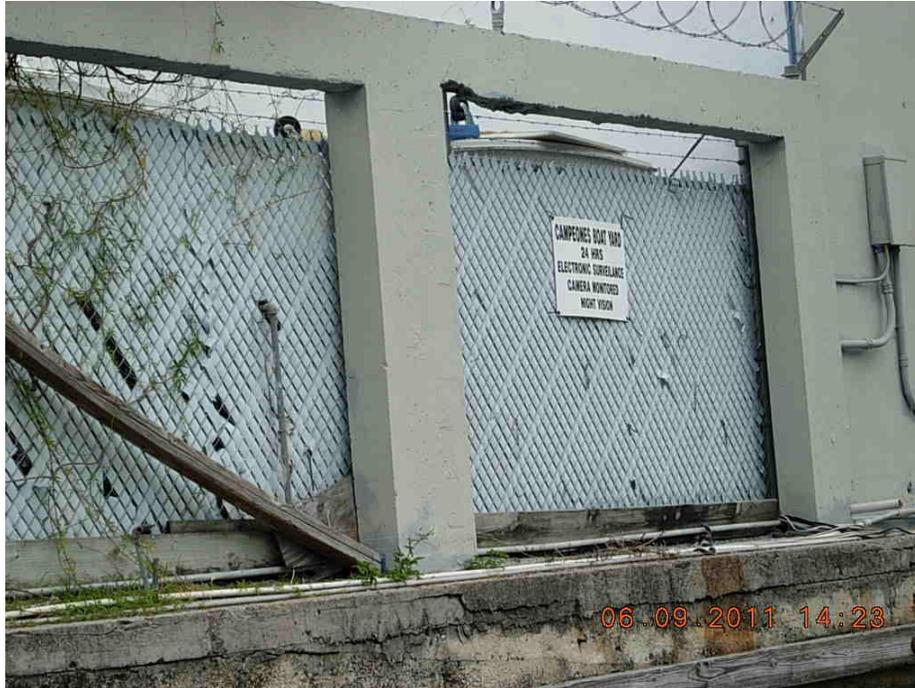
Figure 73. A PIC or electrical connection located a few feet north of the two Campeones Boatyard outfalls. GPS coordinates are still 25 46' 49.231" N, 80 12' 25.968" W.

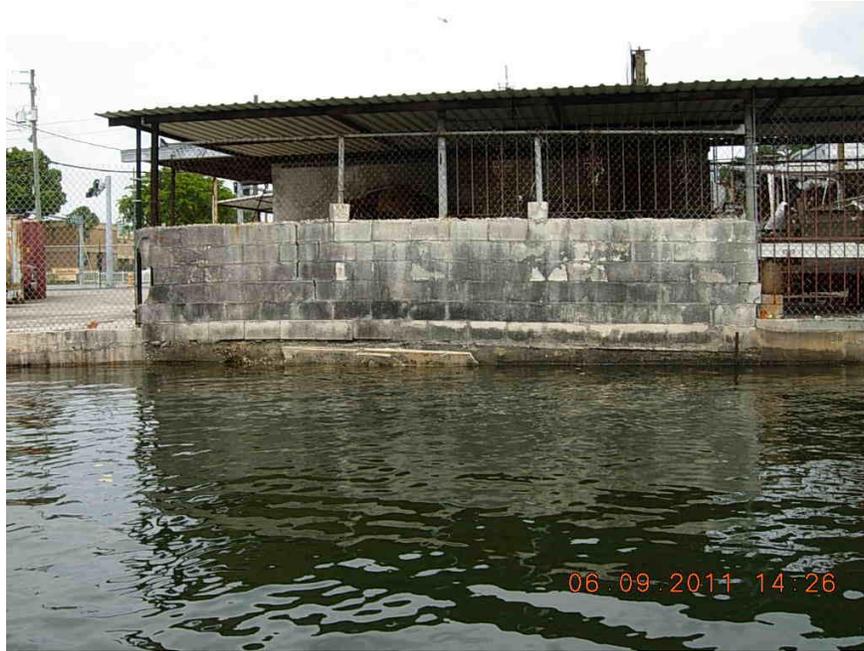
Figure 75. At 732 NW 7th Avenue, the team observed a concrete structure that may be a submerged outfall. The structure could not be observed in its entirety. GPS coordinates are 25 46' 50.661" N, 80 12' 26.025" W.

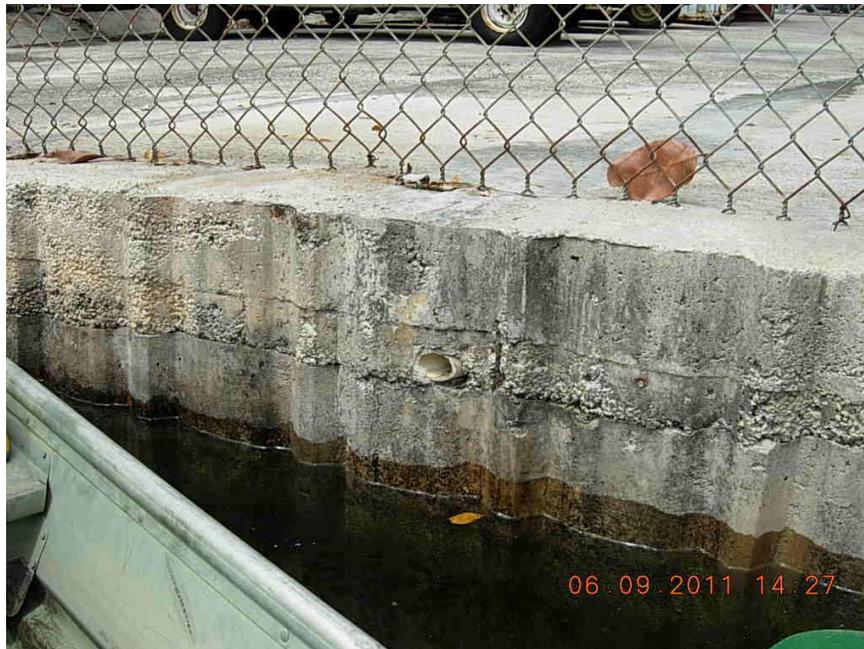
Figure 76. A 1.5-inch PVC pipe originating from Florida Precision at 800 NW 7th Avenue. GPS coordinates are 25 46' 52.232" N, 80 12' 25.917" W.

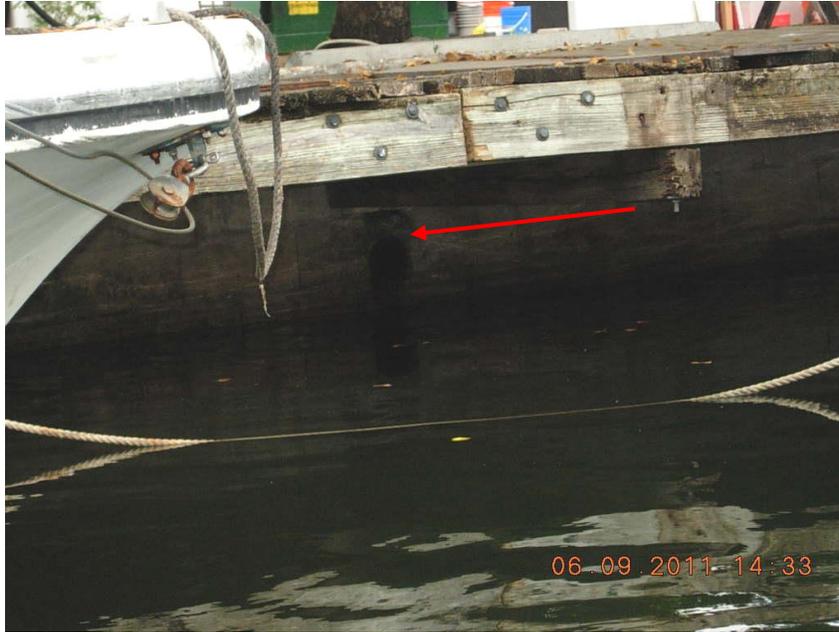
Figure 77. Three 4-inch rusted pipes protruding from Popeye Marine at 810 NW 8th Street. GPS coordinates are 25 46' 52.232" N, 80 12' 26.621" W.

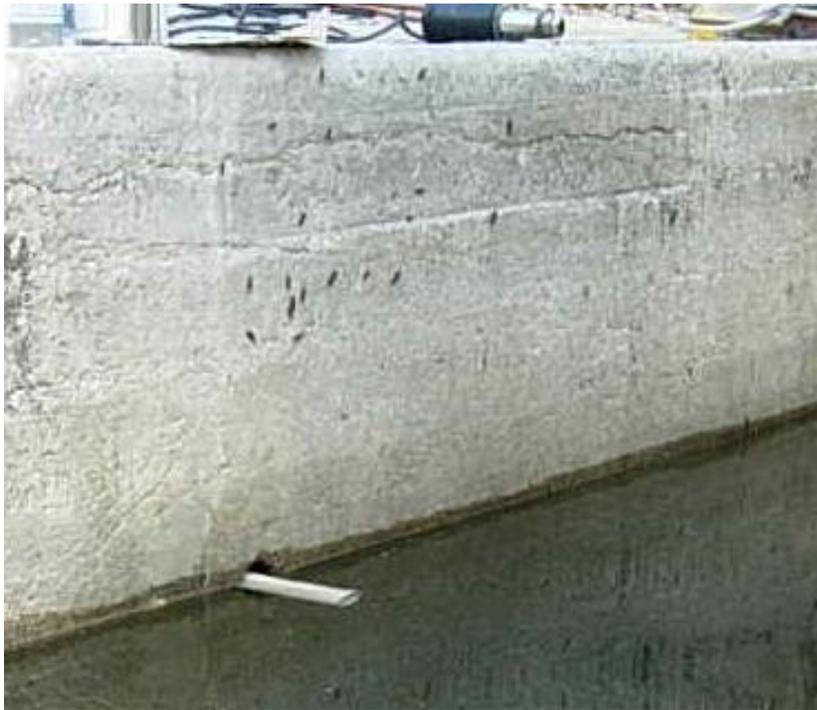
Figure 78. A 2-inch diameter PVC pipe protruding from a private residence. The approximate address is 922 or 938 NW 8th Street. GPS coordinates are 25 46' 57.121" N, 80 12' 29.900" W.
