Summary of Results

Walk the WBID Exercise for Wagner Creek (WBID 3288A)

September 2011

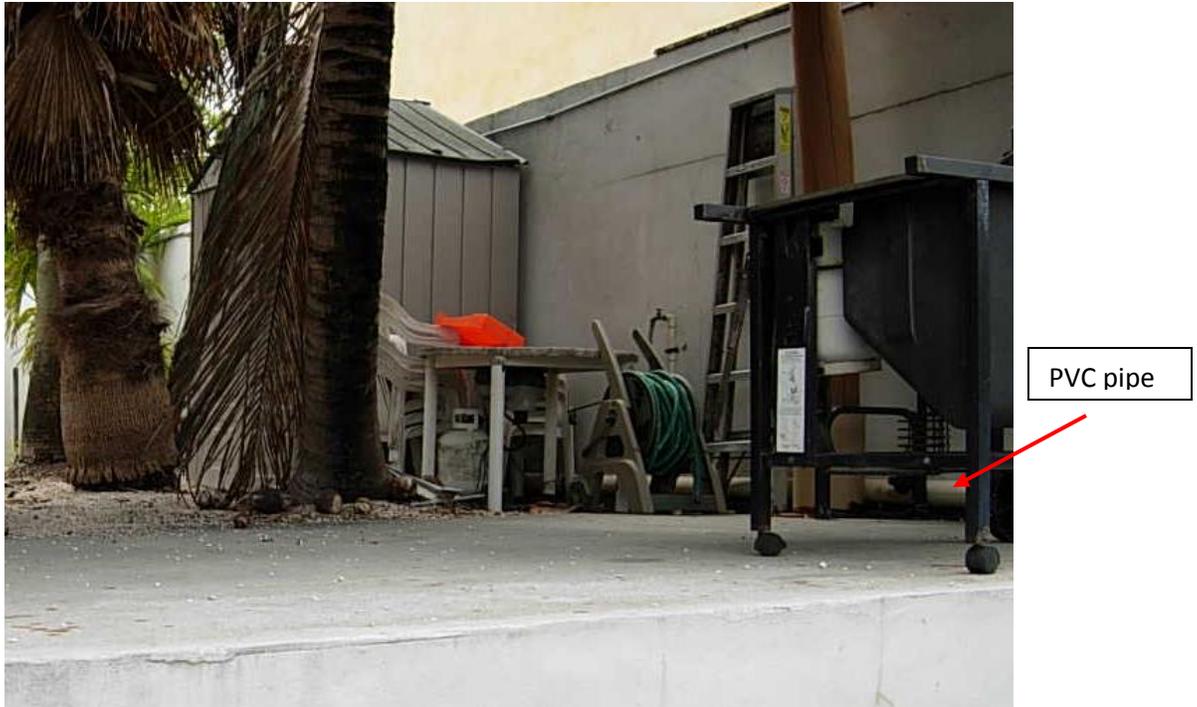
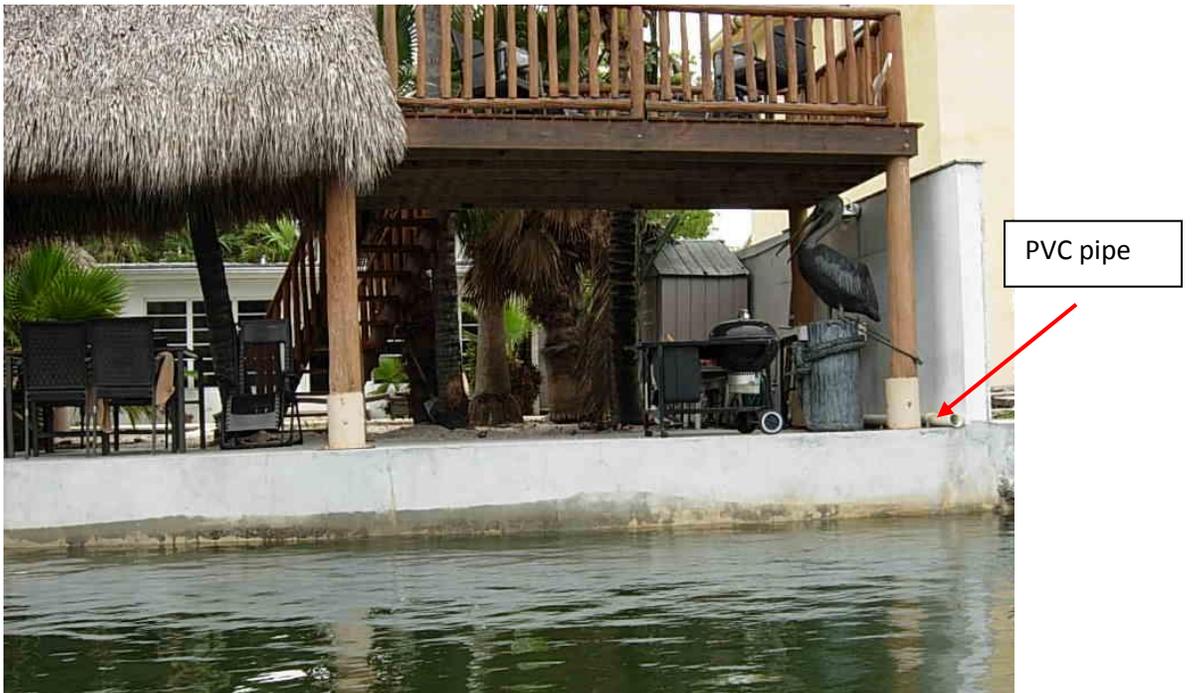
Figure 81. At 727 NW 7th Street, the team observed a 4-inch white PVC pipe running from the property line at Seybold Canal towards the front of the property.
