Juan Valdes, Inspector

## Overview

Along the 1.6 mile from 20<sup>th</sup> Street to the Miami River, we have identified seven (7) locations where the WASD System crosses the Wagner Creek Canal.

WASD's investigation involved dye tests and visual inspections to check for leaks at the force main and gravity main crossings with the canal.

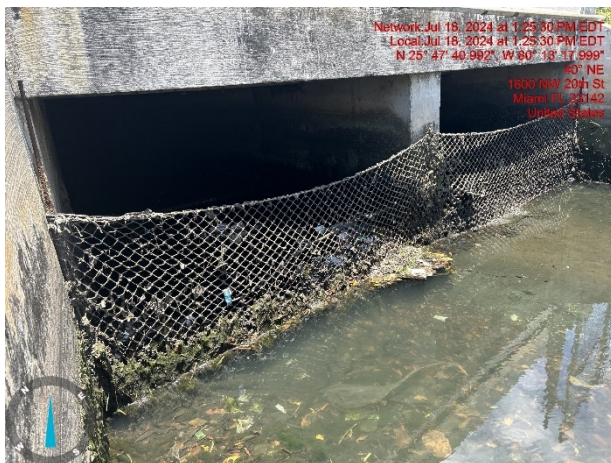
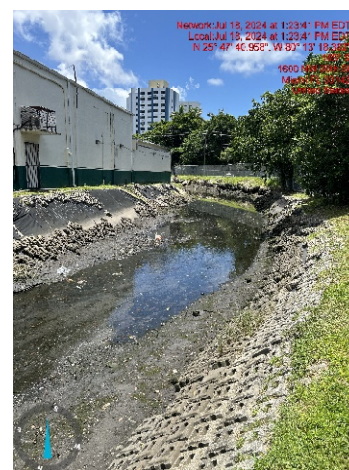
## Location #1: 1500 NW 20<sup>th</sup> Street

This is the starting point of the Wagner Creek Canal, dye was introduced into manhole # 193 located on 20 Street, no traces were detected in the canal.

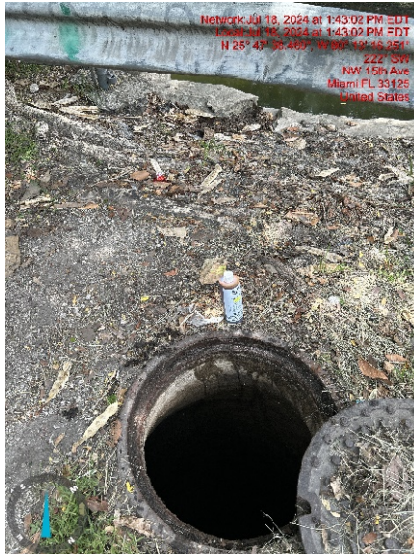
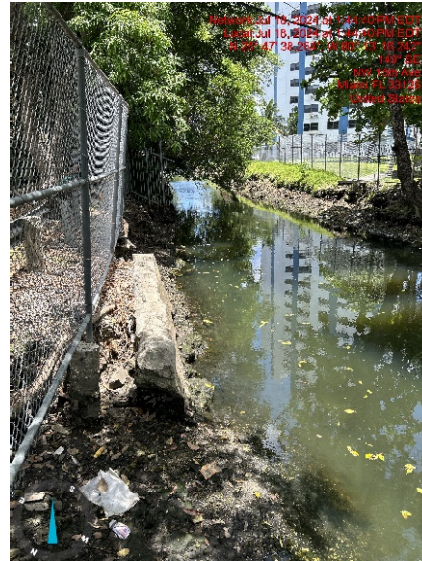
## Location #2: NW 15<sup>th</sup> Ave & NW 19 Ter

This location is where the 42" gravity line crosses the Wagner Creek Canal. Dye was introduced at manhole # 173 the result was negative. No traces were detected into the canal.

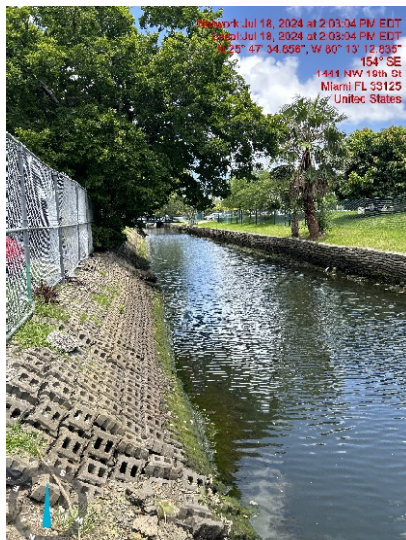
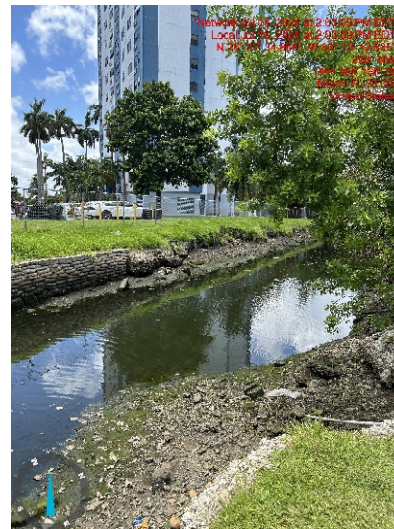
## Location #3a: 1441 NW 19<sup>th</sup> Street

This location is where the 30" force main coming from PS 0054 crosses the Wagner Creek Canal. We did a visual inspection of the canal, and no issues were found.

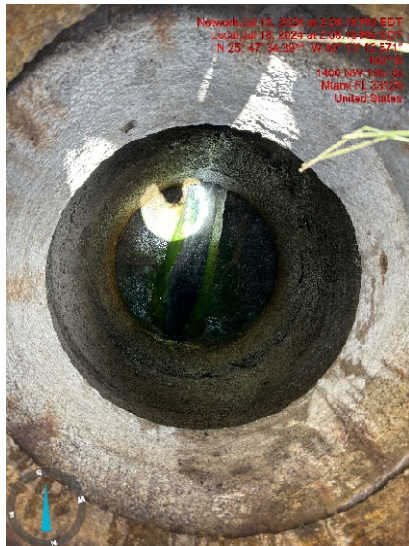
### Location #3b: 1441 NW 19<sup>th</sup> Street

This location is where the 16" gravity main coming from PS 0054 crosses the Wagner Creek Canal. Dye was introduced into manhole #121 and no traces were detected in the canal.

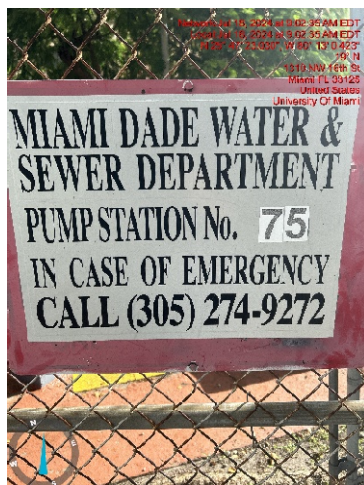
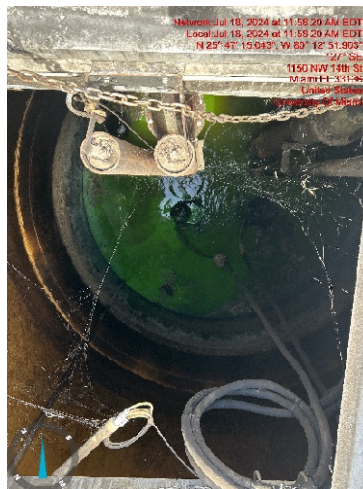
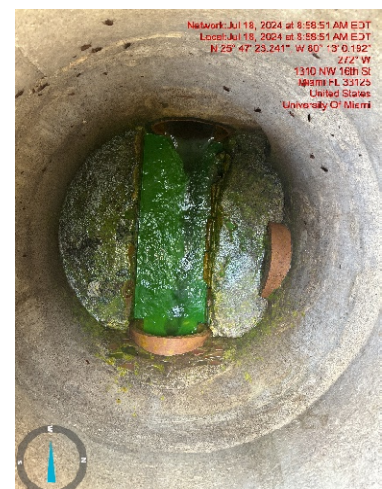
### Location #4: 1310 NW 16<sup>th</sup> Street

This location is where pump station 0075 is located. Dye was introduced into the wet well and tracked the force main that discharges in manhole 379. No trace of dye was detected in the canal.

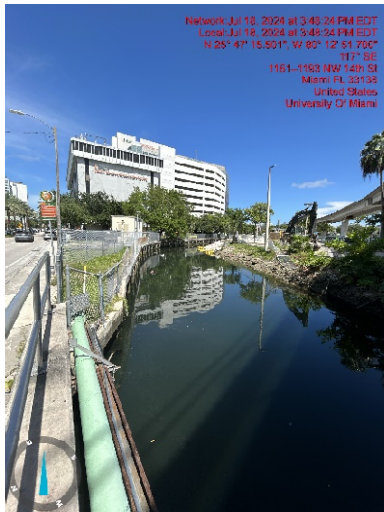
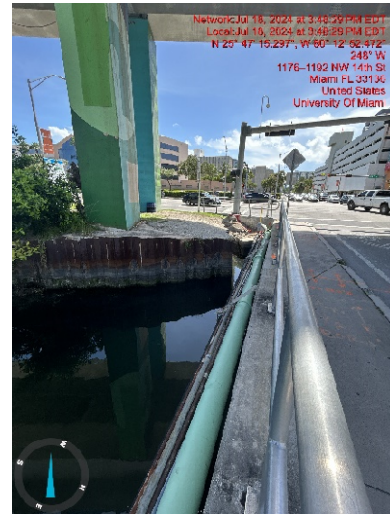
#### Location #5: NW 12<sup>th</sup> Ave & NW 14<sup>th</sup> Street

This location is where the 18" gravity main crosses the canal. Dye was introduced into manhole #270 and no signs of dye was detected in the canal.

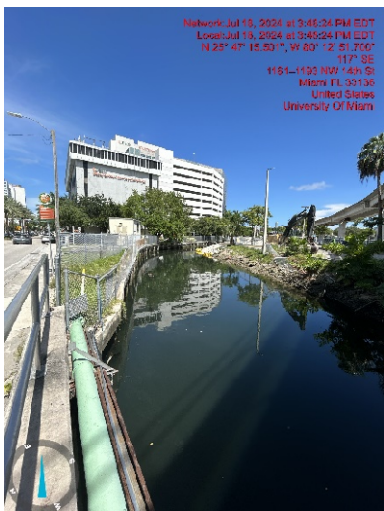
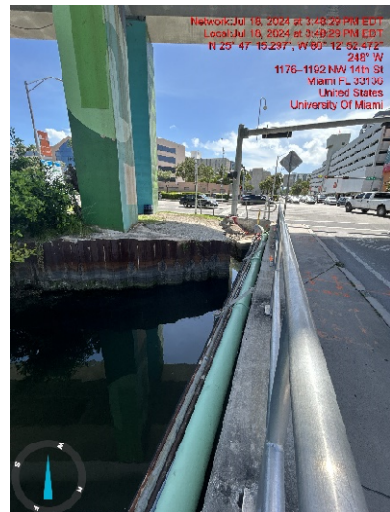
#### Location #6: 1150 NW 14<sup>th</sup> Street

This location is where a 10" force main coming from PS 0045 is located. We did a visual inspection and no issues were found.

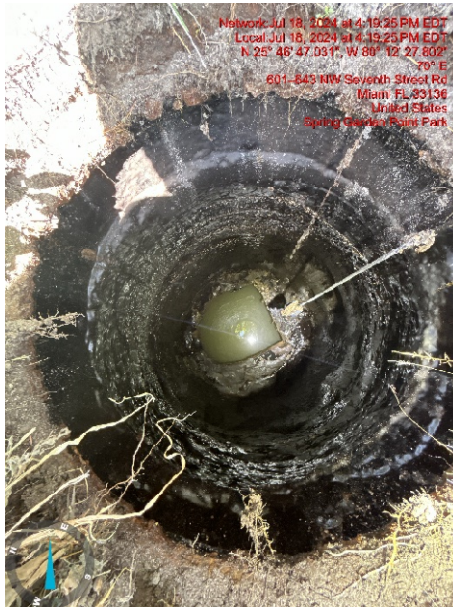
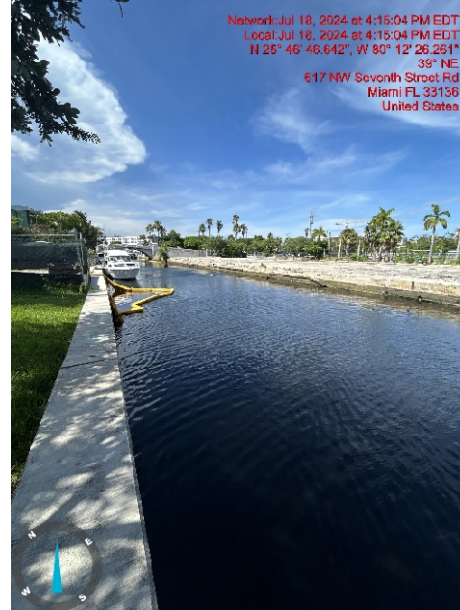
### Location #7: 617 NW 7<sup>th</sup> Street

This location is where the 60" interceptor crosses the Seybold Canal. Dye was introduced into manhole #105 with no signs of dye in the canal.
