Summary of Results

Walk the WBID Exercise for Wagner Creek (WBID 3288A)

September 2011

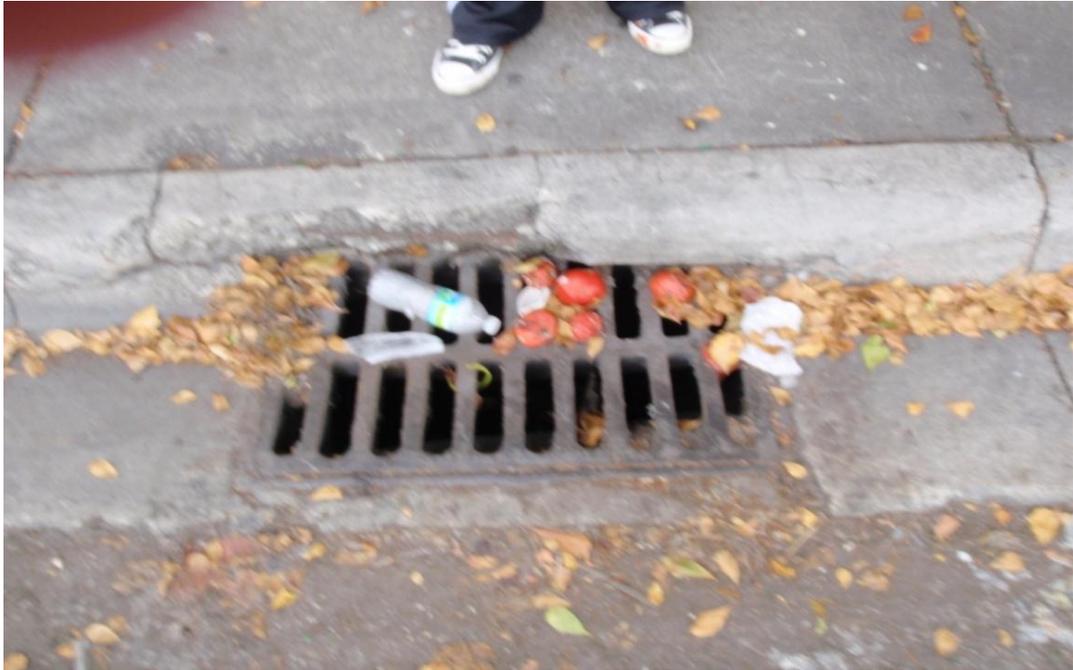
Figure 10. Fruit and trash collected on a storm drain at the Allapattah Produce Market.

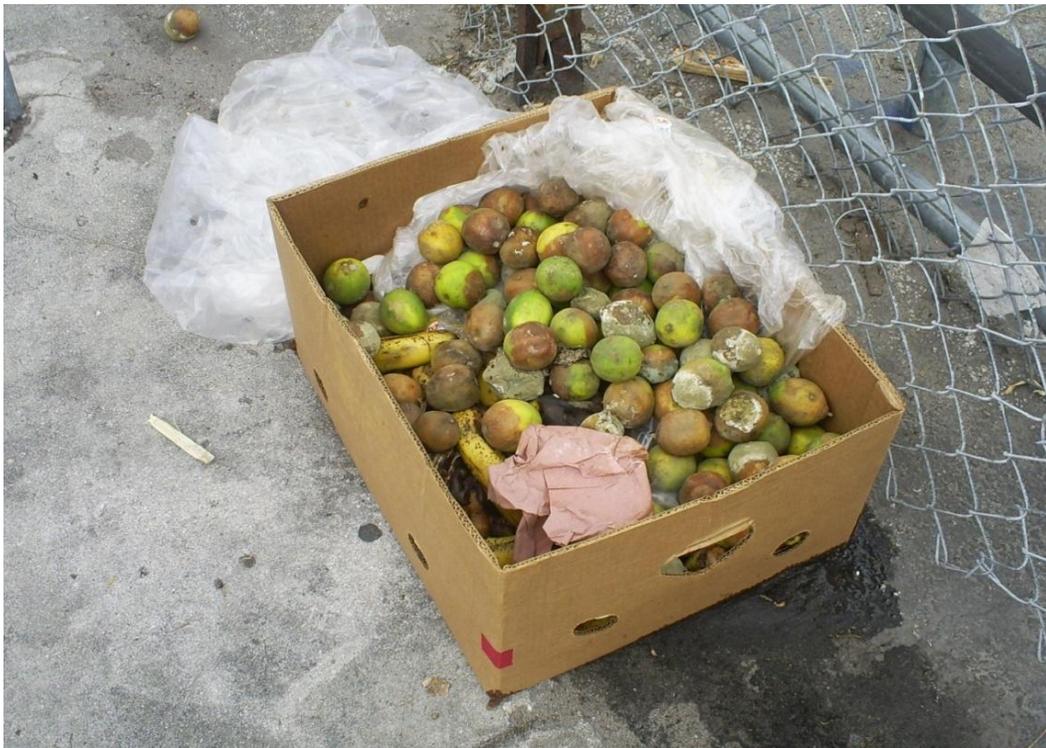
Figure 11. Box of rotting fruit outside a warehouse at the Allapattah Produce Market.

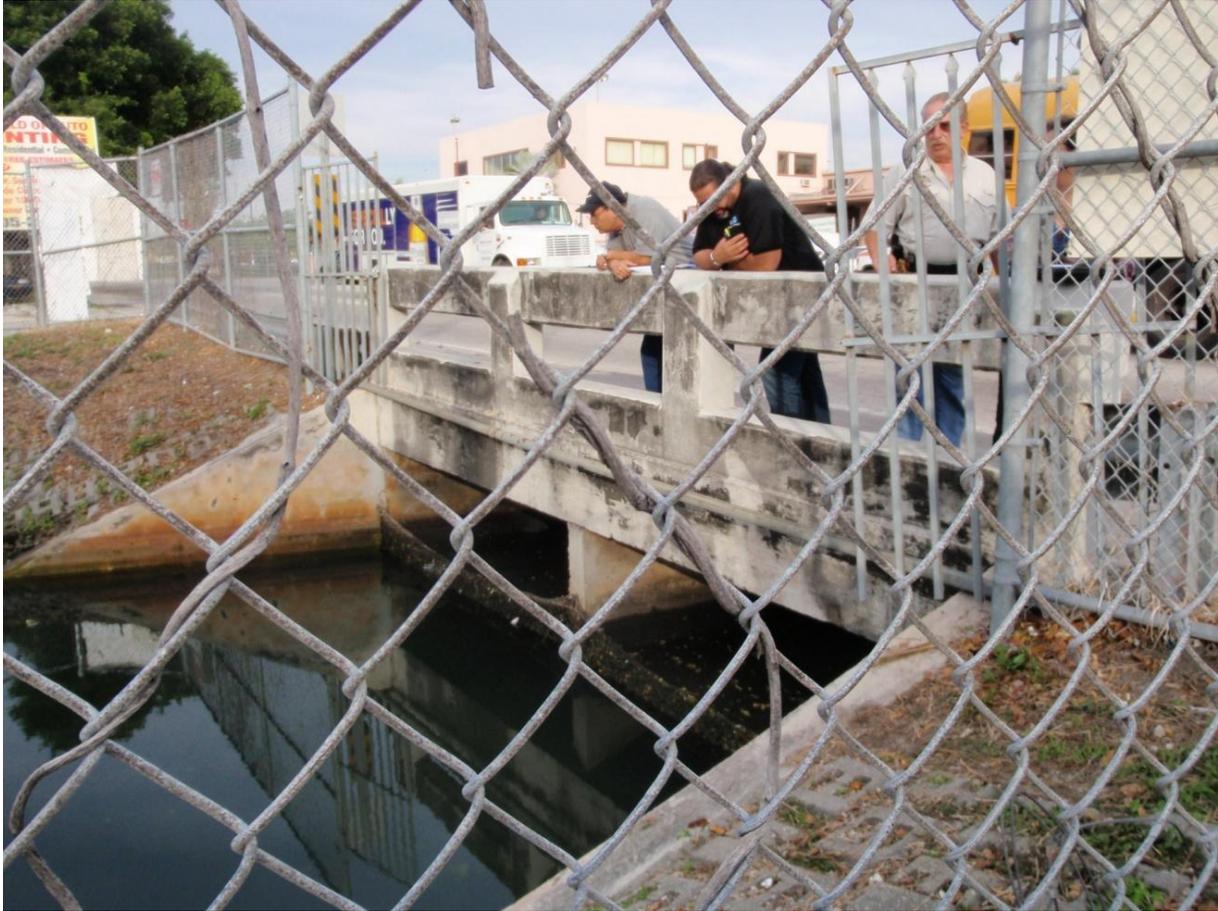
Figure 13. *20th Street Bridge, where Wagner Creek re-emerges from the underground conveyance.*

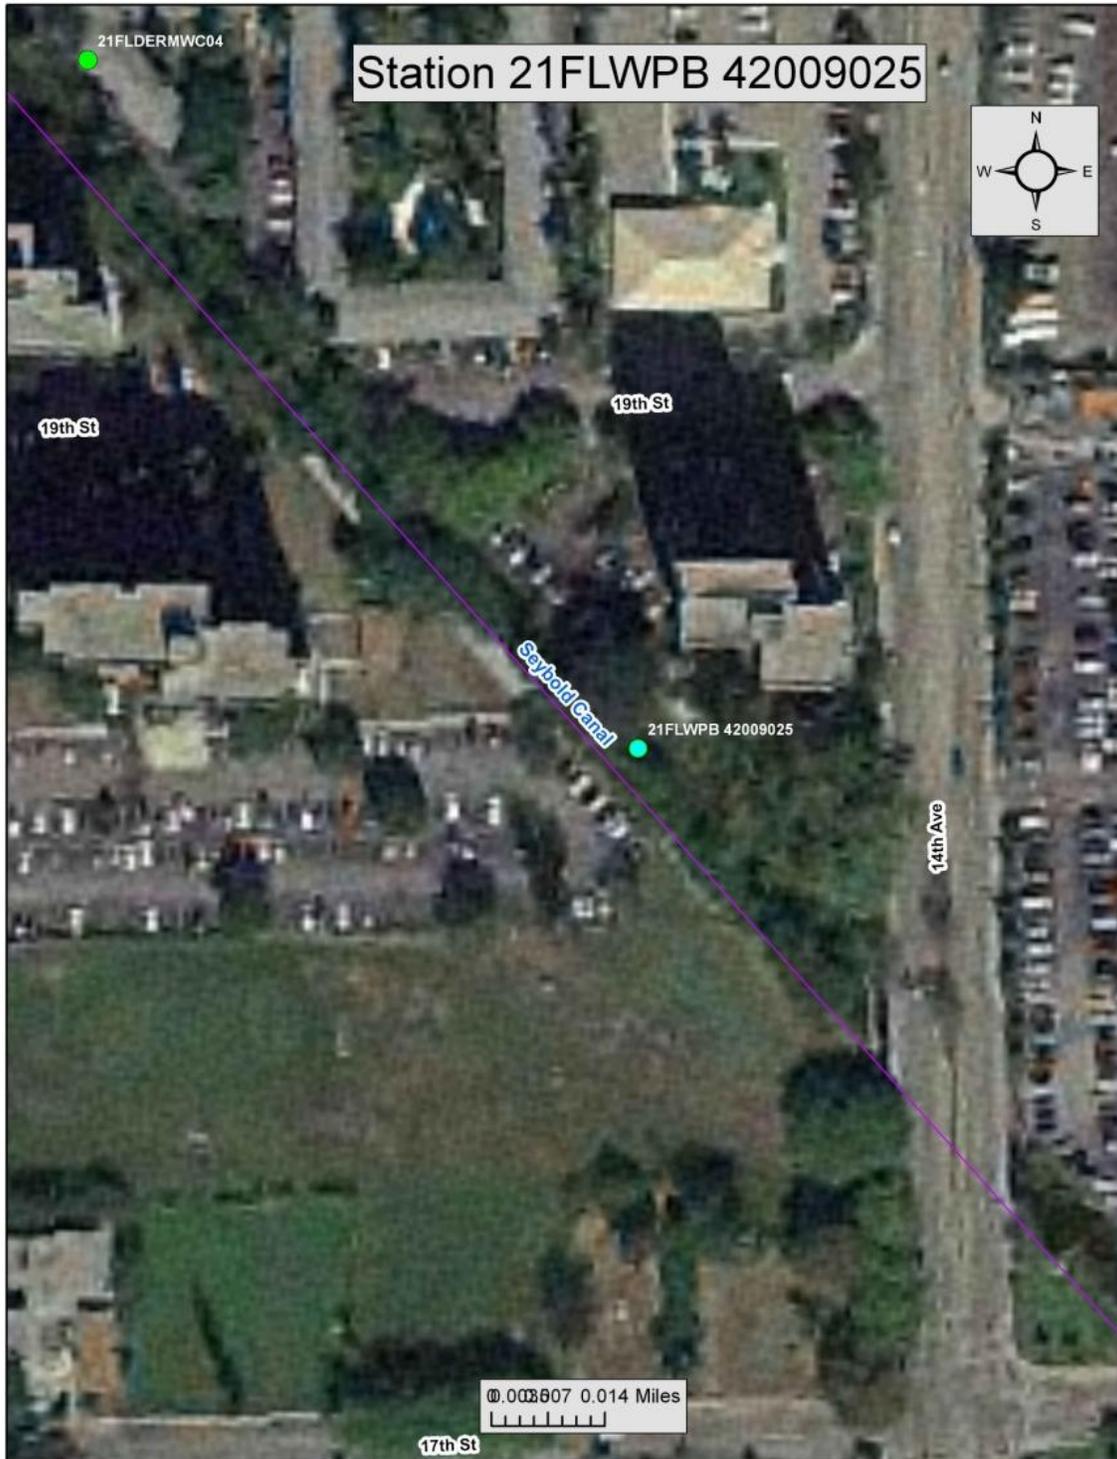
Figure 23. Aerial photo showing the location of Station 21FLWPB 42009025 along Wagner Creek–Seybold Canal. Note the apartment properties along the waterway. Additional research is needed to determine whether any of the apartments have a direct connection to Wagner Creek. The follow-up boat tour revealed several direct connections from the apartment complex to Wagner Creek.

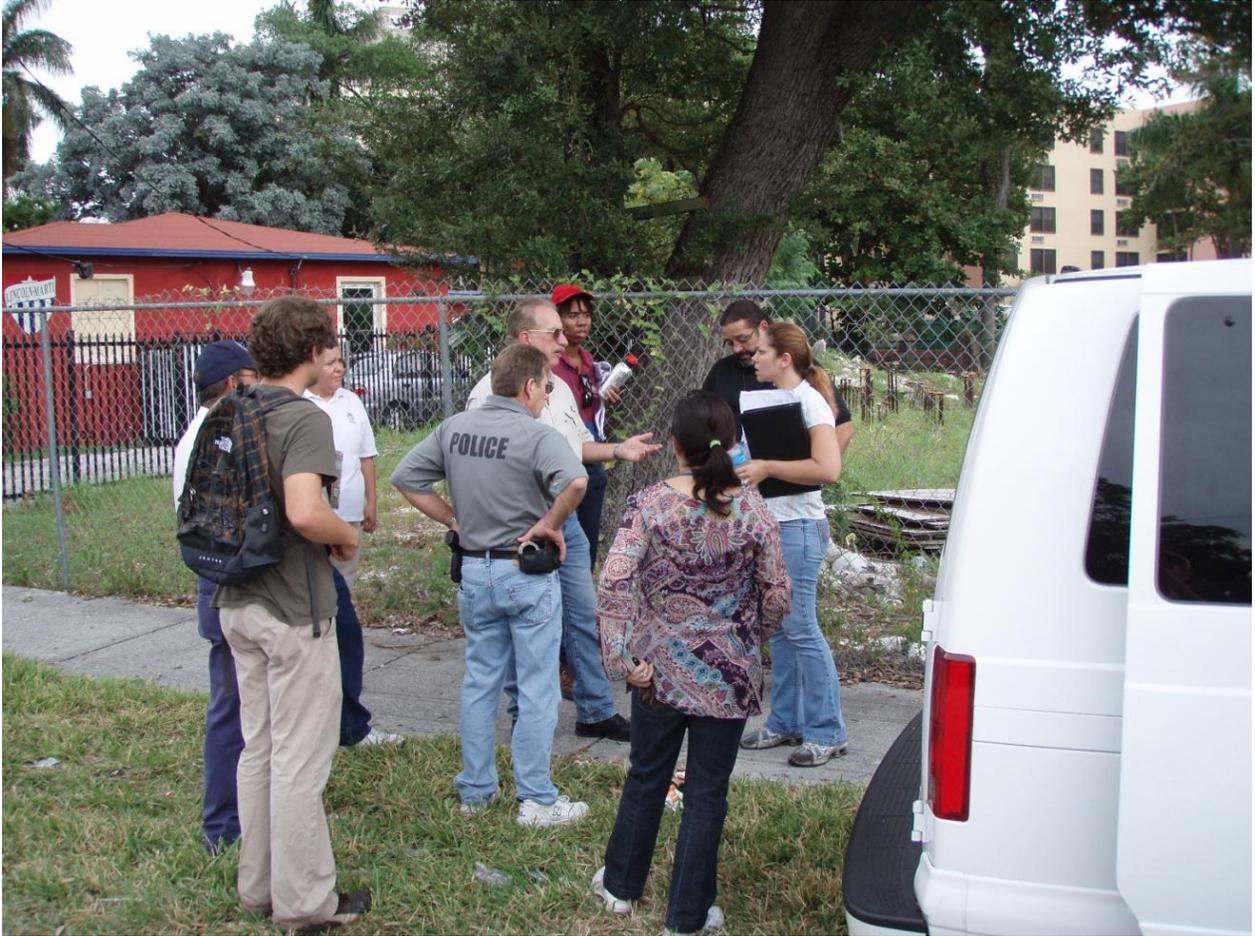
Figure 26. Team members and law enforcement personnel investigating potential septic system failures and PICs at NW 13th Court.

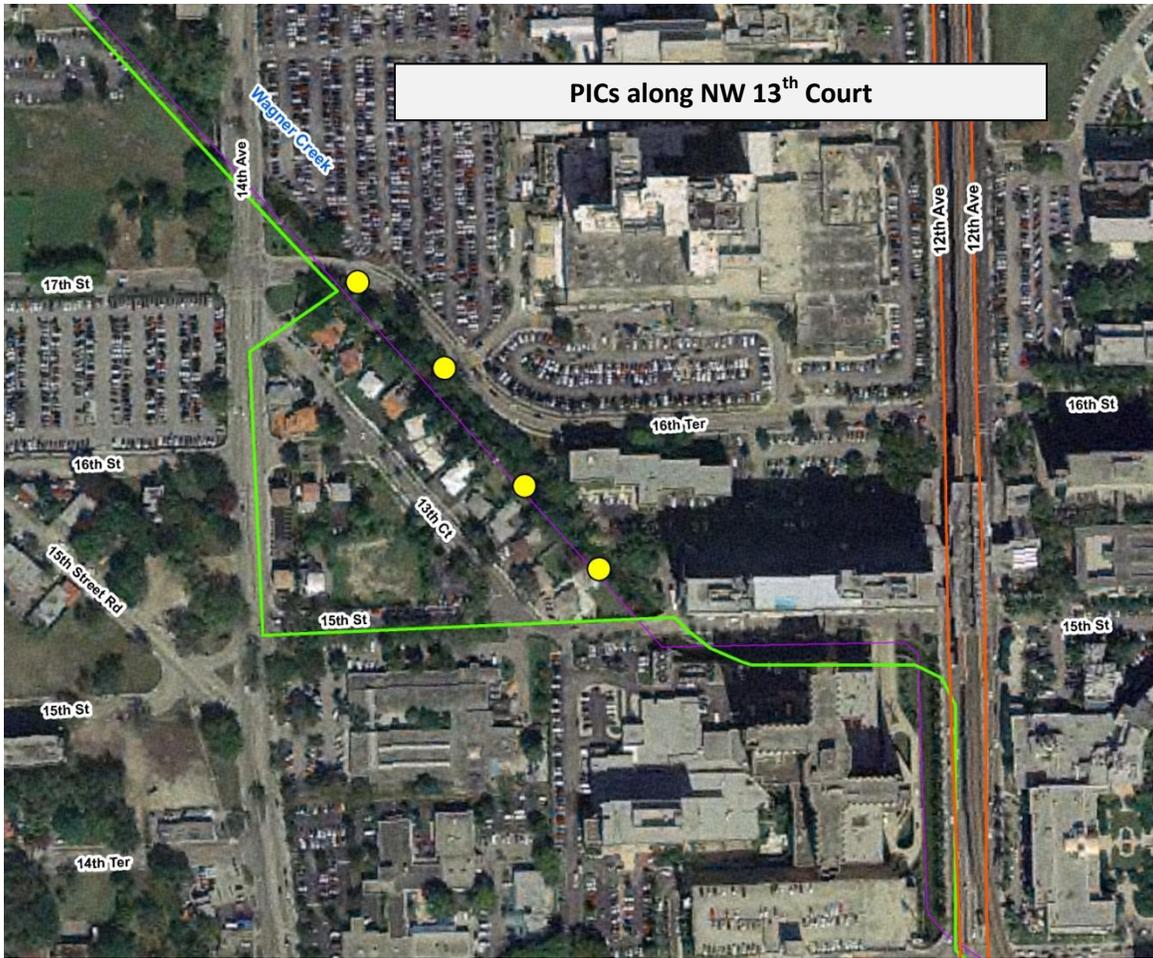
Figure 27. Aerial photo showing the locations of PICs along NW 13th Court.

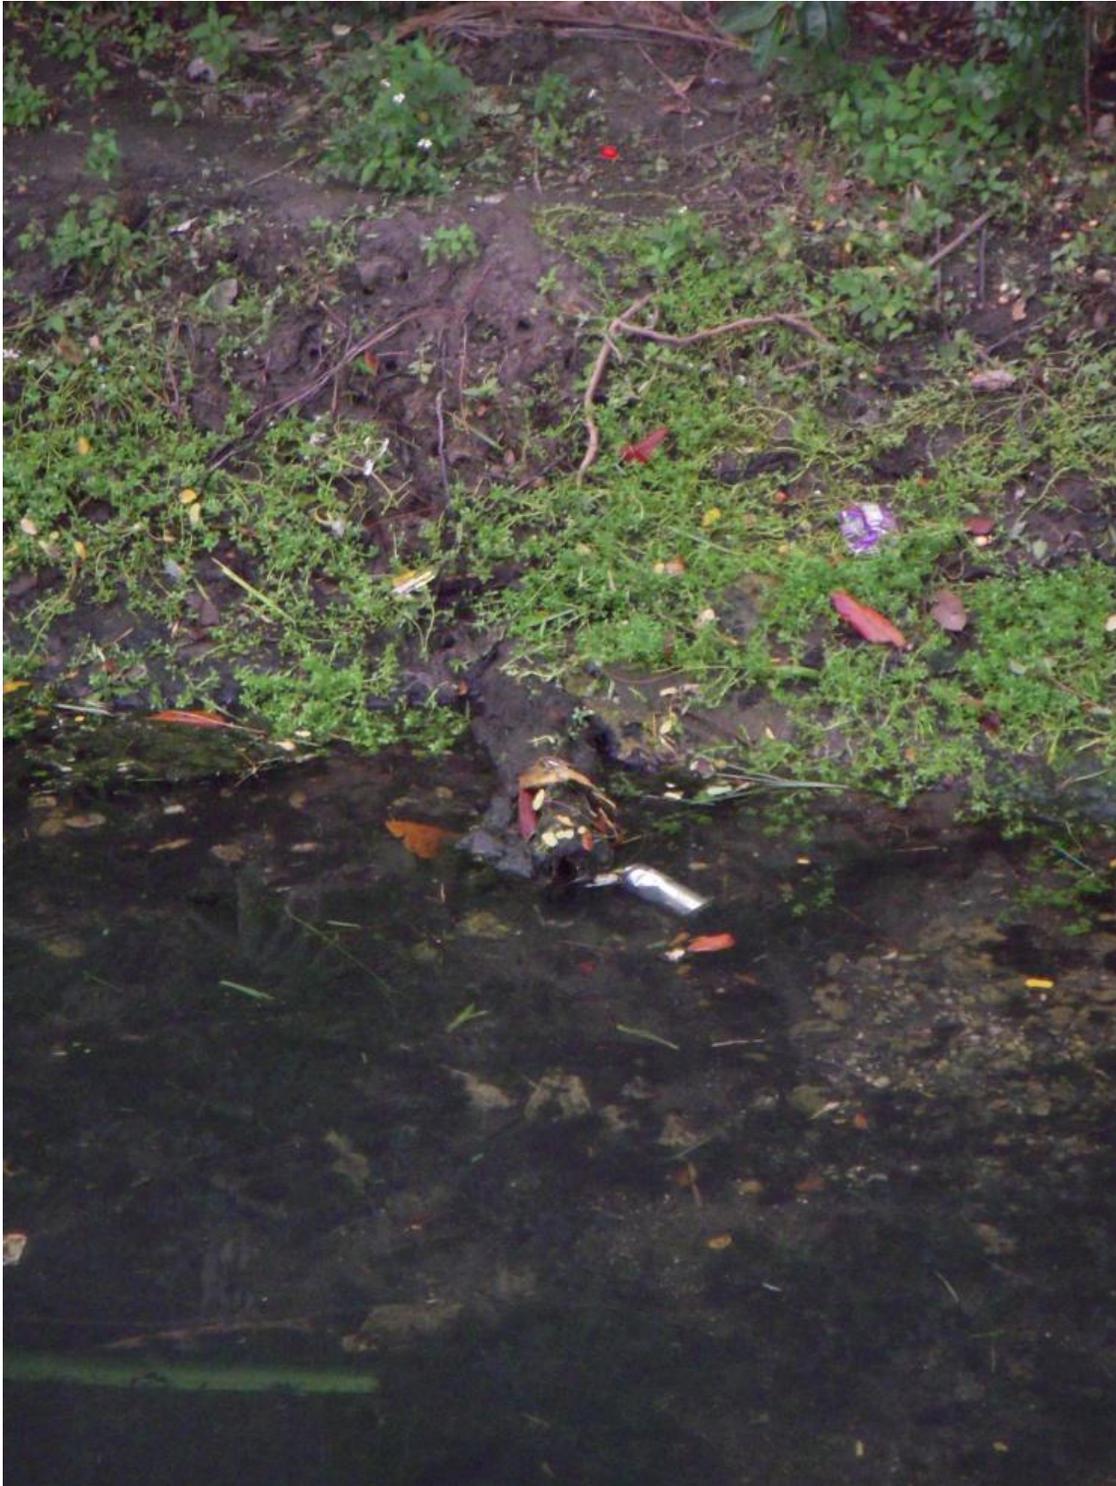
Figure 31. PIC 4 was thought to be a pipe but was confirmed to be a log.

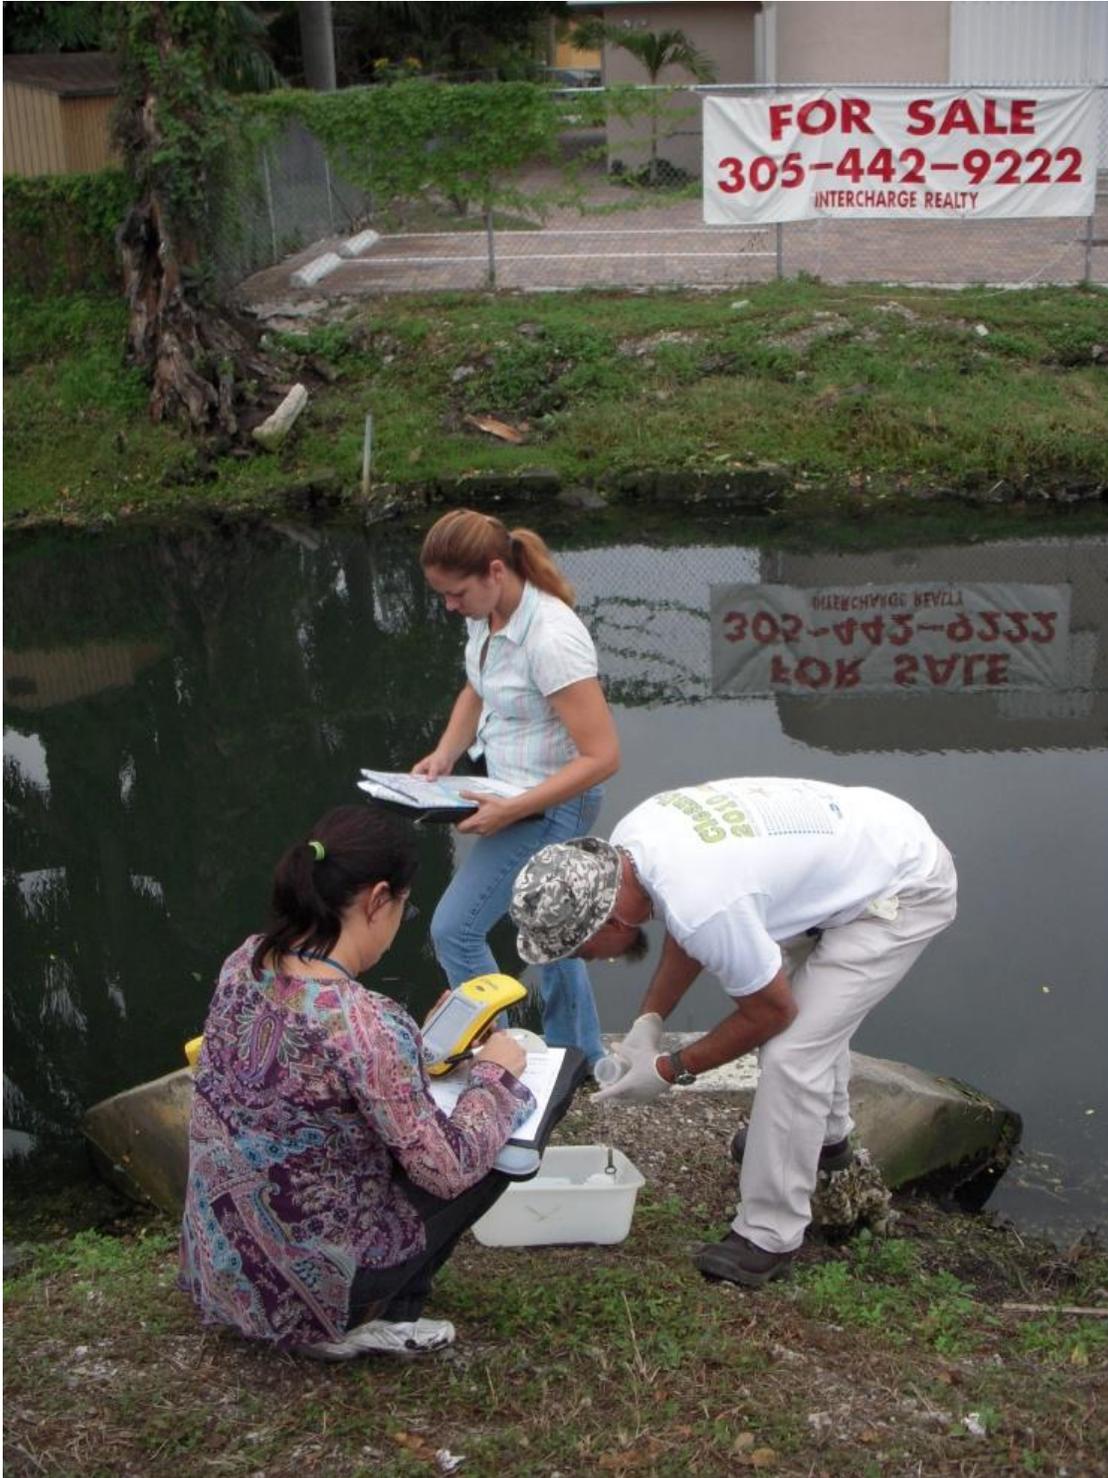
Figure 33. Walk the WBID team members carrying out water quality sampling at one of the VA Hospital outfalls.

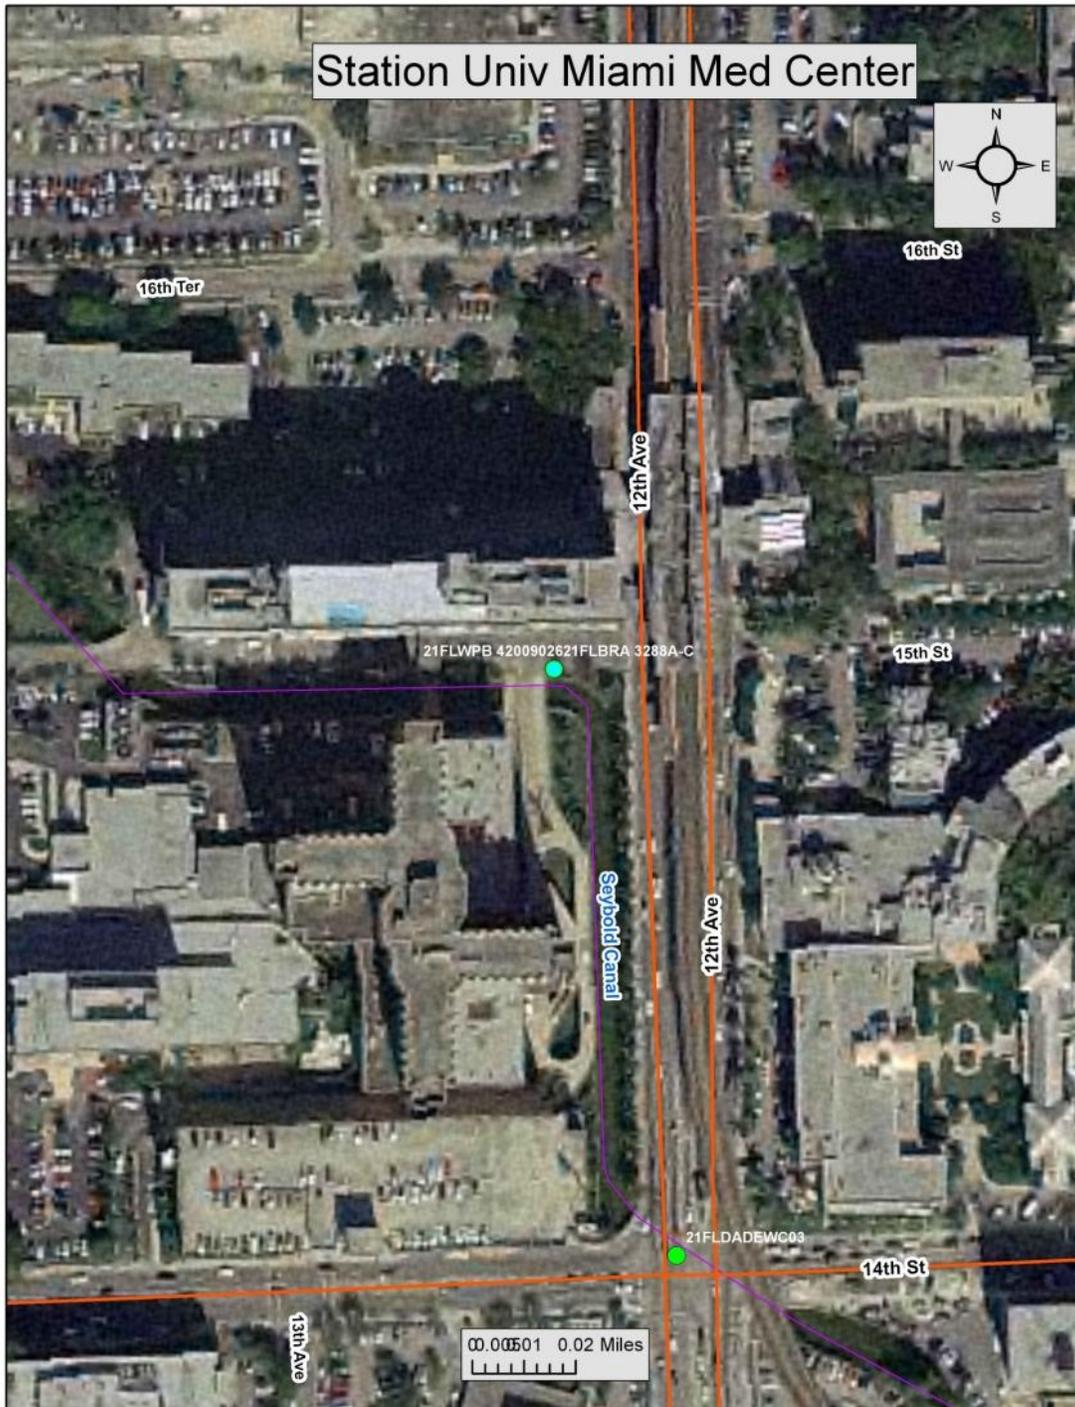
Figure 36. Aerial photo showing the location of Station 21FLWPB 42009026 along Wagner Creek–Seybold Canal, just to the north of the University of Miami Medical Center. Sylvester Comprehensive Cancer Center is visible on the east side of NW 12th Avenue.

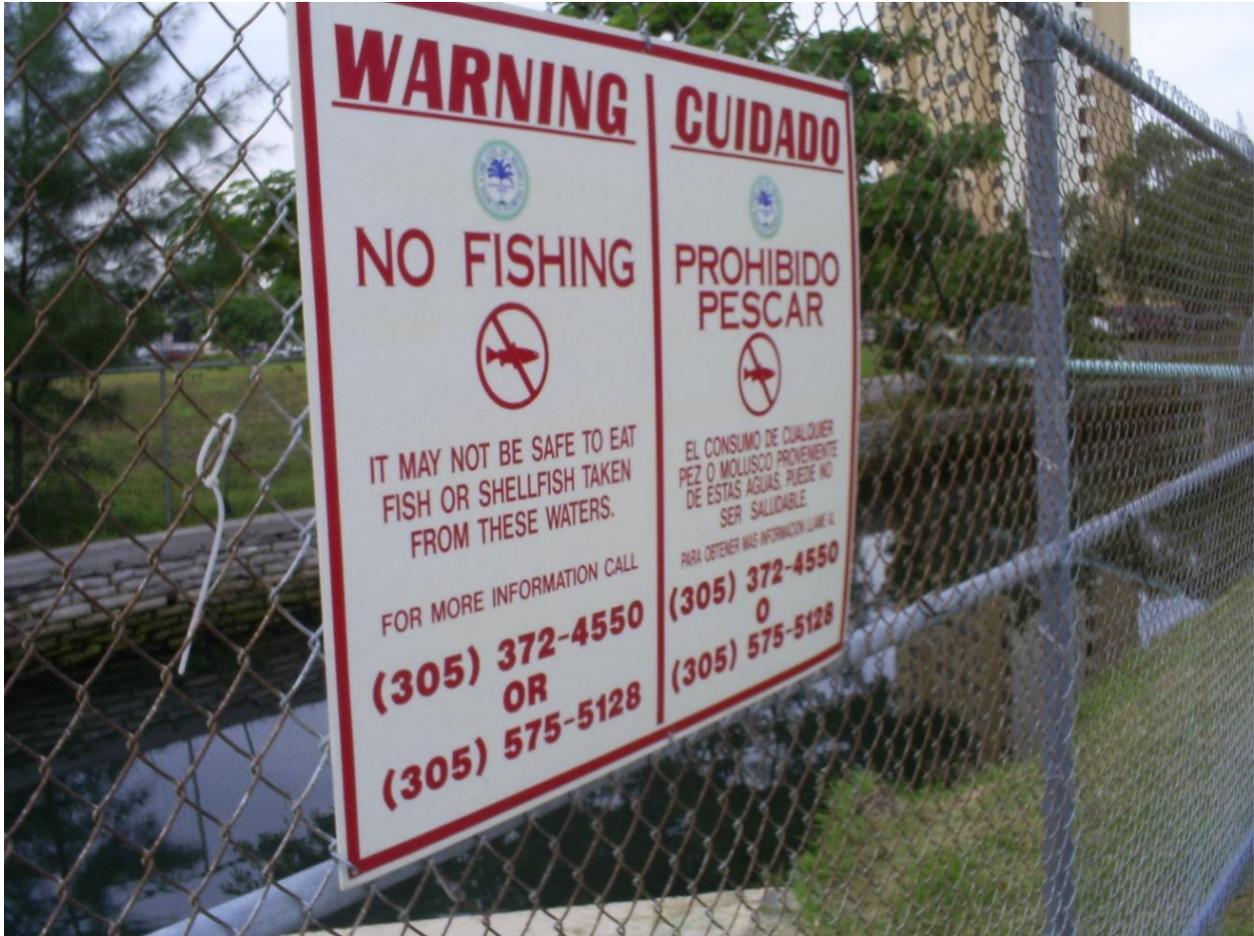
Figure 41. Access to Wagner Creek after the NW 14th Avenue Bridge is limited, and the team was not able to carry out its inspection because a boat is needed to inspect this area.

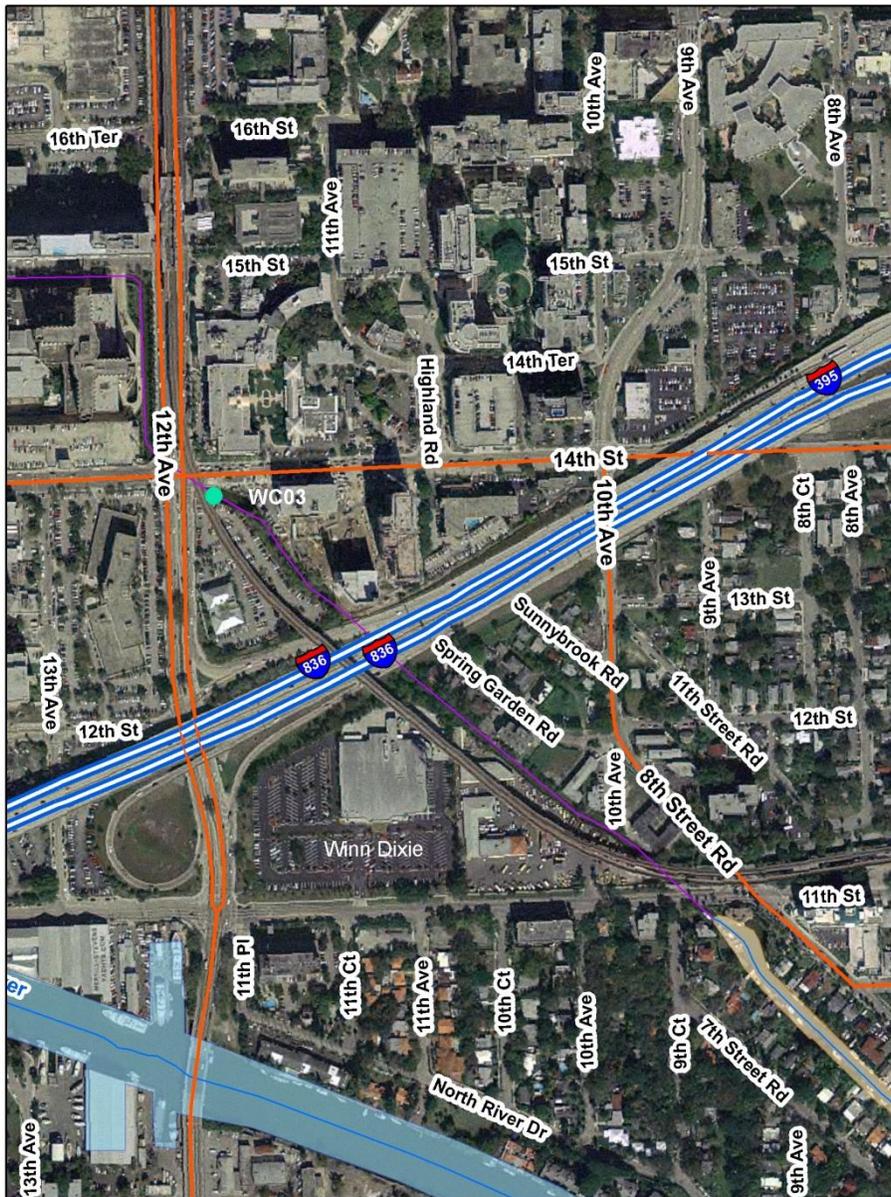
Figure 43. Aerial photo showing the location of Station WCO3 along Wagner Creek–Seybold Canal, adjacent to State Road 836, which is maintained by the Miami–Dade Expressway Authority. Note the drainage swales adjacent to the roadway. These may discharge to Wagner Creek, especially during high-flow conditions. The Winn-Dixie Supermarket, visible in the southwestern corner of the photograph, may have a direct connection to Wagner Creek.

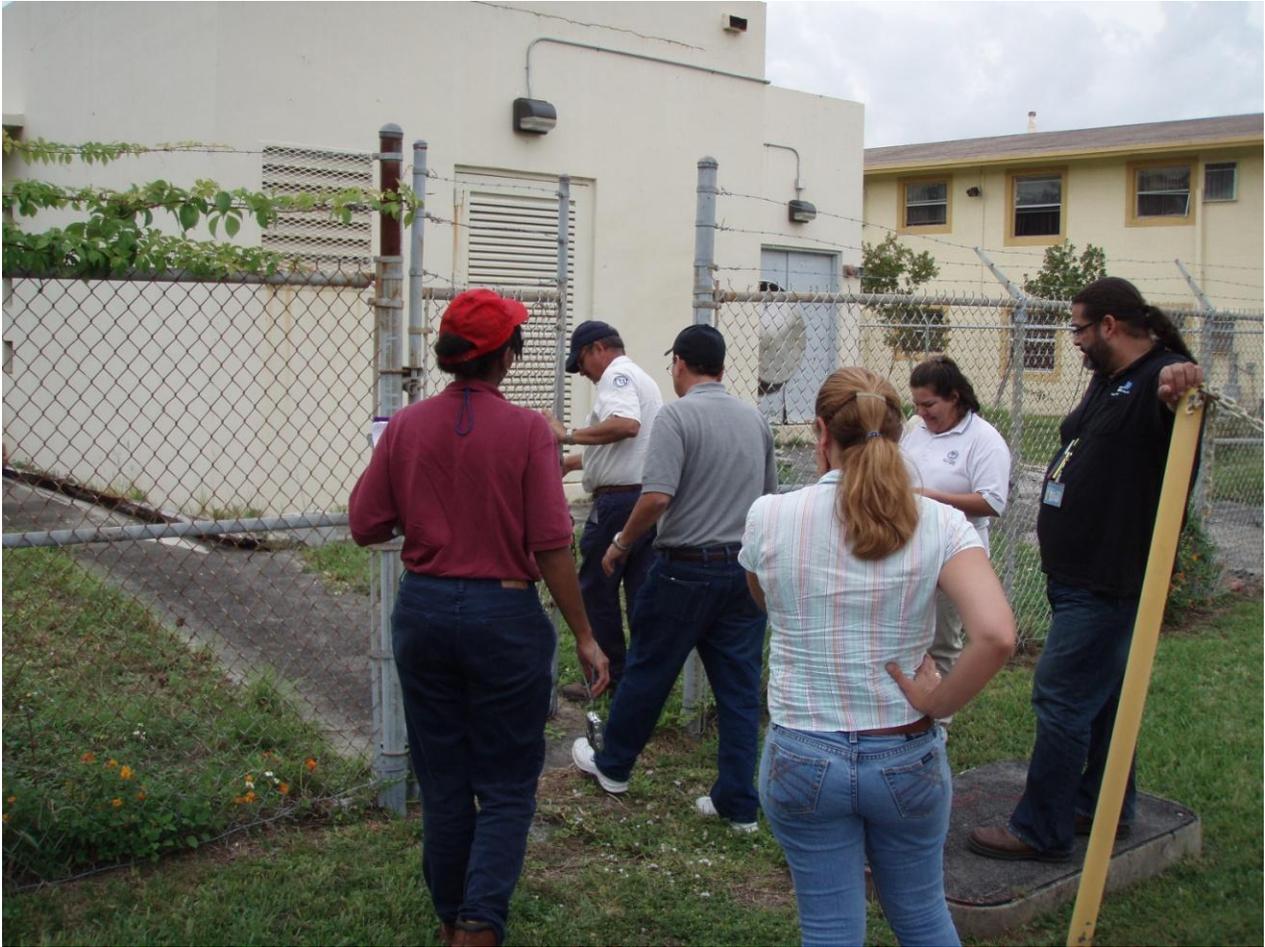
Figure 45. Team members inspecting the City of Miami Overtown stormwater pump station, where construction upgrades are incomplete.

POST-FIELD EVENT NOTE: The City of Miami is currently in litigation with the contractor who was supposed to complete the upgrades. The station has been inoperable for four years, and there is passive gravity flow to the creek from ponds. Documents are not available, and FDOT is checking on the hydrology of the area. The City of Miami obtained the project drawings that show how the Overtown Pump Station connects to Seybold Canal. The information is contained in three separate projects. Drawings for two of the projects were in the City of Miami records, and drawings for the third project had to be requested from FDOT archives. The records indicate that FDOT built the existing Overtown Pump Station as a replacement for a pump station constructed by the City of Miami that had to be removed due to FDOT's Midtown Interchange Project, which routed Interstate 95 and State Road 836/Interstate 395 through the Overtown neighborhood. The project plans confirmed the connection between the Overtown Stormwater Pump Station, the FDOT ponds, and Seybold Canal.

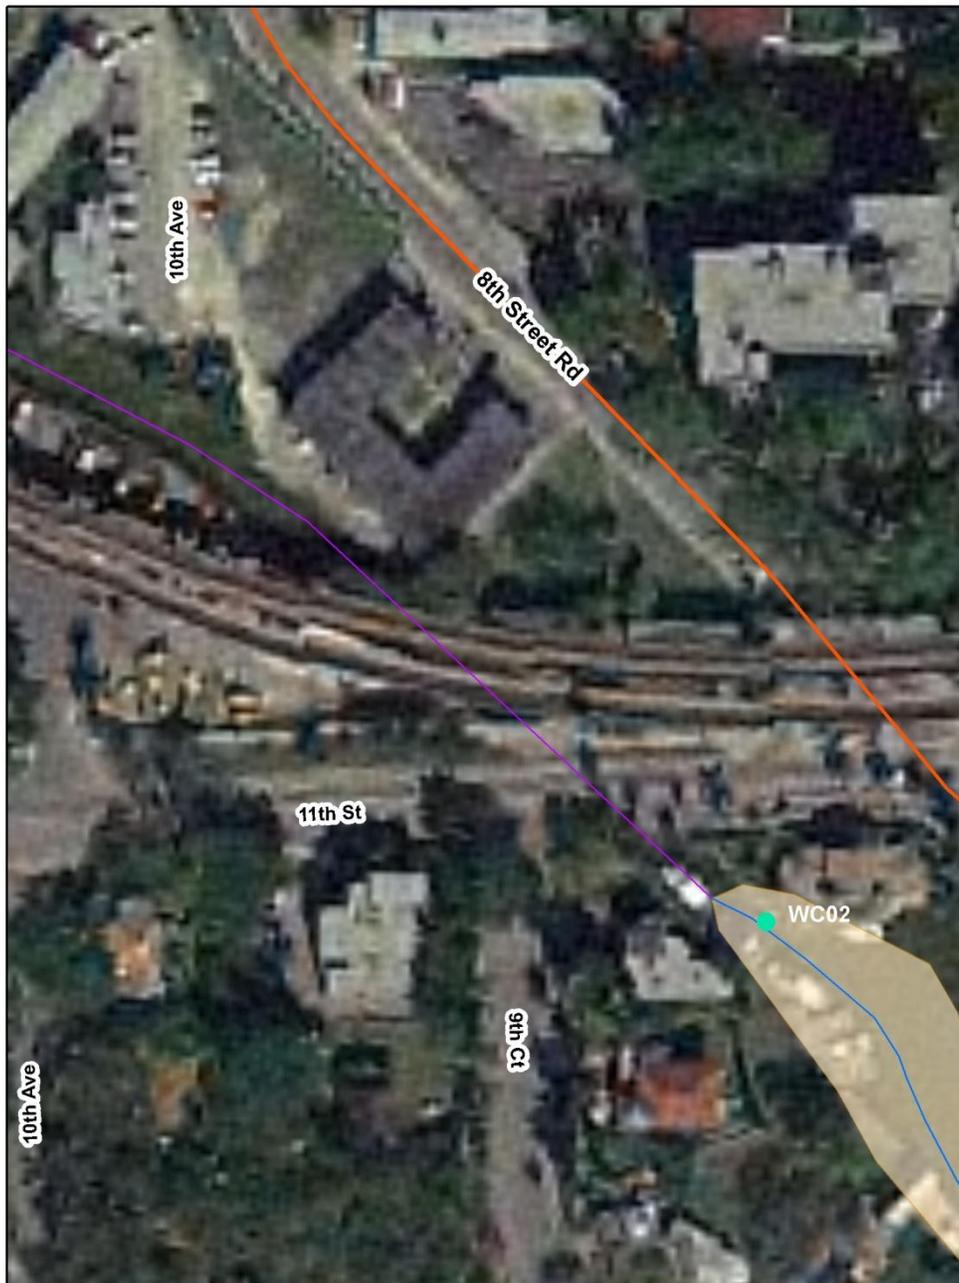
Figure 47. Aerial photo showing the location of Station WCO2 along Wagner Creek–Seybold Canal. A portion of the Miami–Dade County Water and Sewer Department Water Distribution Facility is visible adjacent to Wagner Creek in the westernmost portion of the photo (at far left) to the south of the Metrorail tracks.

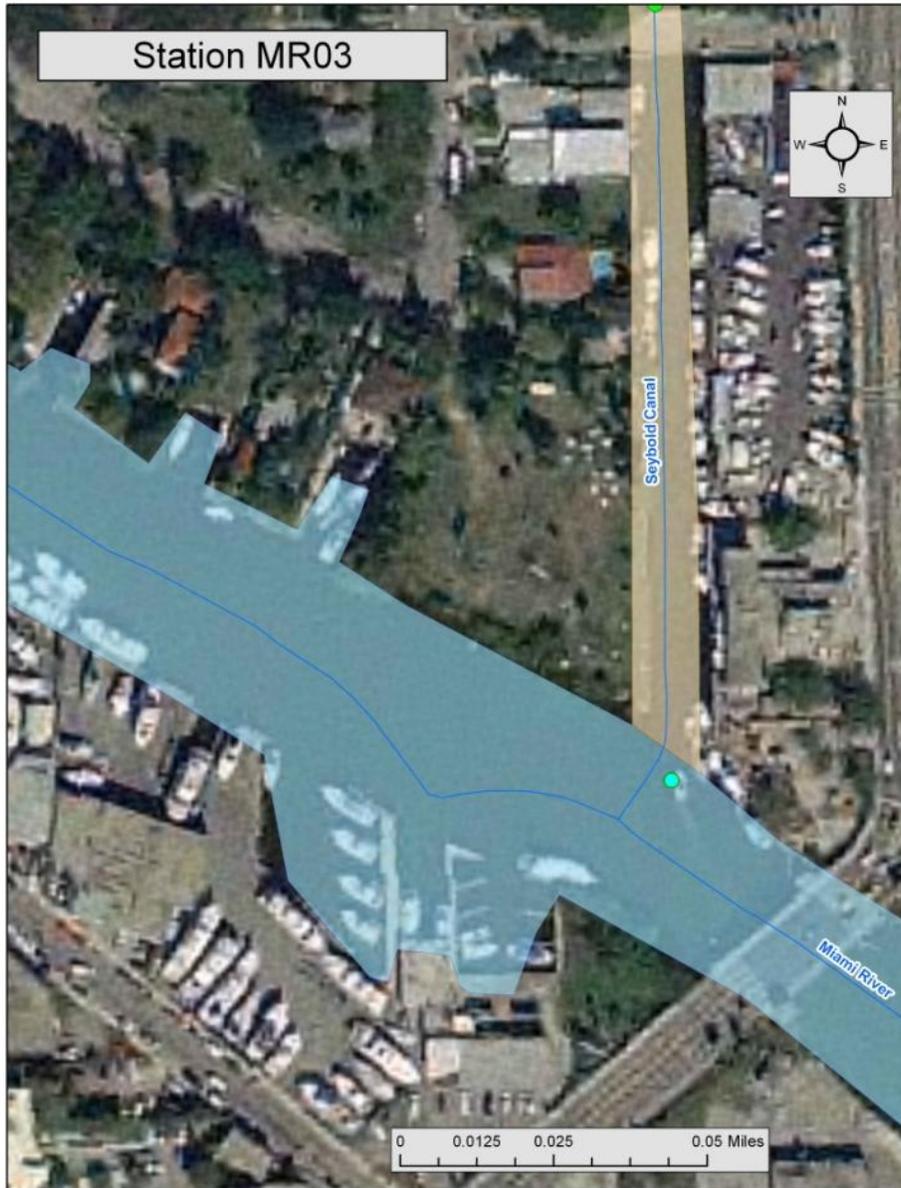
Figure 50. Aerial photo showing the location of Station MRO3, just downstream of where Wagner Creek–Seybold Canal merges with the Miami River. The City of Miami’s Point Park is visible at the confluence of Seybold Canal and the Miami River. A portion of NW 7th Avenue and its bridge that crosses the Miami River are visible on the easternmost portion of the photo (at far right).

POST-FIELD EVENT NOTE: City of Miami records indicate that there are 2 outfalls in the northernmost part of this photo (at top) at the NW 7th Street Bridge. One is a 72-inch line that city records indicate carries the discharge from the Overtown Pump Station. The City of Miami is listed as the owner, and FDOT is listed as the entity with permanent maintenance responsibility for this outfall. The other outfall is a 60-inch by 48-inch box that City of Miami records indicate is owned by FDOT.

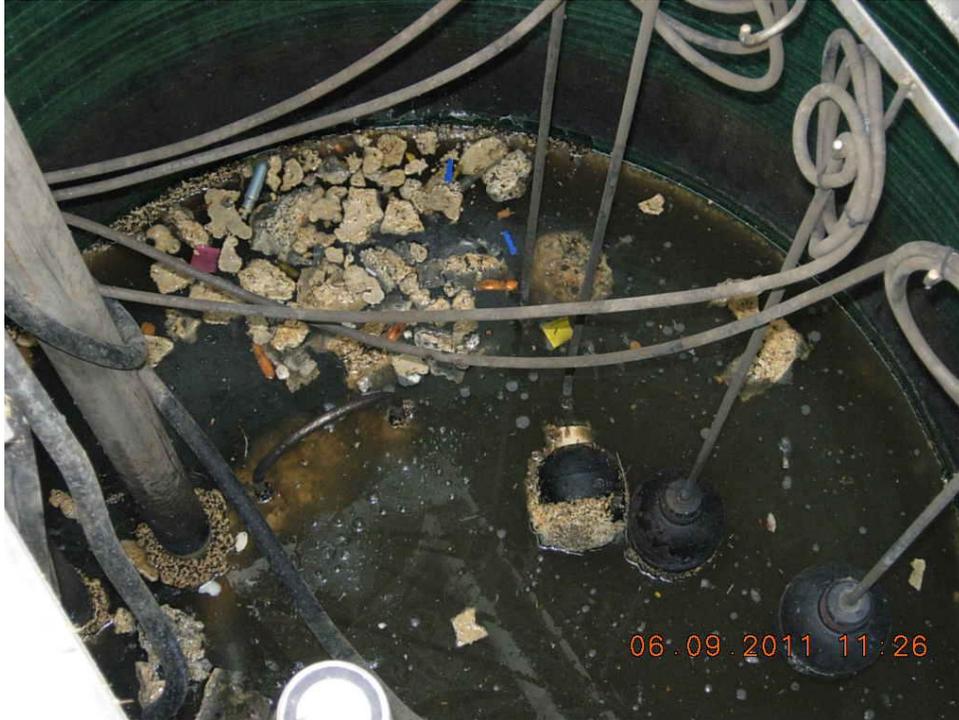
Figure 59. Interior of the new lift station.

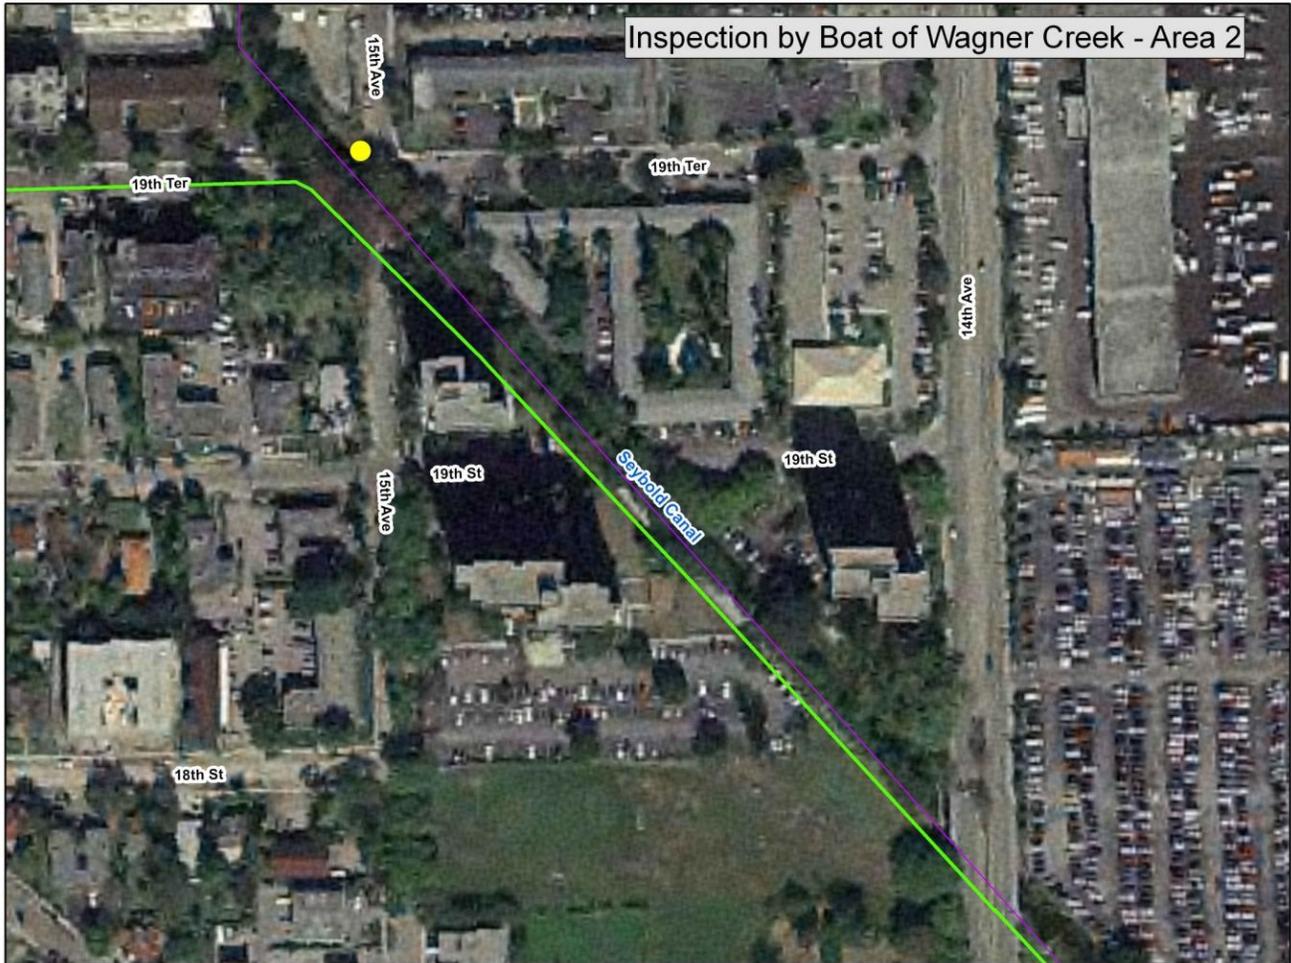
Figure 61. Aerial photo of Boat Tour Area 2, located between NW 19th Terrace and NW 14th Avenue. After leaving the VA Hospital, the field team entered this portion of the creek at NW 19th Terrace and NW 15th Avenue and surveyed it from north to south. An odor of dead fish was detected approximately midway through the tour, but no dead fish were observed.

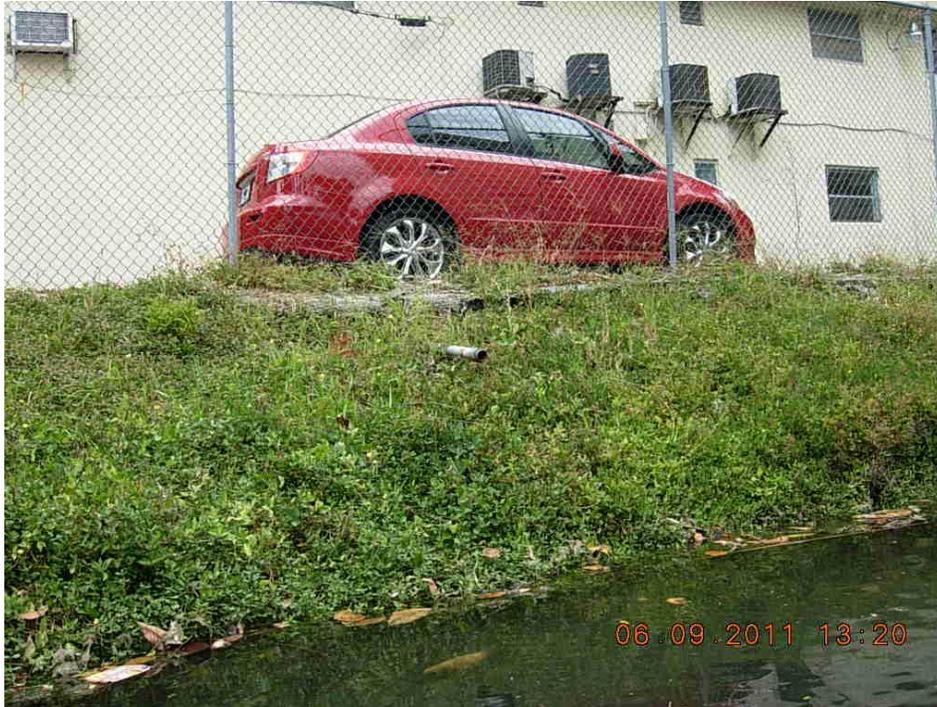
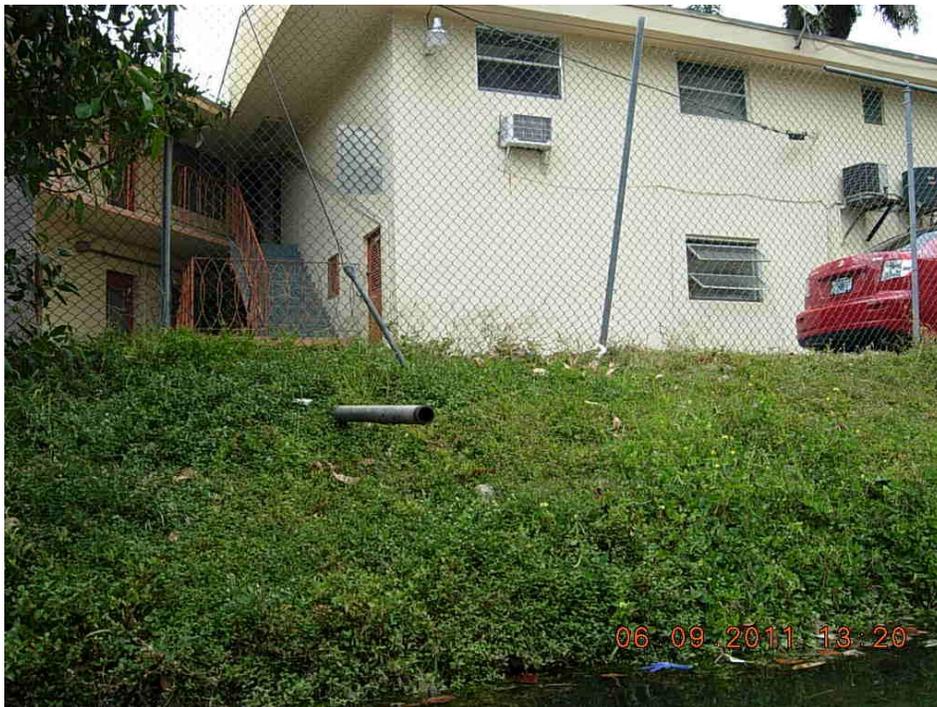
Figure 64. Farther south, two 2-inch diameter metal pipes extended from the same apartment complex. The pipes were within 10 feet of each other. GPS coordinates are 25 47' 36.699" N, 80 13' 15.300" W.
