Summary of Results

Walk the WBID Exercise for Wagner Creek (WBID 3288A)

September 2011

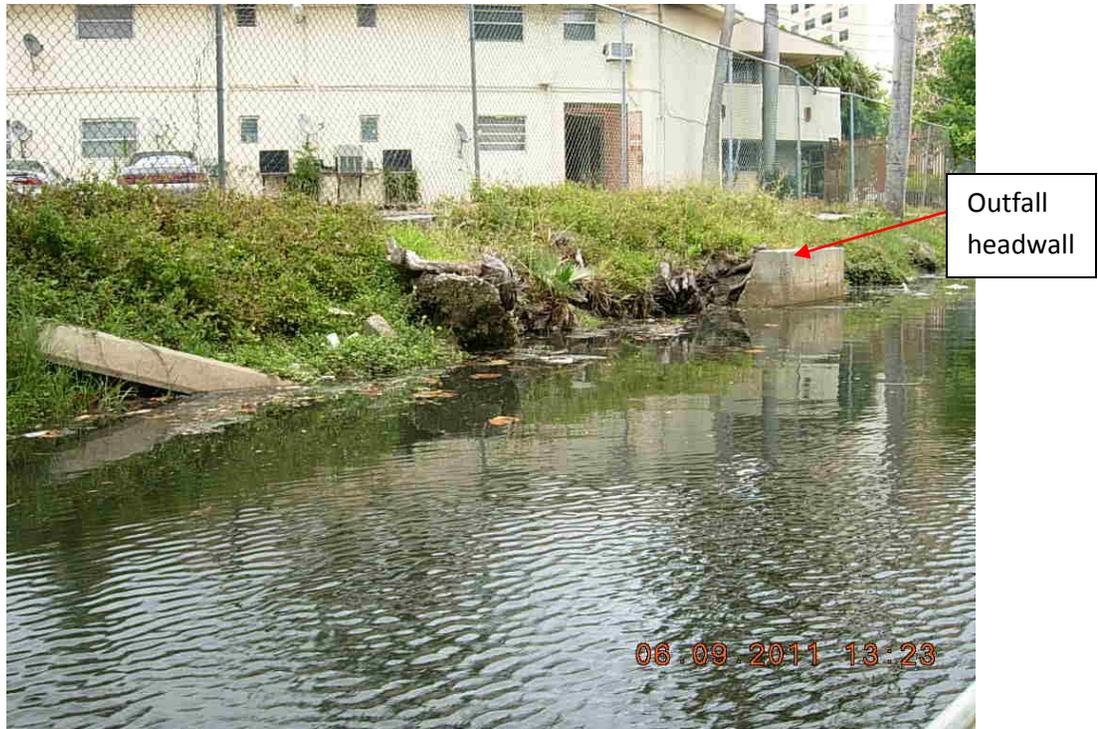
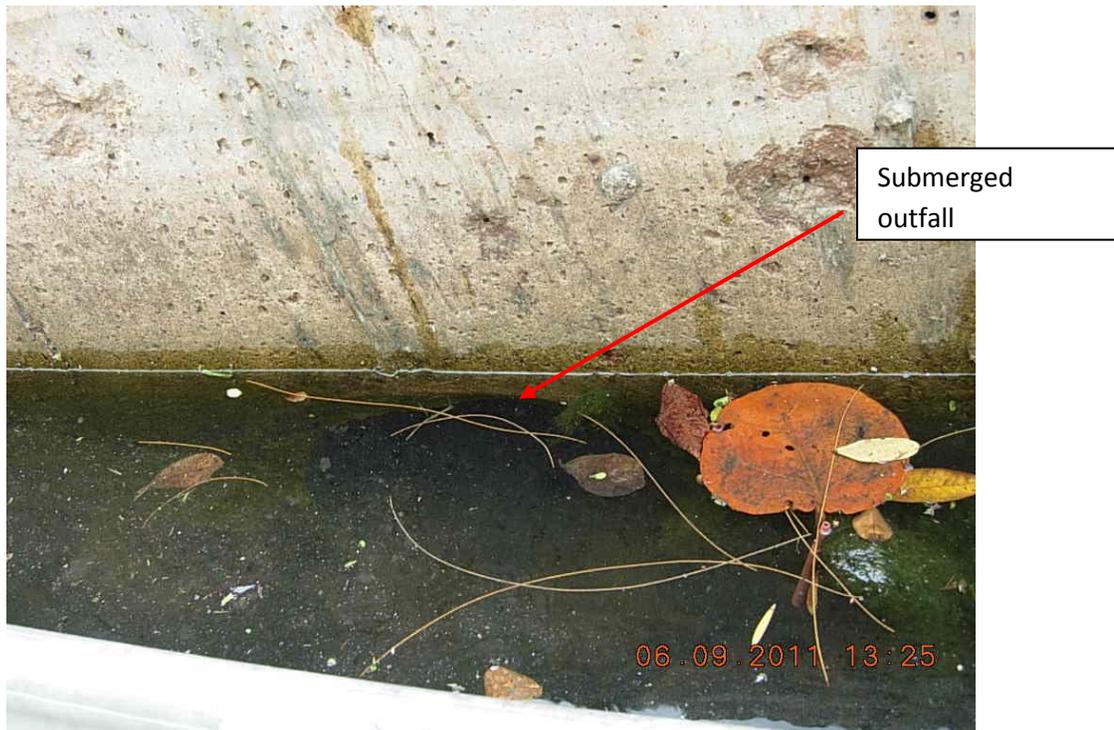
Outfall headwall

Submerged outfall

Figure 66. Farther to the south, a fully submerged outfall with a headwall also appeared to belong to the same apartment complex. GPS coordinates are 25 47' 35.516" N, 80 13' 13.977" W.

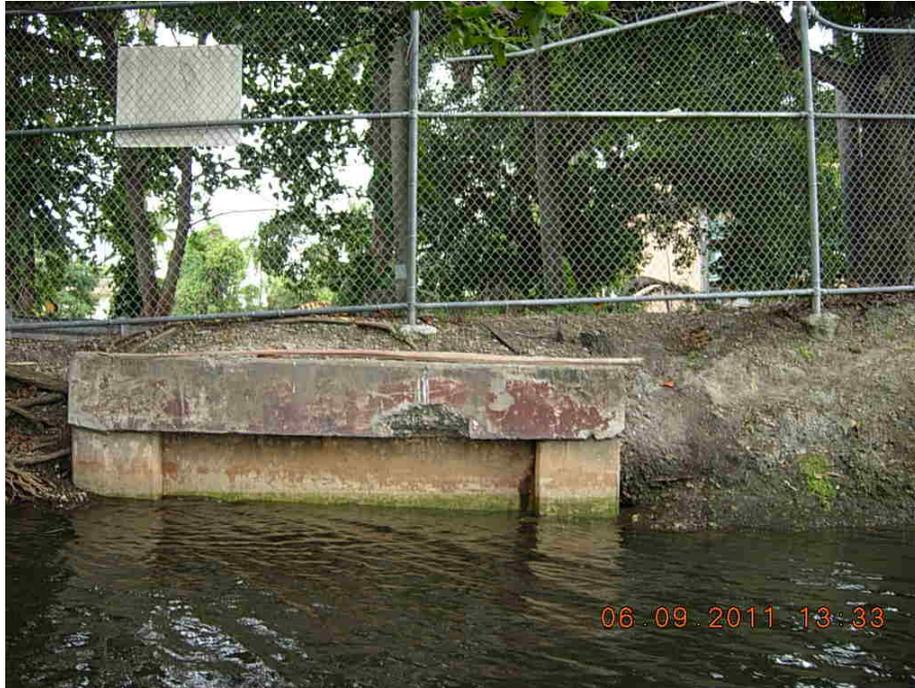
Figure 68. A submerged outfall that appears to be from the public storm sewer system is located across the street from NW 19th Terrace near the put-in point.

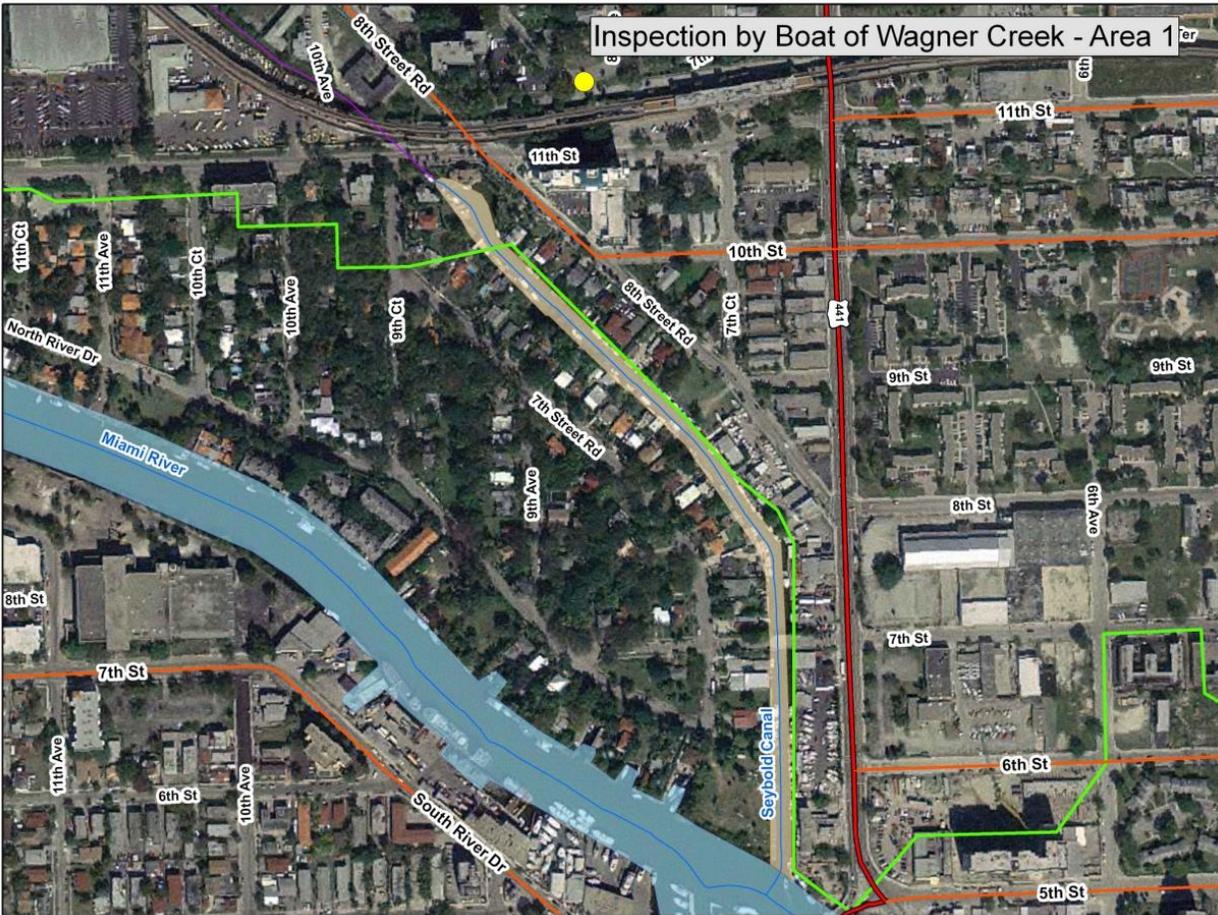
Figure 70. Aerial photo of Boat Tour Area 1. The field team entered this area from Miami's Point Park at the confluence of the Miami River and Seybold Canal and surveyed the area from south to north. A manatee was seen in the southern portion of the creek, but the team was not able to take a photo.

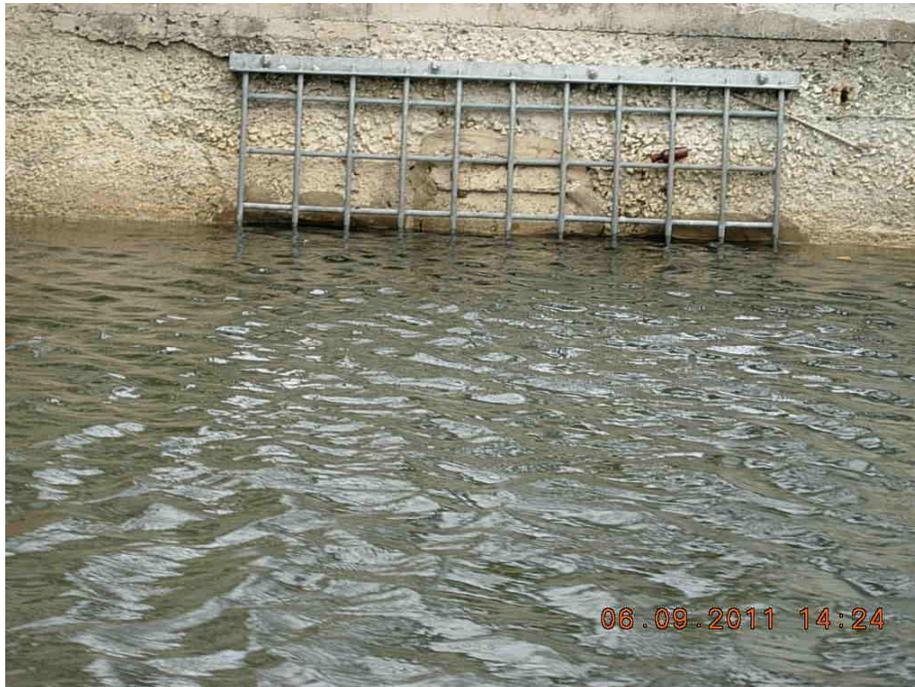
Figure 74. A sealed outfall with a manatee grate at NW 7th Avenue and NW 7th Street. No GPS coordinates were taken.

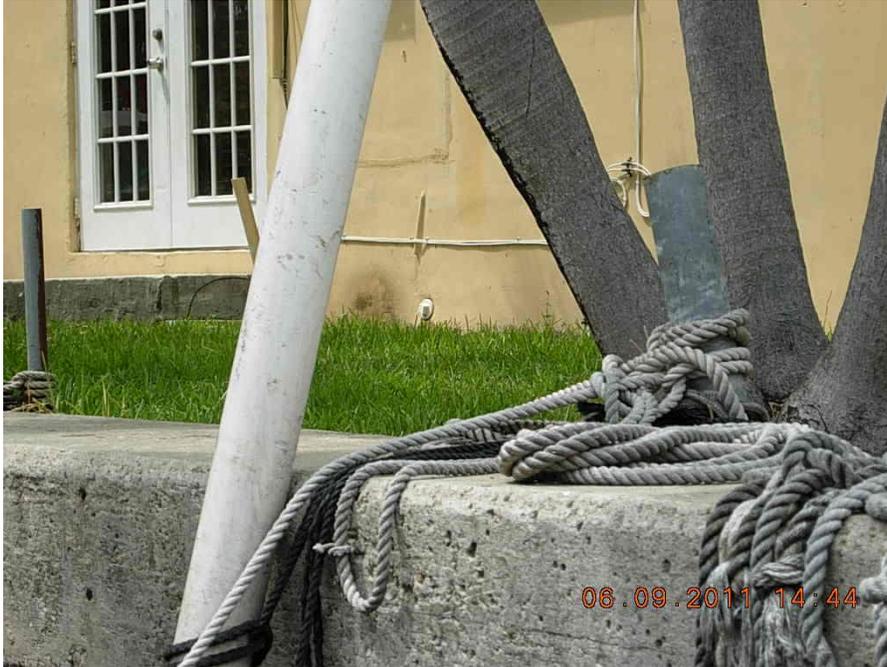
Figure 79. A capped lateral (possibly sanitary) at what appeared to be an apartment house. The approximate address is 938-942 NW 8th Street. GPS coordinates are 25 46' 57.495" N, 80 12' 31.280" W.

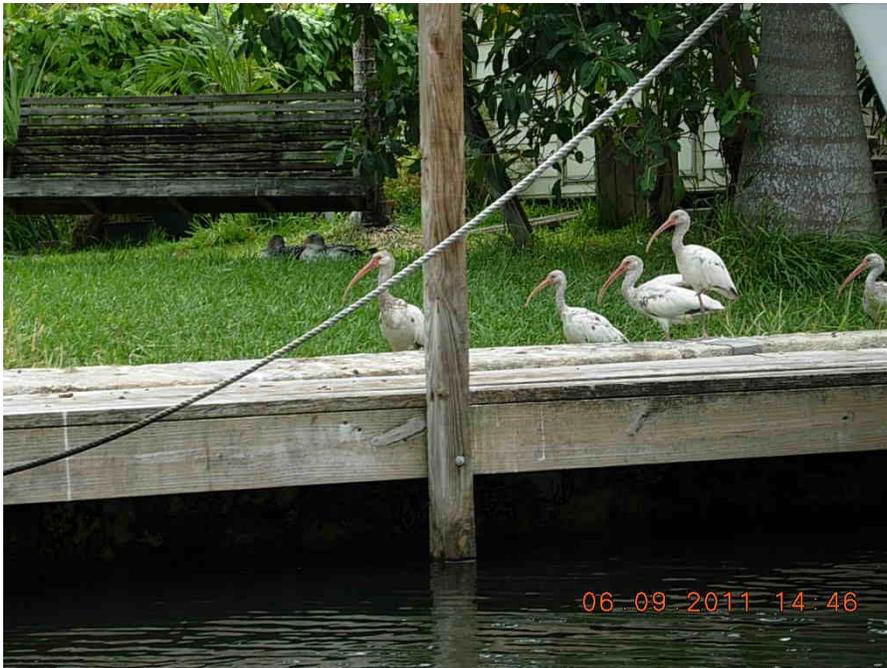
Figure 80. A family of ibises on the south shore of Seybold Canal. No GPS coordinates were taken.
